Midair collision involving Eurocopter EC130 B4, VH-XH9, and Eurocopter EC130 B4, VH-XKQ

Main Beach, Gold Coast, Queensland, on 2 January 2023

ATSB Transport Safety Report

AO-2023-001

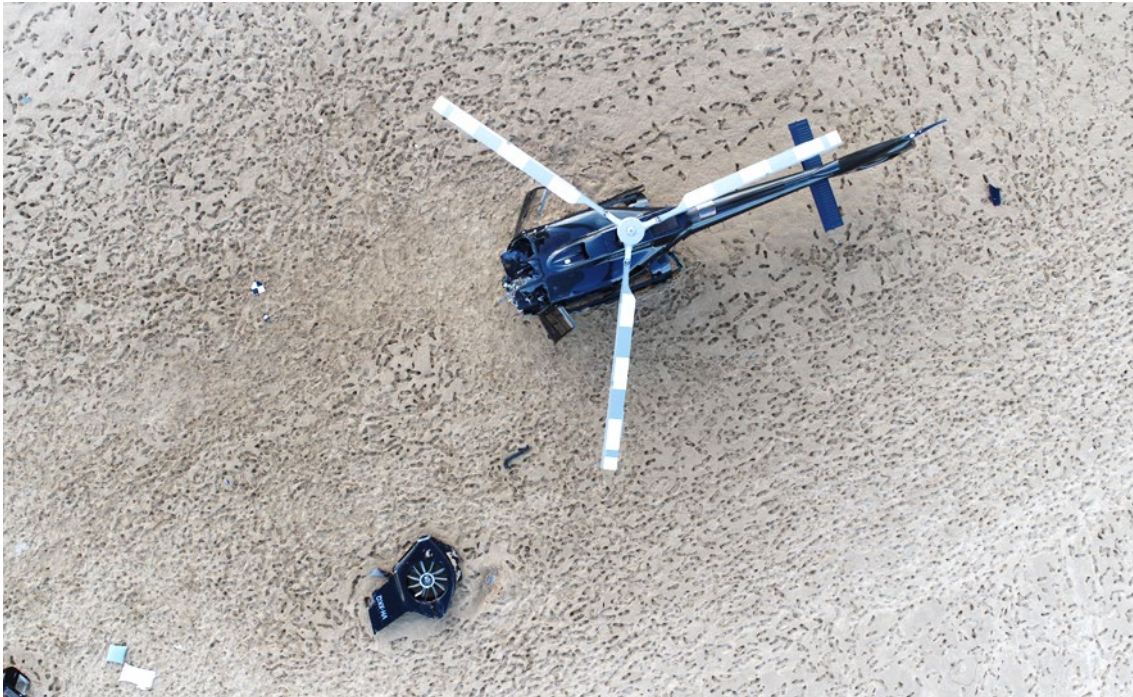
Figure 18: VH-XH9

XH9 landed near to the separated Fenestron from XKQ. The main rotor blades of XH9 display a high-visibility paint scheme.
Source: Queensland Police Service

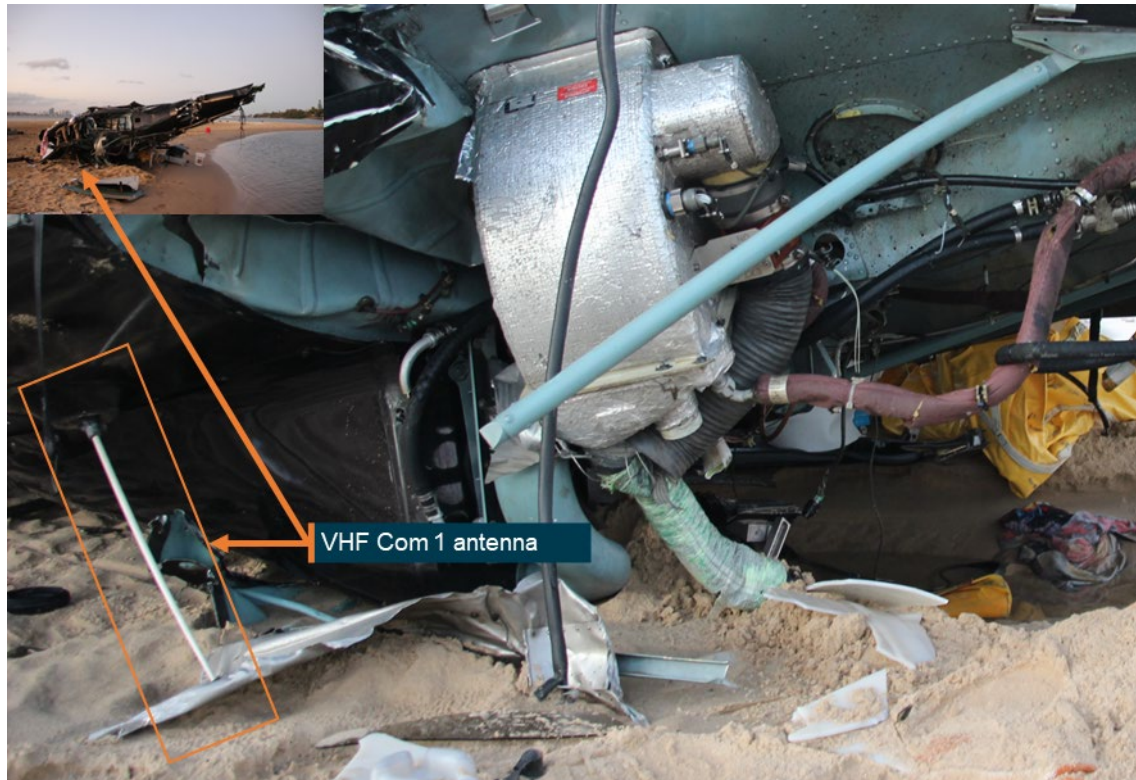
Figure 44: The VHF Com 1 antenna (main) from XKQ at the accident site (inset)

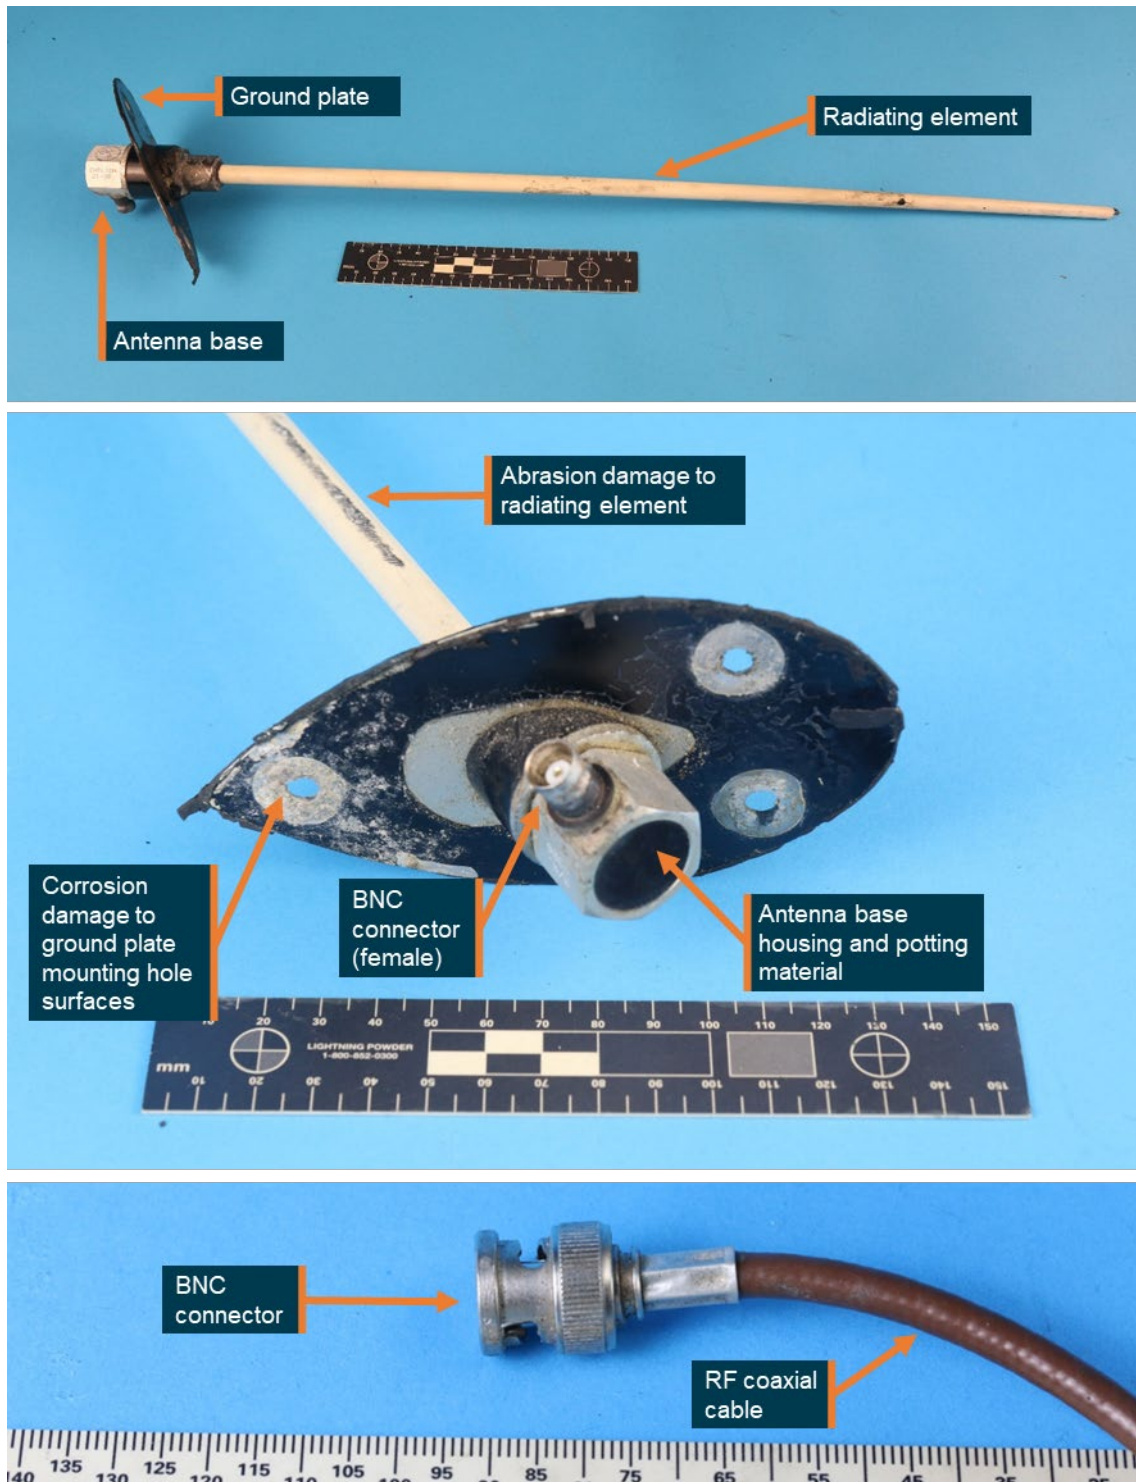
Figure 45: The Com 1 antenna and BNC connector from XKQ

Surface corrosion was identified to each of the underside mounting holes of the ground plate.
Source: ATSB

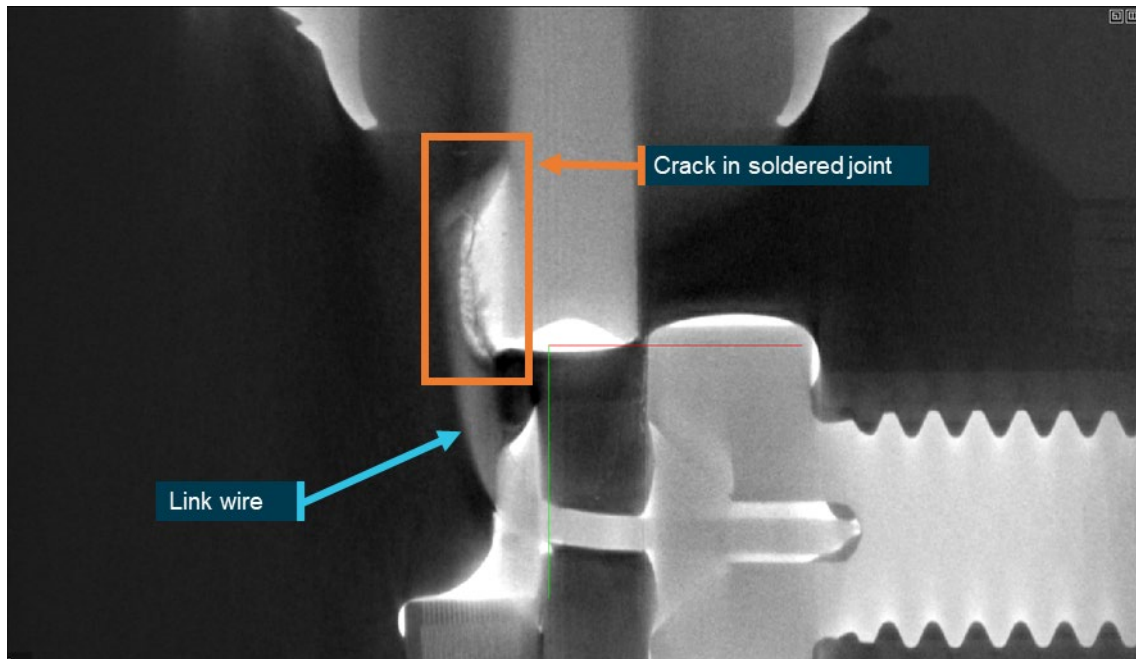
Figure 46: An X-ray of the antenna base identified a crack indication where the link wire was soldered to the circuit board (prior to destructive examination)

The X-ray image was captured when the antenna was intact.
 Source: Australian National University CTLab, annotated by the ATSB

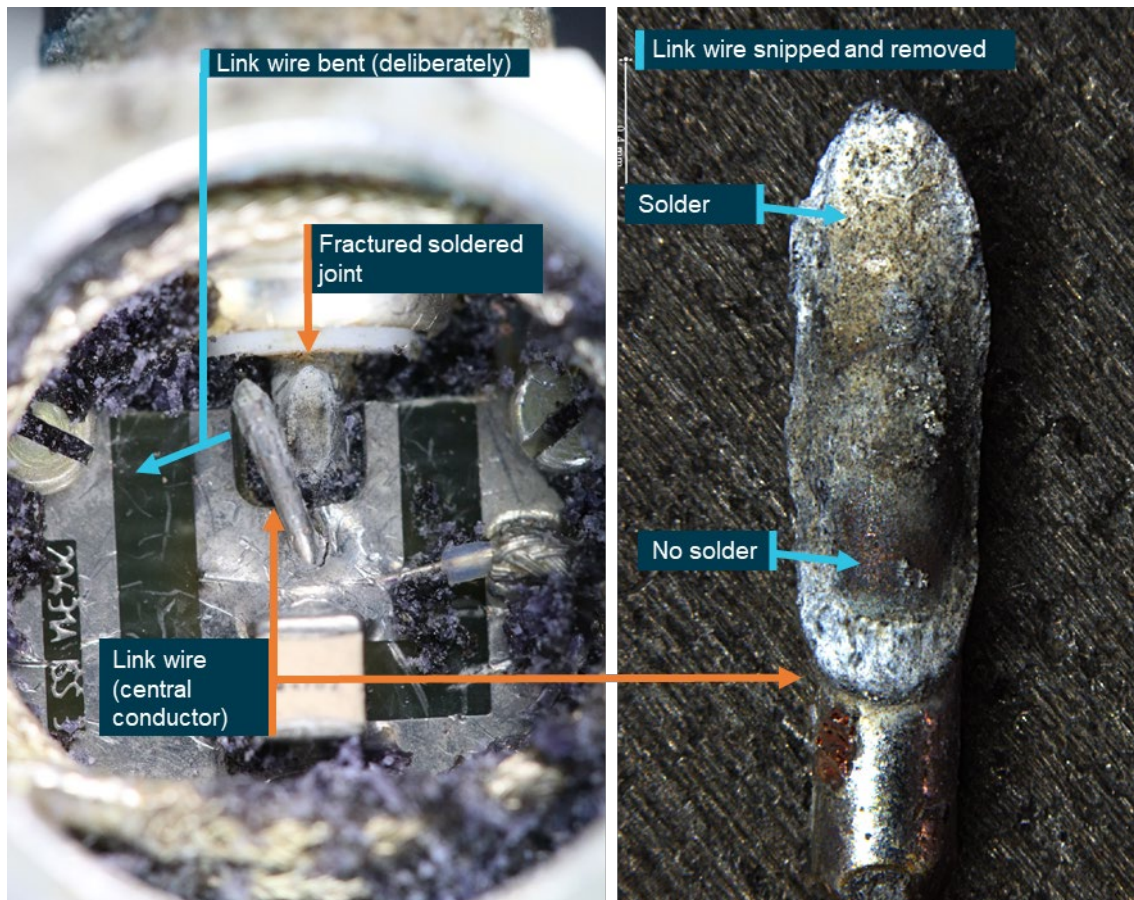
Figure 48: View from within the antenna base showing that the link wire at the soldered joint had cracked then fractured from the circuit board and then over time the surfaces had oxidised

Upon removal of the potting compound, the link wire (central conductor) was able to be moved to the side, confirming that it had fractured from the circuit board.
Source: ATSB

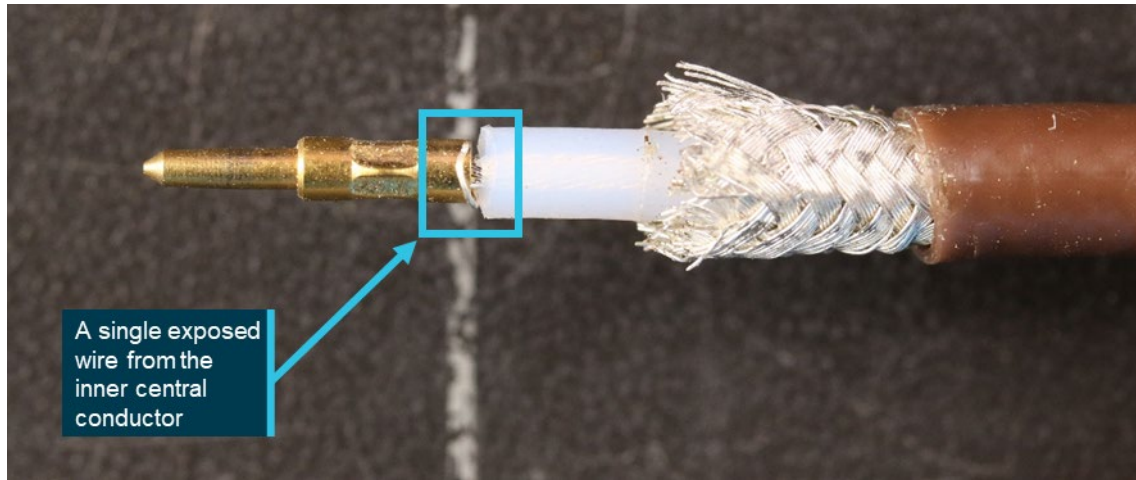
Figure 49: Stray wire from the core of the coaxial cable within the BNC connector was found outside the centre pin

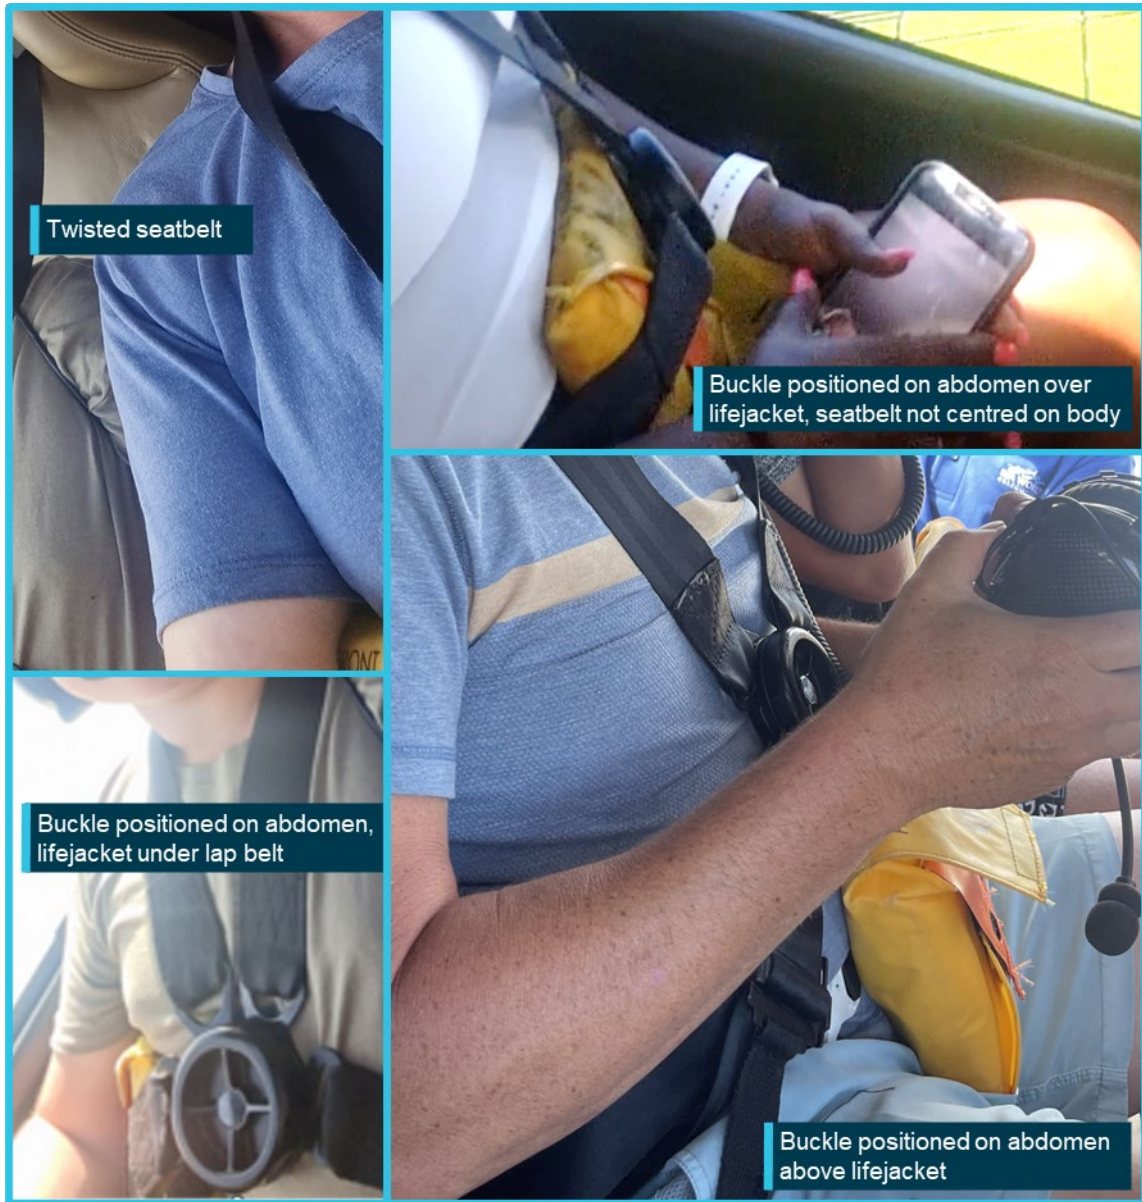
Figure 53: Examples of passenger incorrect seatbelt fitment

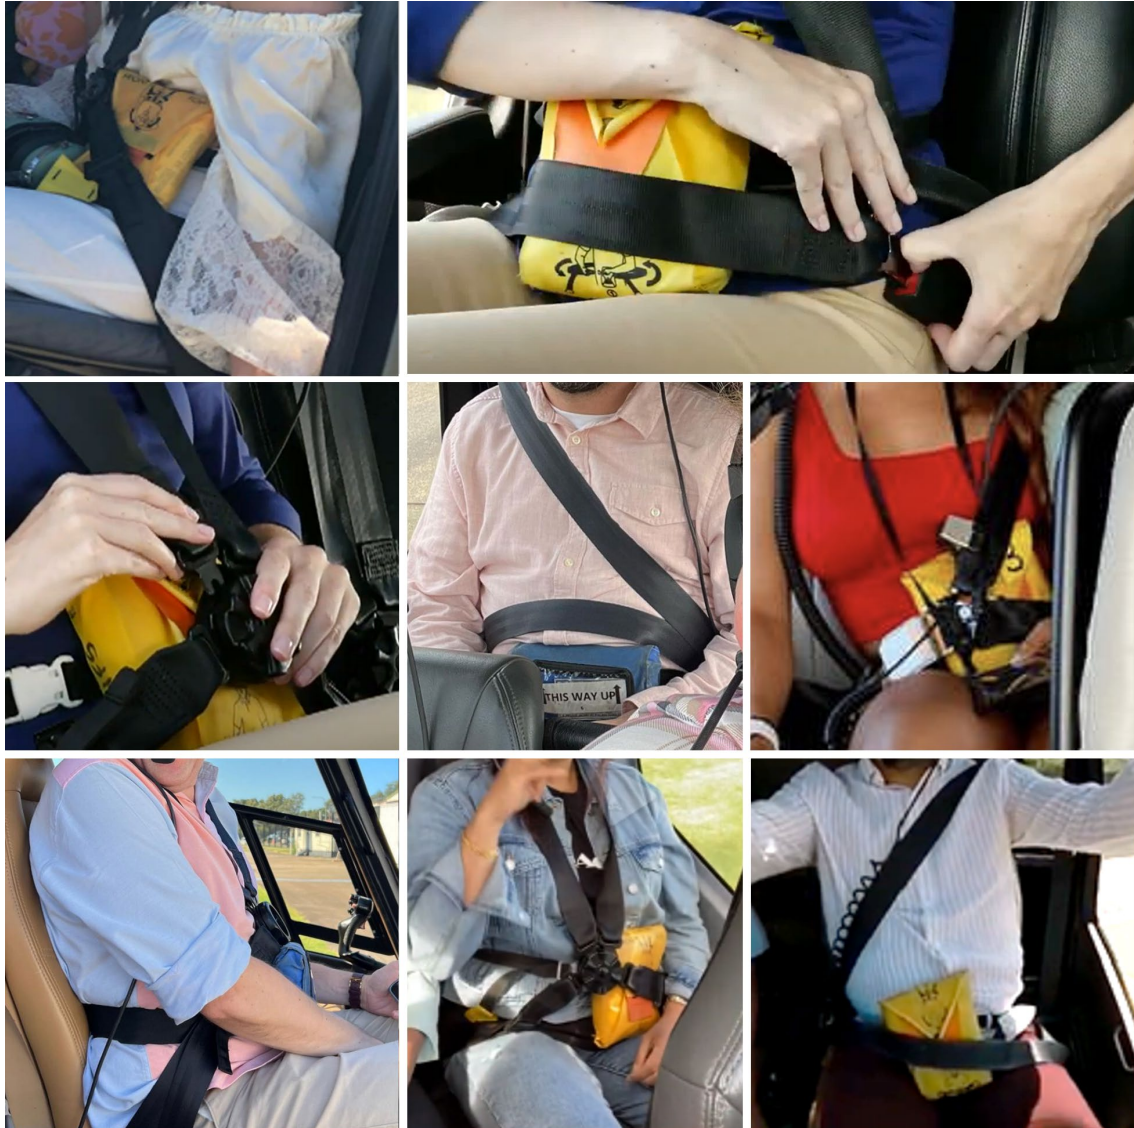
Figure 55: Examples of incorrect seatbelt fitment with constant wear lifejackets

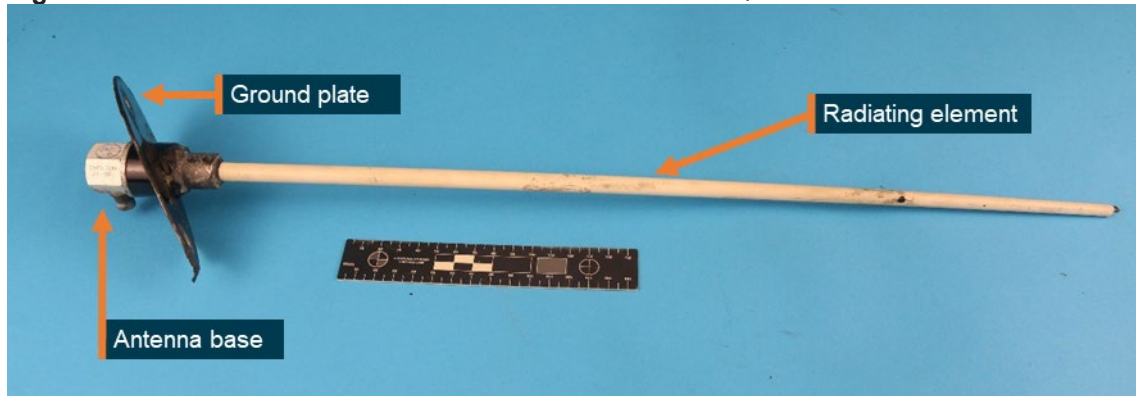
Figure A2: The VHF Com 1 antenna removed from VH-XKQ

Surface corrosion was identified to the underside mounting holes of the ground plate.
Source: ATSB

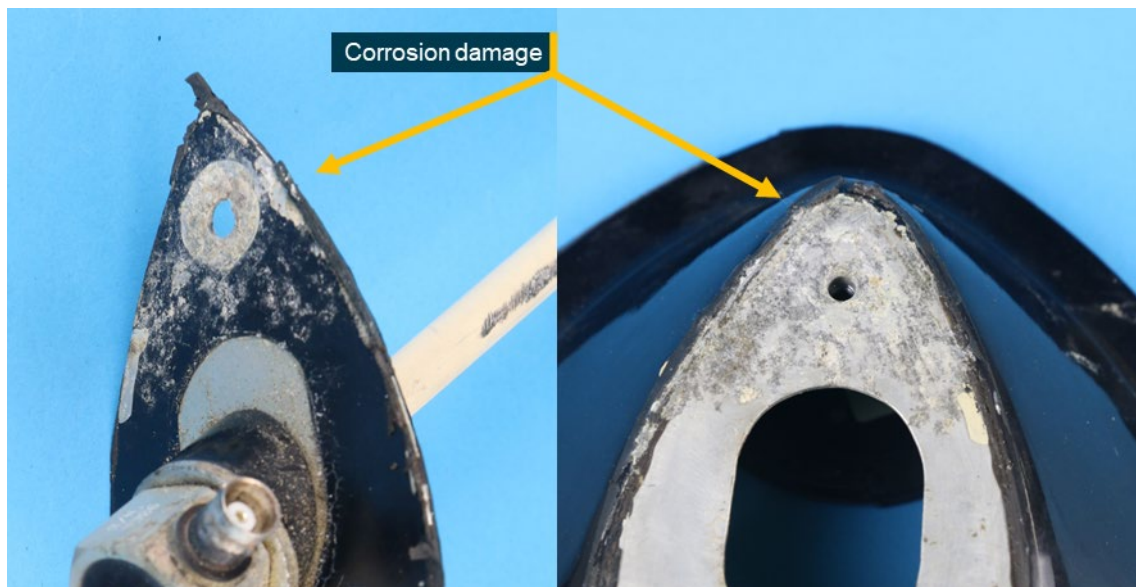
Figure A3: Corrosion damage to the fix hole surfaces surrounding where the antenna mounting plate (left) was attached to the blister panel (right)

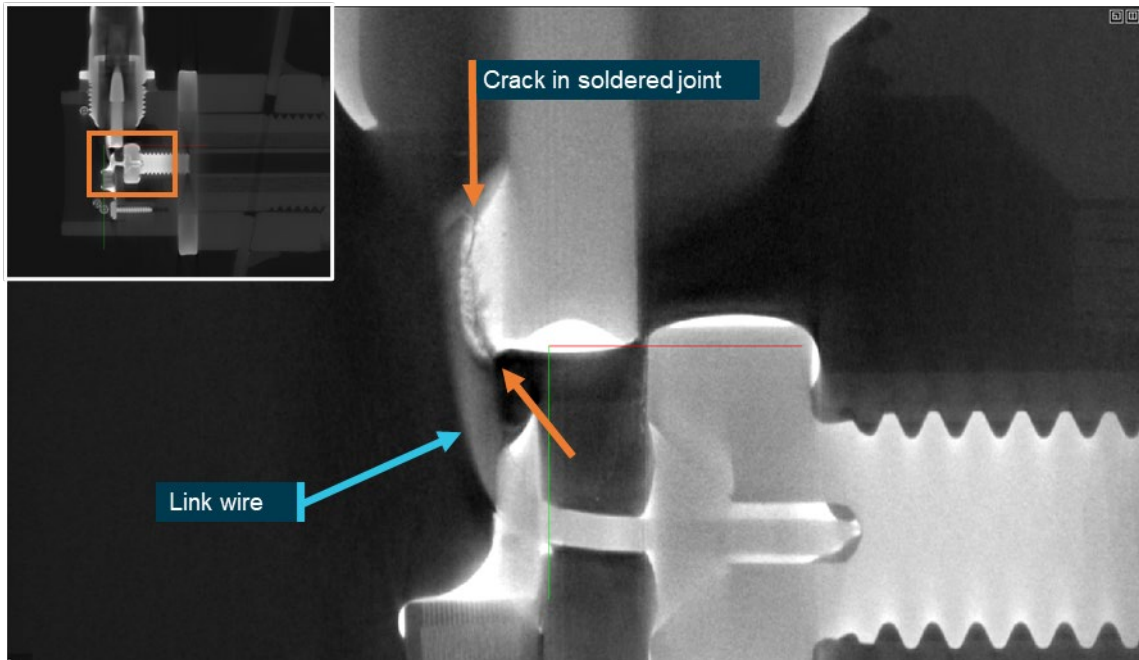
Figure A4: Micro-CT of the antenna base (inset) showing a crack in the soldered joint to the link wire (main)

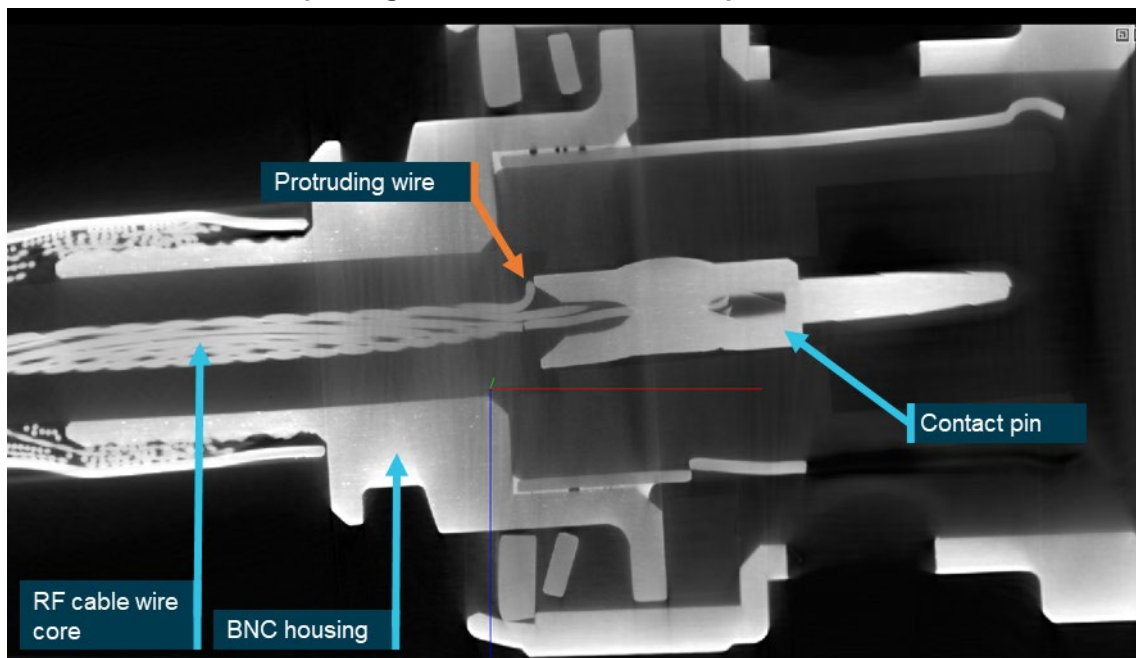
Figure A5: Micro-CT of the helicopter's RF cable BNC connector: a protruding wire was identified from the crimped region of the central contact pin

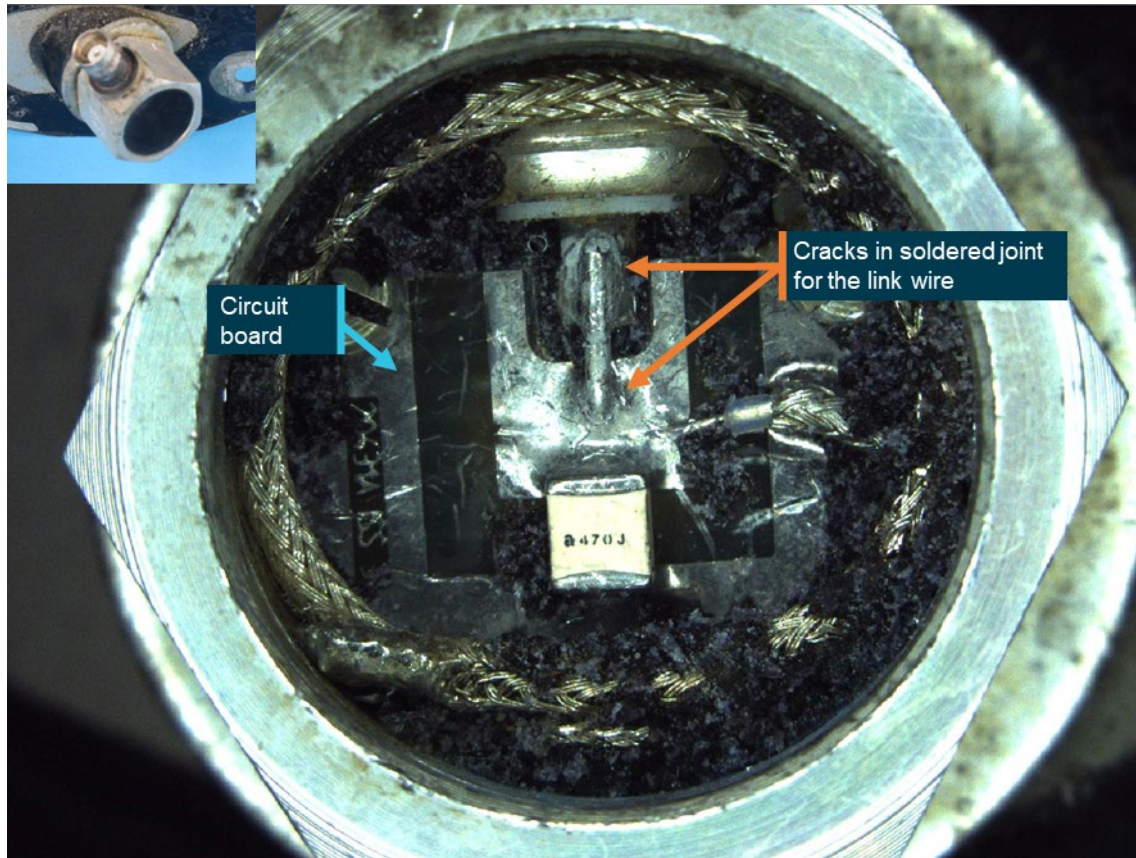
Figure A7: Antenna base: removal of the potting compound from within the antenna base confirmed the soldered joint containing the link wire had cracked and fractured from the circuit board

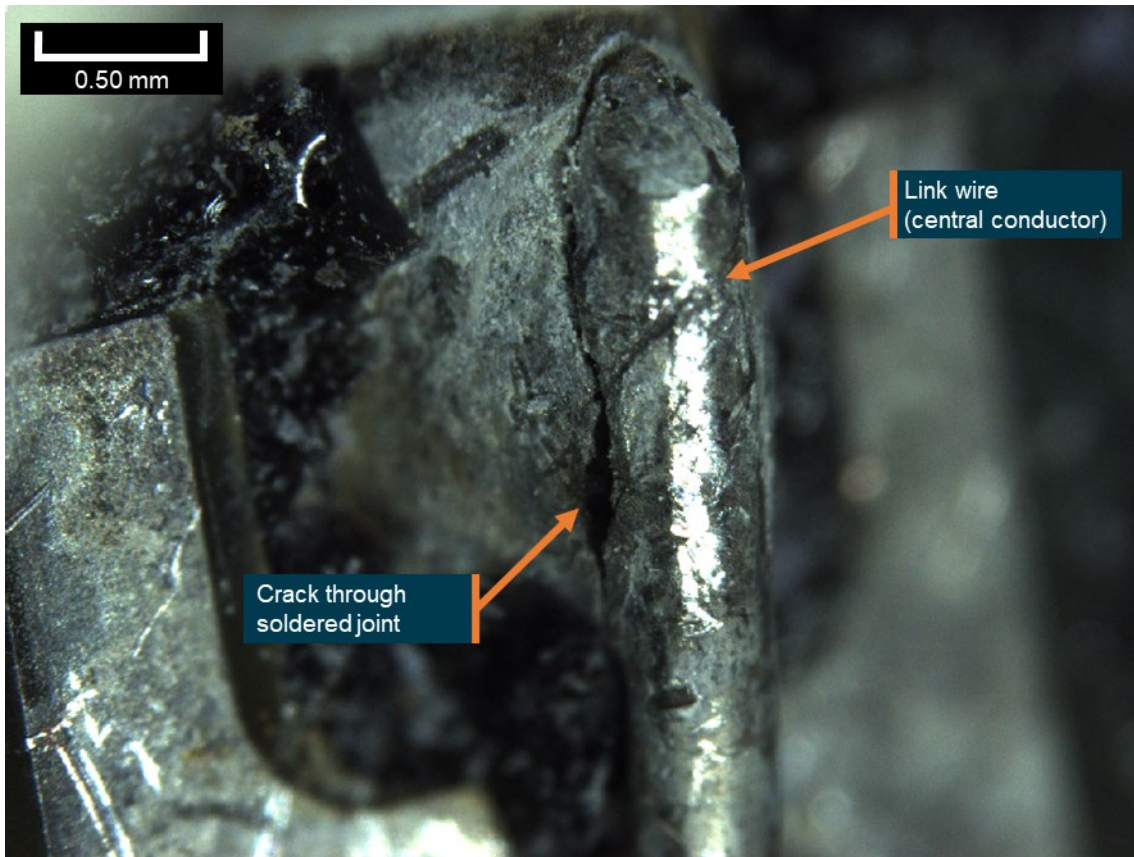
Figure A8: Antenna base: close view of the crack in the soldered joint between link wire and circuit board

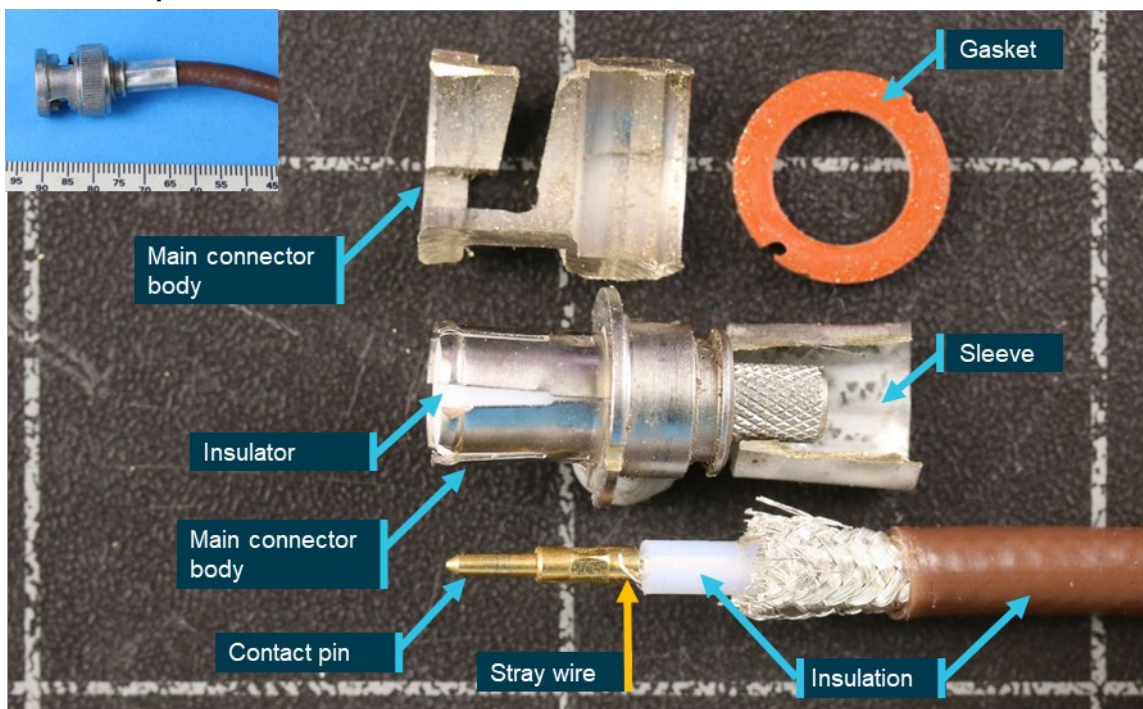
Figure A9: Helicopter RF cable BNC connector: cross-section through the connector (inset) from the radio frequency coaxial cable confirming that a stray wire was external to the contact pin

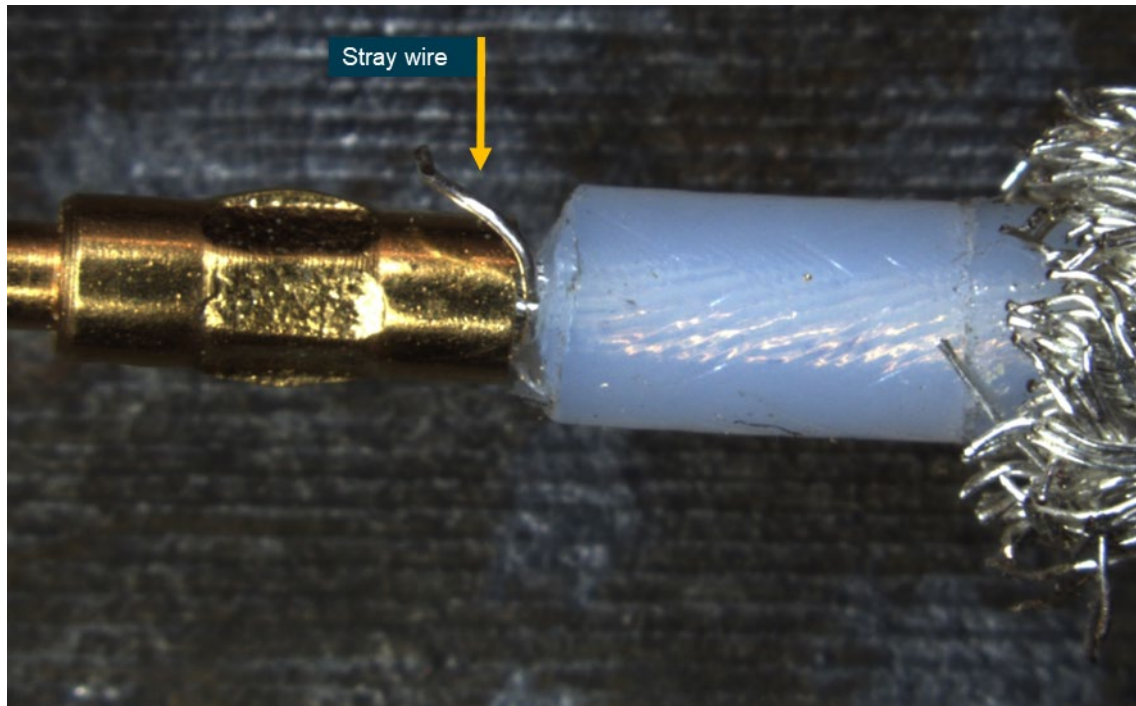
Figure A10: BNC connector: close-up showing a stray wire was not contained within the crimping of the contact pin

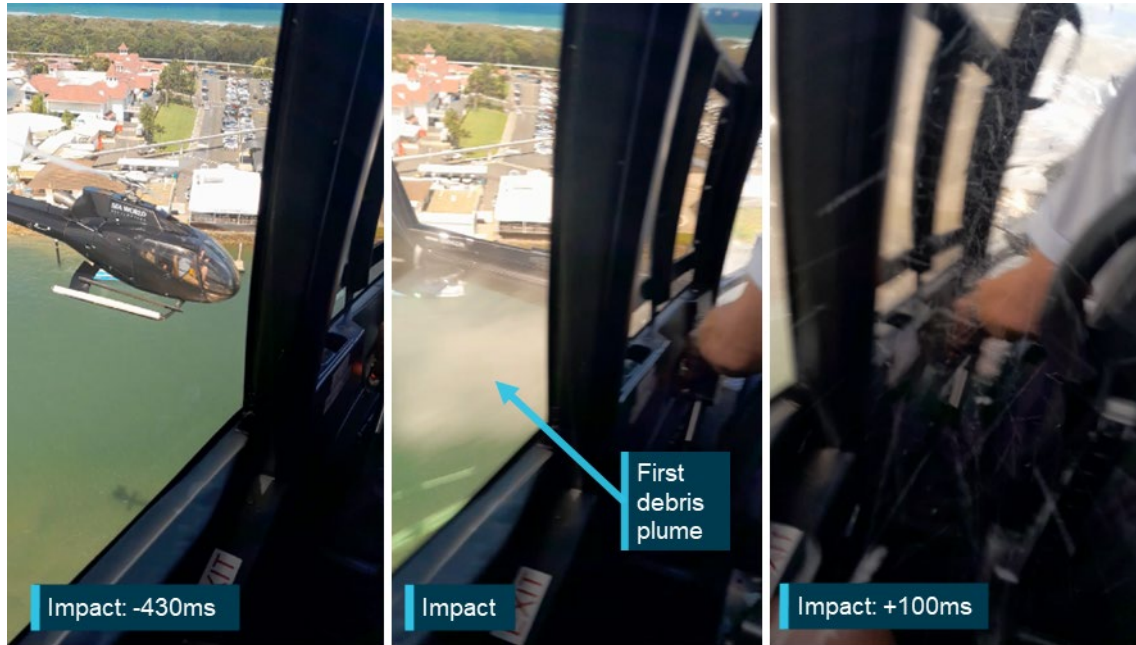
Figure B2: VH-XKQ initial main rotor blade strikes to VH-XH9

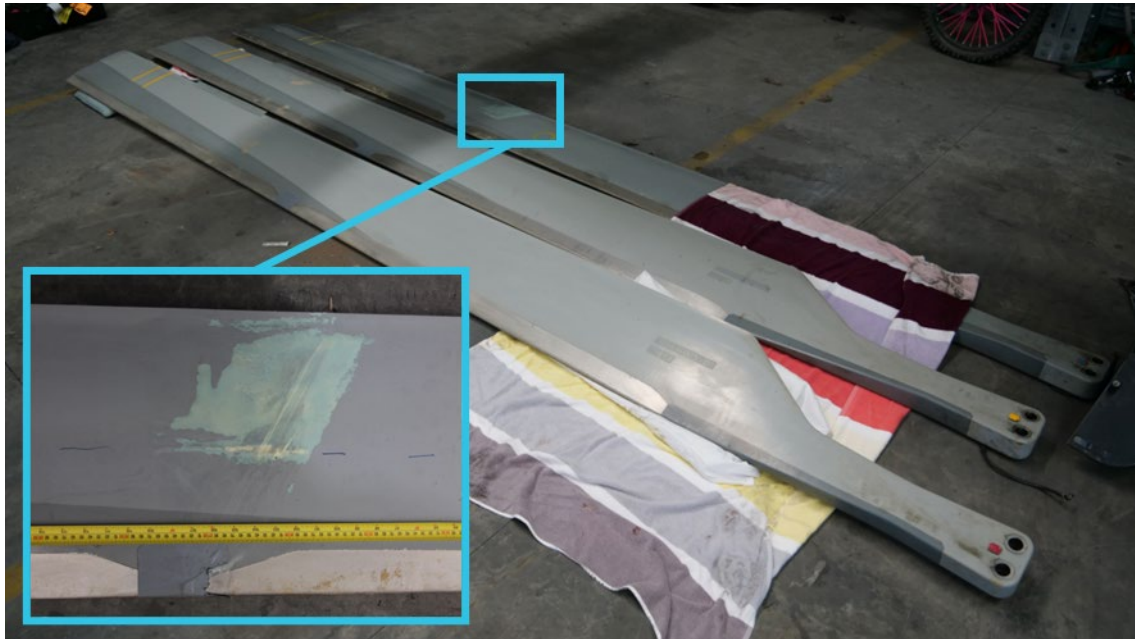
Figure B4: Paint removal mark in VH-XH9 blue blade (dashed blue pen mark denotes delamination edge)

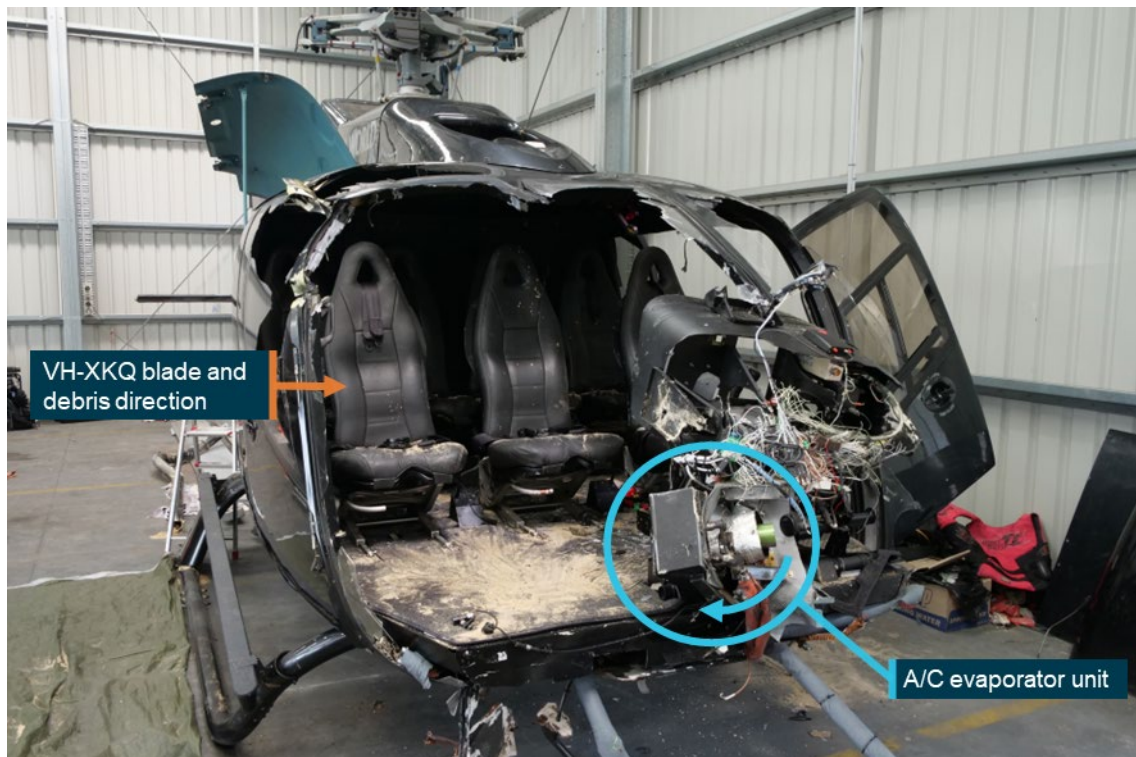
Figure B5: VH-XH9 air-conditioning cockpit evaporator unit distorted in the direction of VH-XKQ's travel

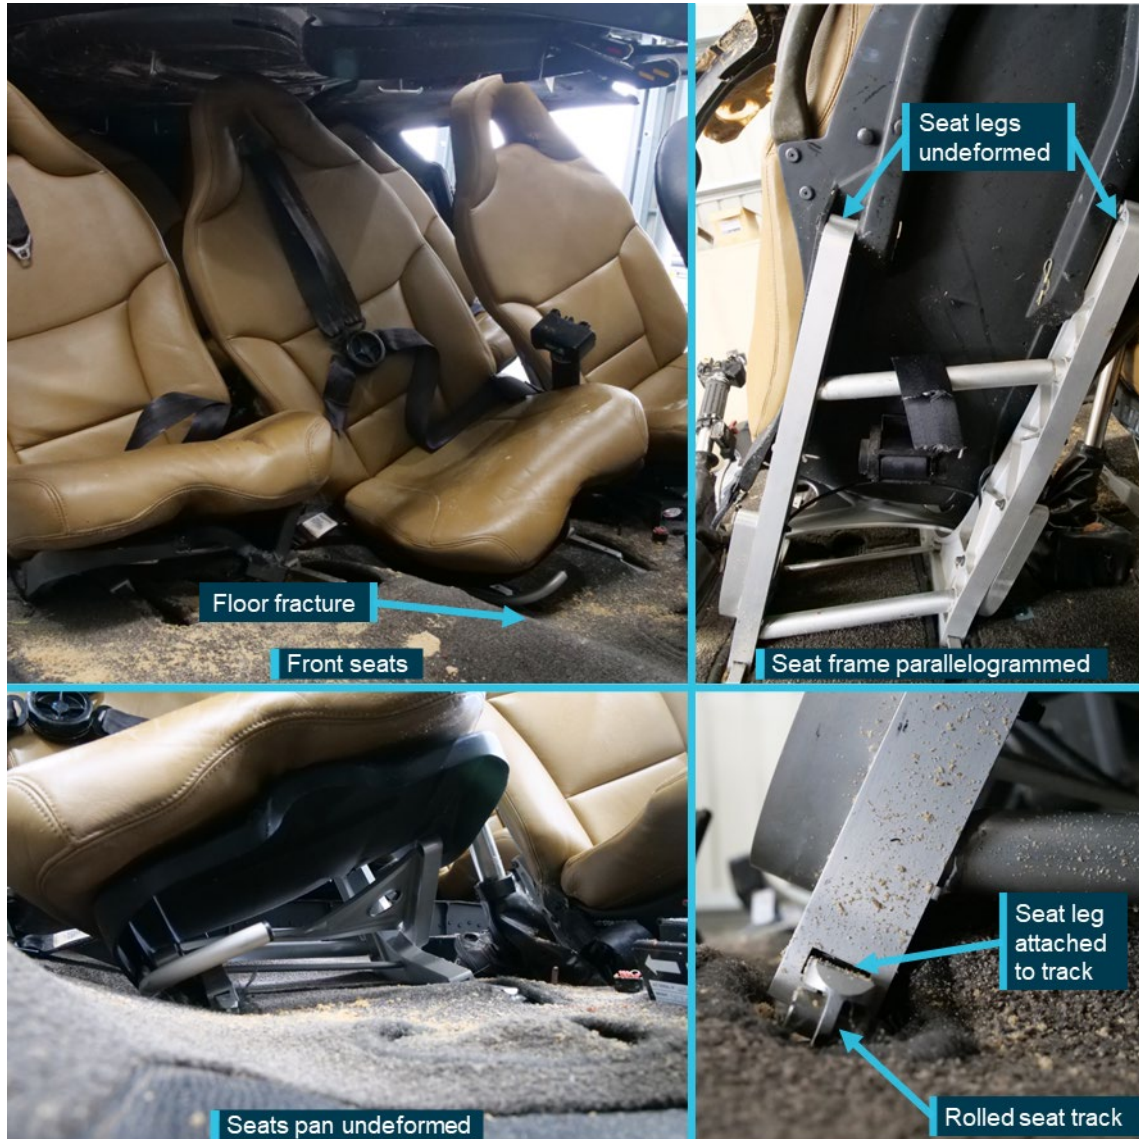
Figure B12: Composite picture of typical seat damage

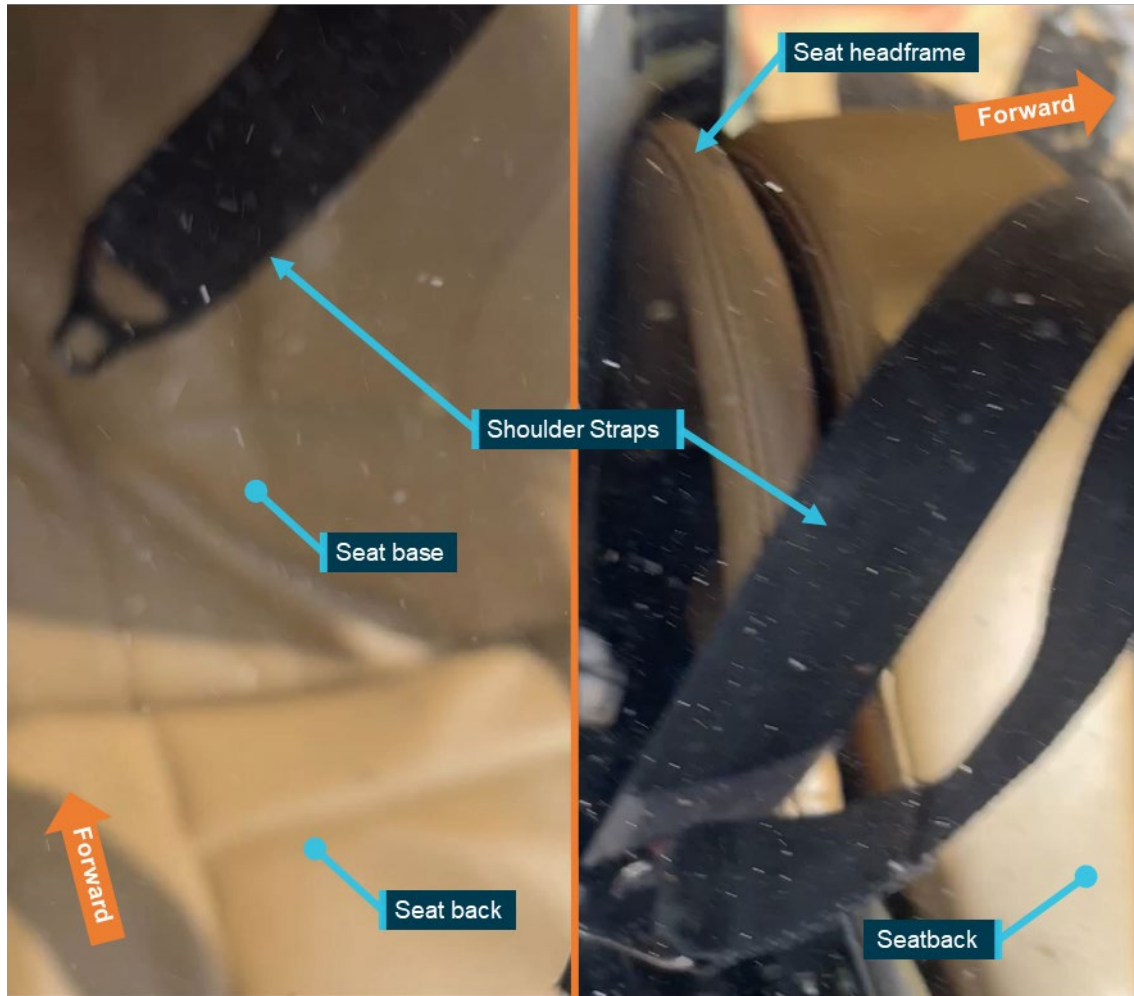
Figure B1486: Front right seat shoulder harness disconnected during rollover
