Fuel starvation and forced landing involving Cessna 310R, VH-DAW

About 5 km south-east of Derby Airport, Western Australia on 20 June 2023

ATSB Transport Safety Report

AO-2023-029

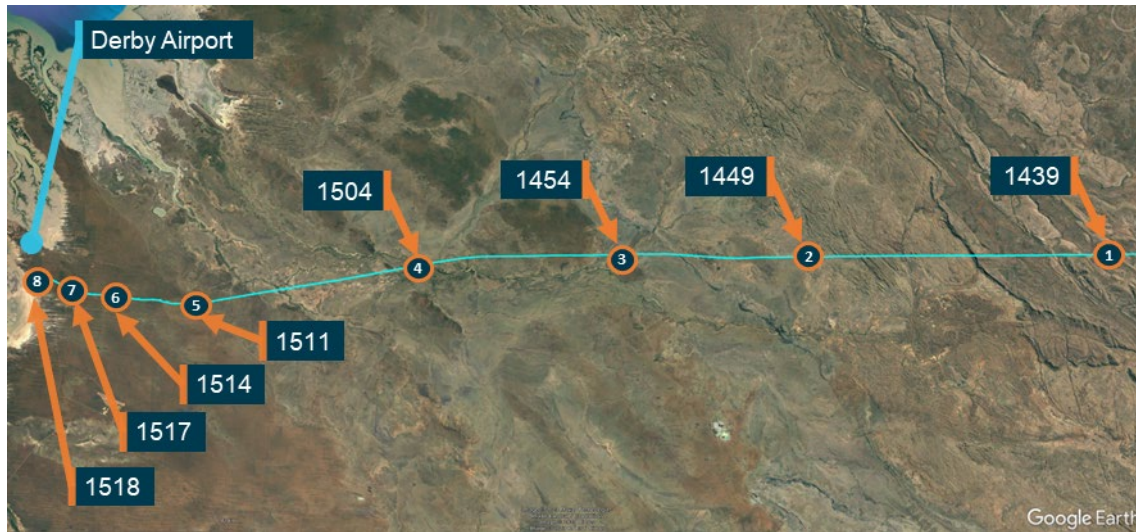
Figure 2: VH-DAW flight path

1. Change from main tanks to auxiliary tanks; 2. Change the left engine from auxiliary tank to main tank; 3. Right engine surge – changed the right engine to right main tank; 4. Right engine surge – crossfeed right engine off left main tank; 5. Inbound call for Derby Airport; 6. Dual engine surge; 7. Mayday call; 8. Accident site.

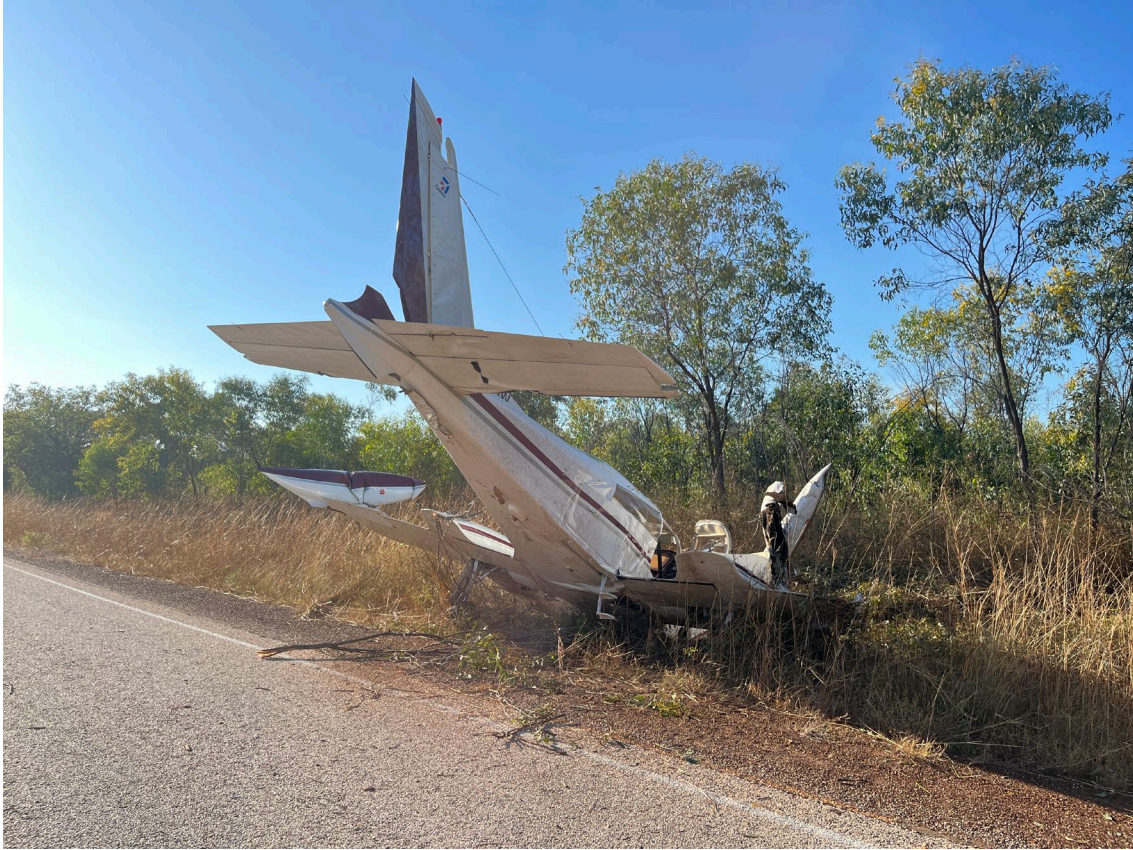
Figure 4: Accident site

The wreckage was located on the edge of the road in an area of low foliage, approximately 2.8 NM (5.2 km) east-south-east of Derby Airport. The left main tank and right auxiliary tank were ruptured during the accident sequence.

The left auxiliary tank was reported by the operator as being intact and found to contain about 20 L of fuel, while the right main tank contained negligible amounts of fuel. As both wings displayed visible damage (Figure 5), the ATSB was unable to verify if fuel had leaked from the fuel tanks following the ground collision. The propellers on both engines were not in the feathered position.

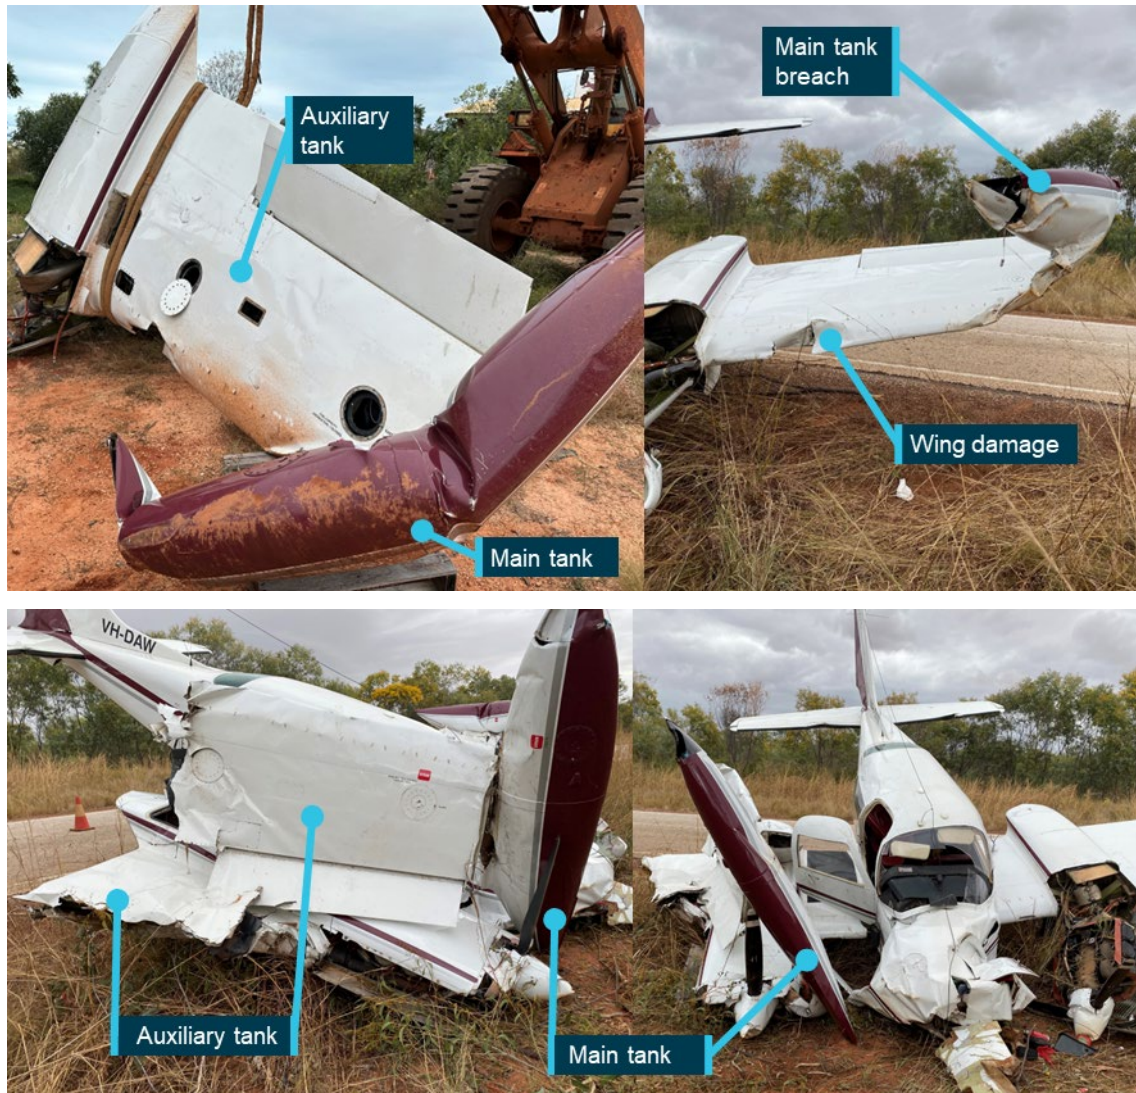
Figure 5: Left and right wing damage

Top image – left wing; bottom image – right wing.
Source: Western Australia Police Force, annotated by the ATSB

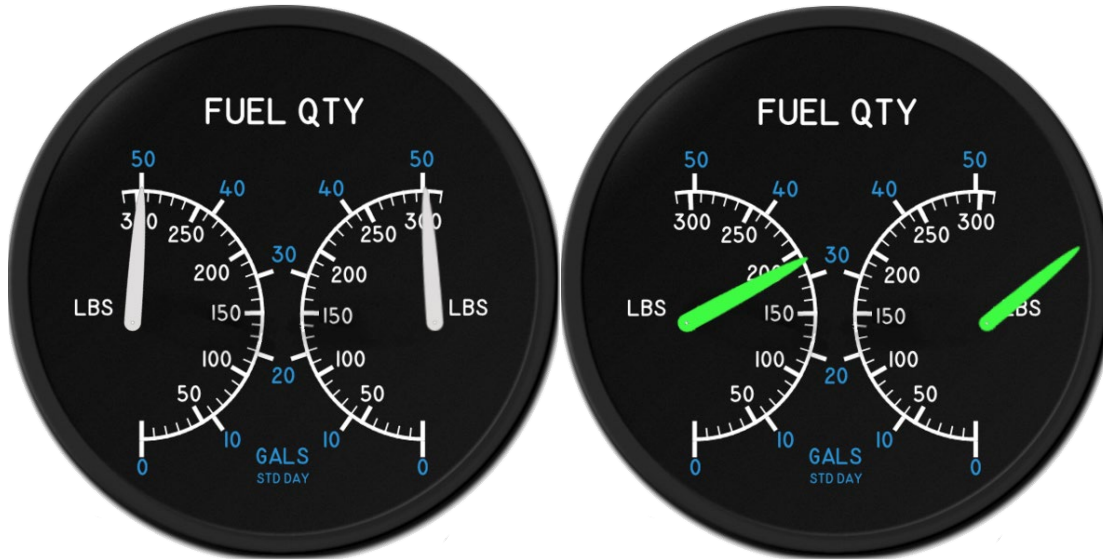
Figure 6: VH-DAW main tank fuel gauges

would exceed full scale deflection, while the left main tank display would under-read by approximately 64 L (105 lbs) (Figure 6).

Left image – expected fuel gauge indications for main tanks when full; right image – the reported fuel gauge indications for main tanks when full.

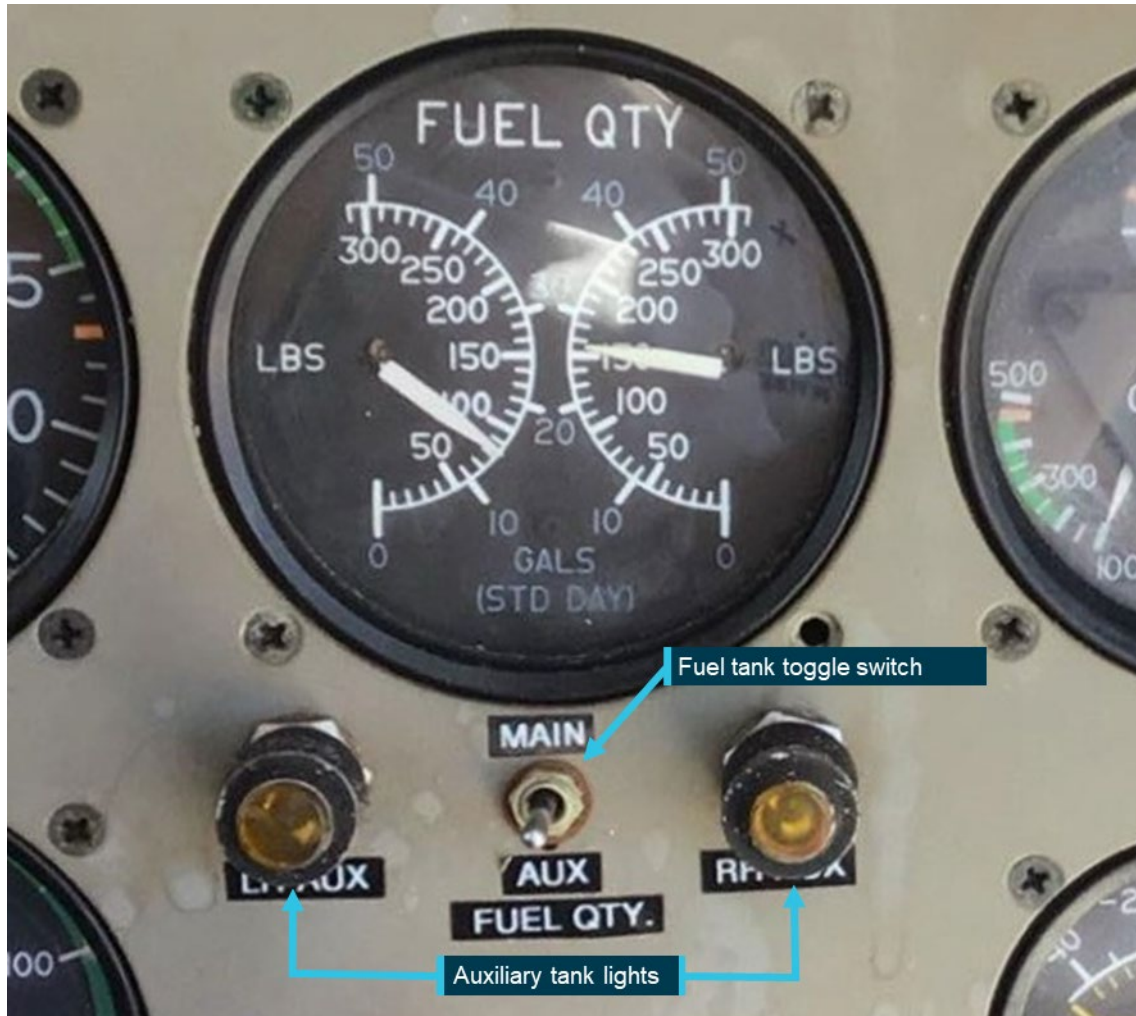
Figure 7: VH-DAW main tank fuel gauge indications after supplying the engines for the same time

It was reported that, as fuel was used during the flight, the displays became progressively more accurate, however there was still a large discrepancy between the displays (Figure 7). The expectation was that, when the fuel tank selection was changed from main to auxiliary or vice versa, both sides would be changed at the same time.

*Both the left and right main tanks had been used for the same amount of time during the flight.
Source: Pilot of VH-DAW, annotated by the ATSB*

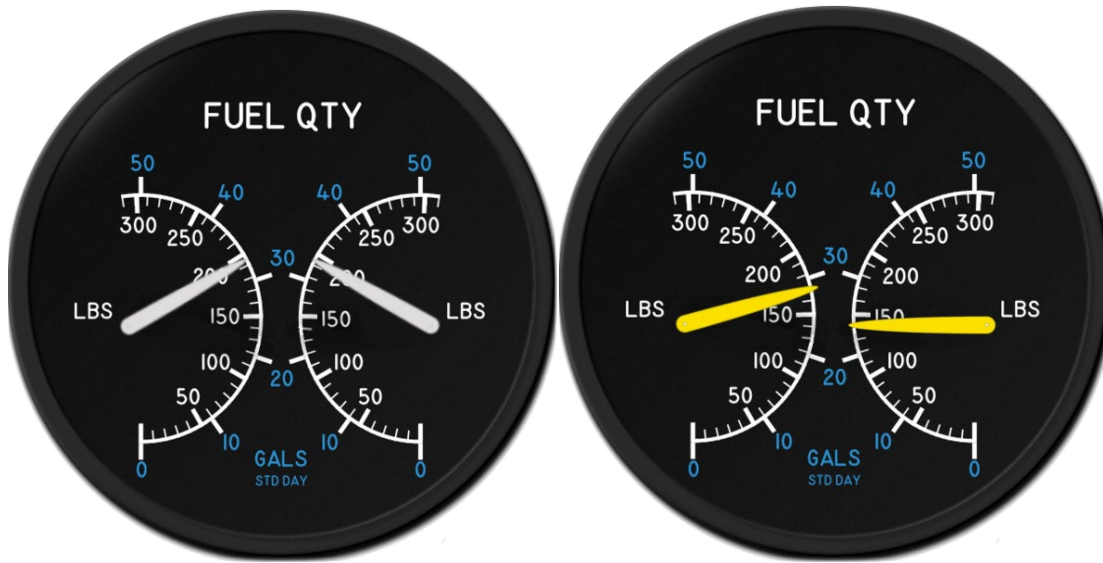
Figure 8: VH-DAW auxiliary tank fuel gauges

It was reported that when the gauge was selected to the auxiliary tank display, there was also a discrepancy when the tanks were full, although the difference was not as significant as that observed with the main tank display. It was reported that the display for the left auxiliary tank under-read by approximately 9 L (15 lb), while the display for the right auxiliary tank under-read by approximately 36 L (60 lb) (Figure 8). Pilots did not indicate that the accuracy of the auxiliary tank gauge displays improved during use. However, it was noted that the auxiliary tanks were never used below about 12 L.

Left image – expected fuel gauge display for auxiliary tanks when full; right image – reported fuel gauge display for auxiliary tanks when full.

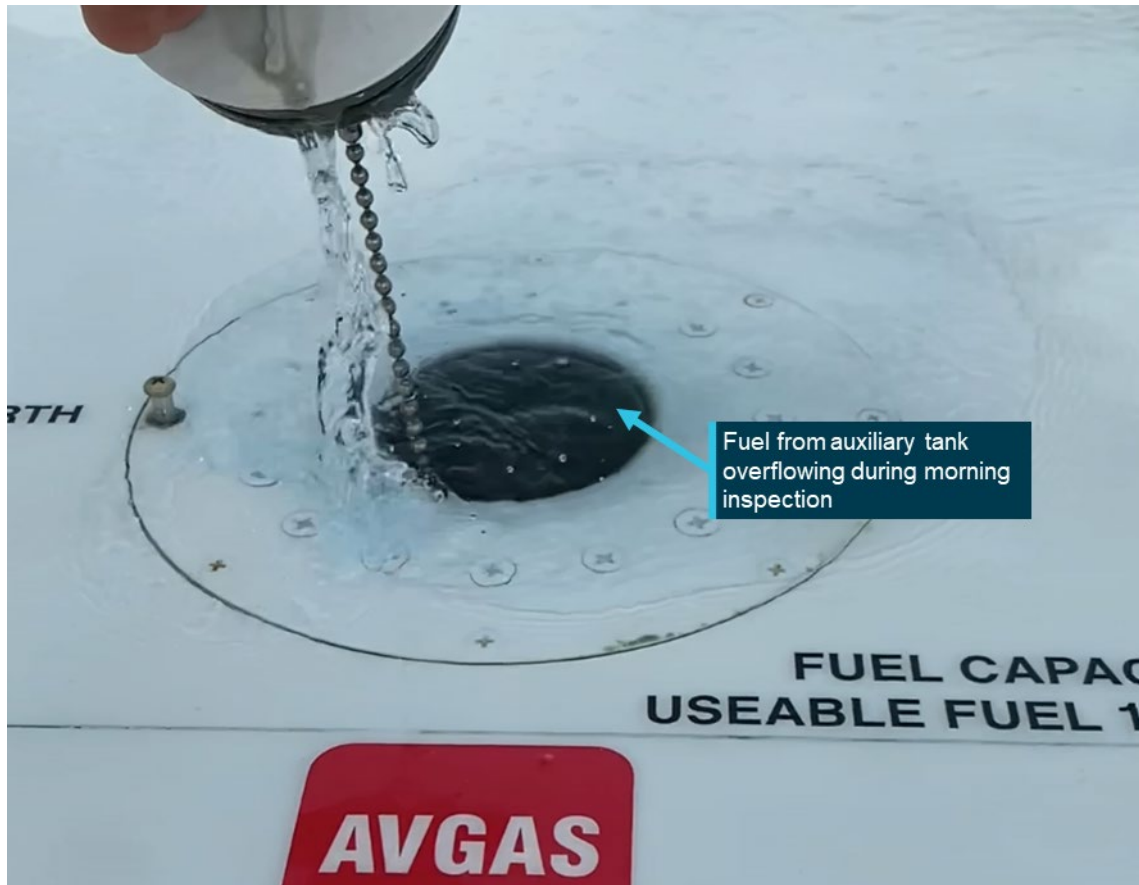
Figure 9: Auxiliary fuel tank overflowing on morning inspection

This issue was informally reported to maintenance staff, but not recorded on the MR. The CEO reported being unaware of the issue. After the initial report, the reporting pilot noted that engineers in the maintenance facility were unable to identify a fuel leak. Although the issue reportedly recurred, it was not further reported.

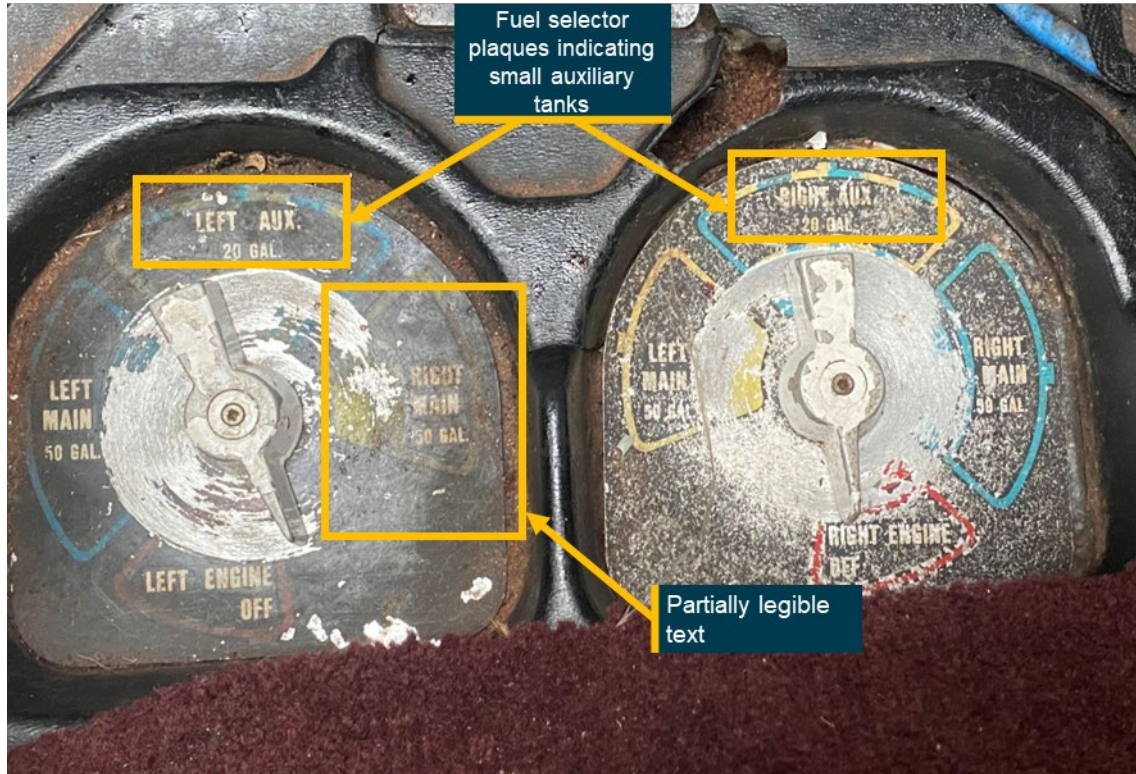
Figure 10: VH-DAW fuel selector plaques

The fuel selectors had plaques stating the amount of fuel in each tank in US gallons. On inspection, it was noted that the auxiliary tank capacity for both sides incorrectly indicated that small auxiliary tanks (20 US gallons) were fitted to the aircraft (Figure 10).

The fuel selector placards had last been replaced on 24 October 2008, prior to the aircraft being registered to Broome Aviation. The installed placards were the incorrect part number and as such displayed the incorrect size of the auxiliary tanks. The ATSB was unable to determine if the plaque relating to the 90 minutes on mains had been removed previously or never installed.

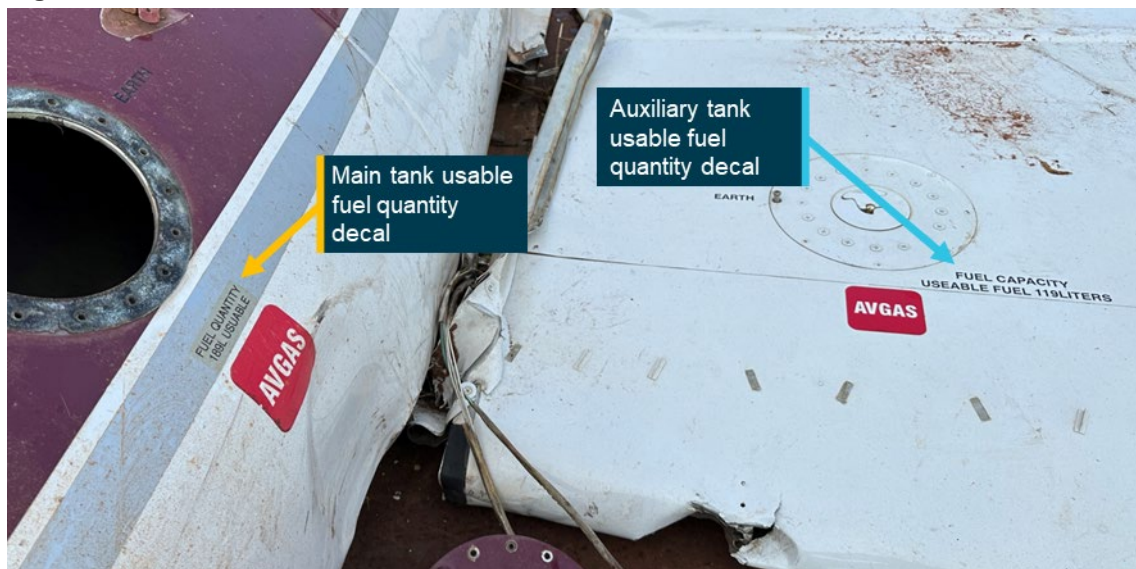
Figure 11: VH-DAW fuel decals

This contradicted the usable fuel decals next to each filler cap on the airframe, which identified that the auxiliary tanks held 119 litres (31.5 US gallons) (Figure 11).

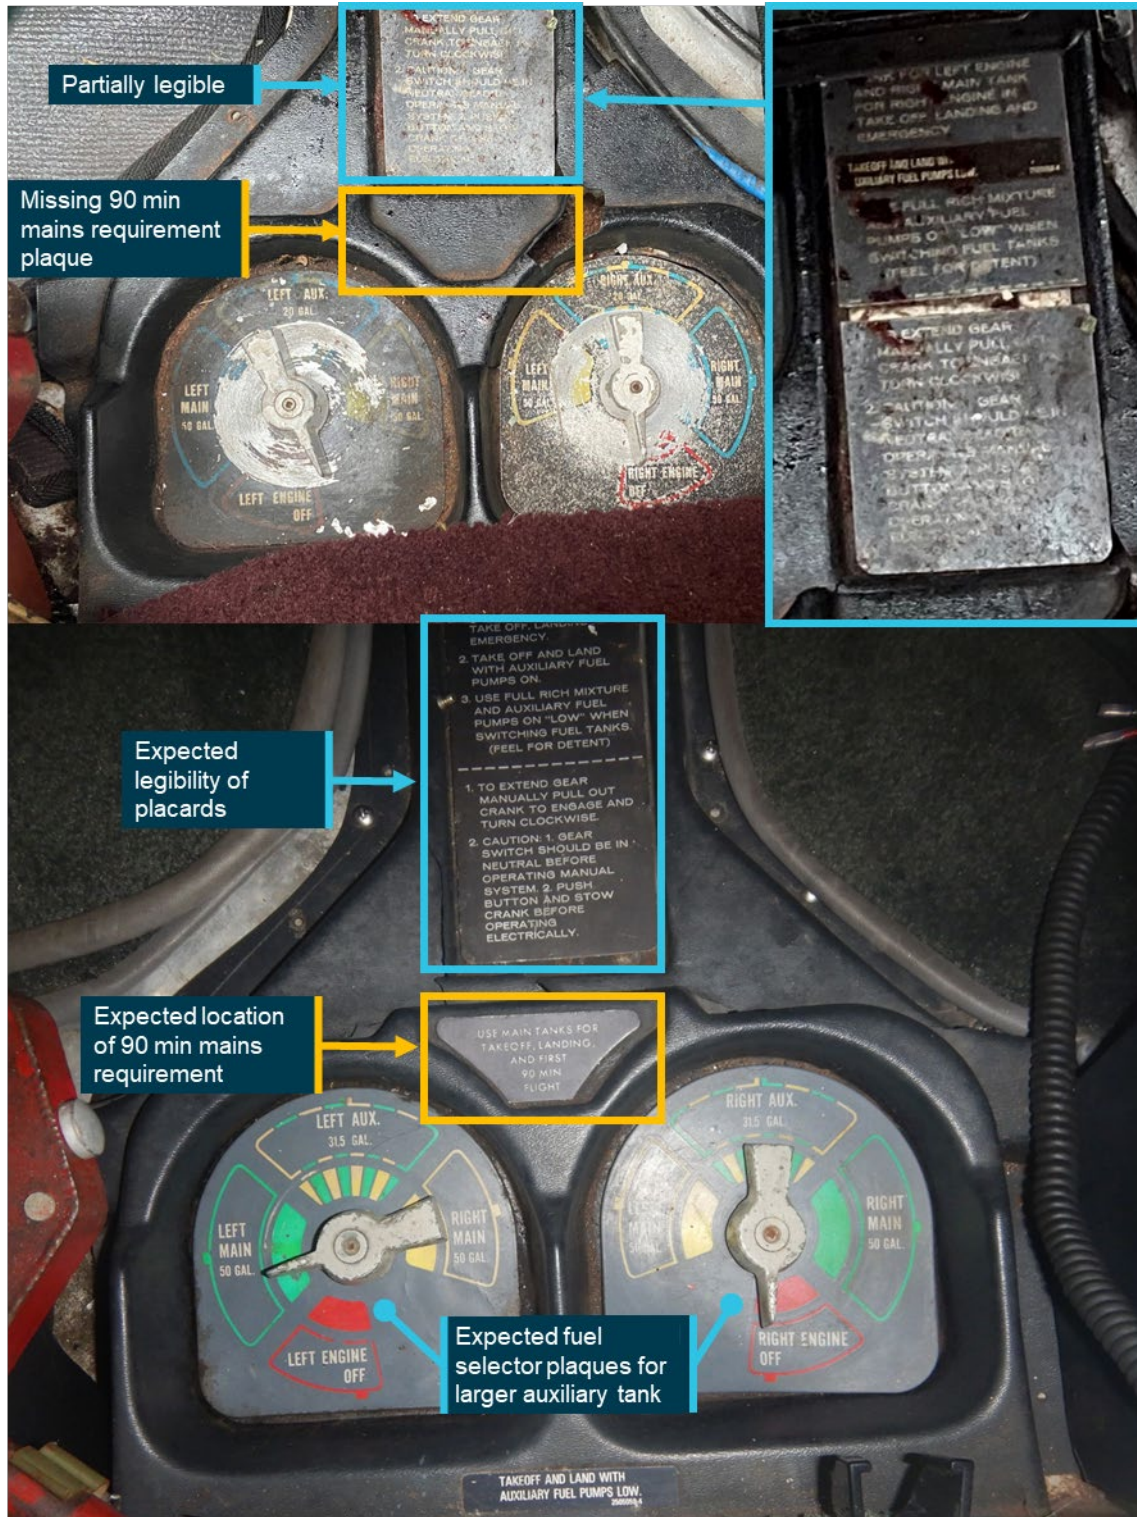
Figure 12: VH-DAW internal placards relating to the fuel system

Just above the fuel selector plaques, there was a requirement for a plaque specifying how long to operate on the main tanks when first taking off with full tanks. For a C310 with the larger auxiliary tanks, the plaque was required to include:

This plaque was missing from the aircraft (Figure 12).

All aircraft placarding was required to be checked under the aircraft system of maintenance every 200 hours for security, presence and legibility. There was no requirement to check the validity of the information presented on the placards. The aircraft had five 200-hourly maintenance events in the last 5 years, the last being August 2022.

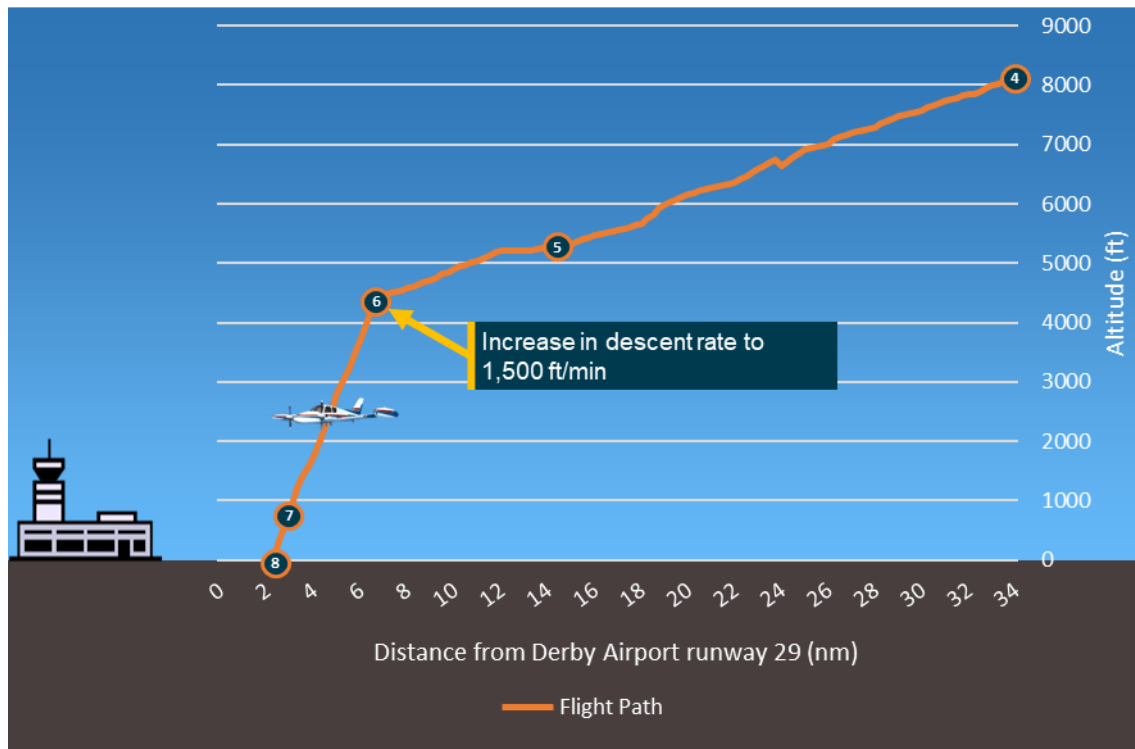
Figure 16: Aircraft altitude variation with distance to Derby Airport

The pilot continued tracking to Derby Airport while switching fuel tanks, attempting to draw any remaining fuel. The manufacturer noted that the certification rule, at the time of the aircraft's certification, required multi-engine aircraft to regain full power and fuel pressure within 20 seconds after switching from an empty tank to a full tank in level flight. The aircraft tracking data indicated that at an altitude of approximately 4,500 ft the descent rate increased to 1,500 ft/min. The aircraft travelled approximately a further 5.5 NM over approximately 3 minutes before a forced landing was conducted (Figure 16).

4. Right engine surge – crossfeed right engine off left main tank; 5. Inbound call for Derby Airport; 6. Dual engine surge; 7. Mayday call; 8. Accident site.
Source: ATSB
