# Incorrect configuration involving Embraer E190, VH-UYI

Near Honiara International Airport, Solomon Islands on 23 February 2024

AO-2024-007

Final – 3 April 2025

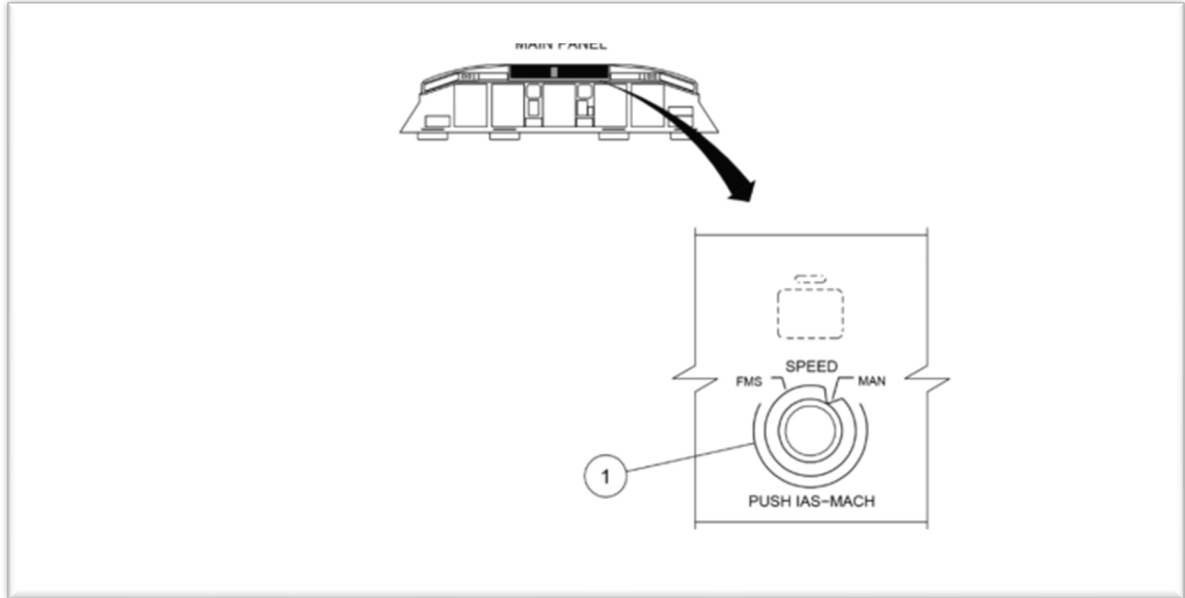
**Figure 1: E190 speed selector knob on guidance panel**

The flight crew had the option of selecting either of 2 speed management modes on the GP – FMS or manual mode (Figure 1).

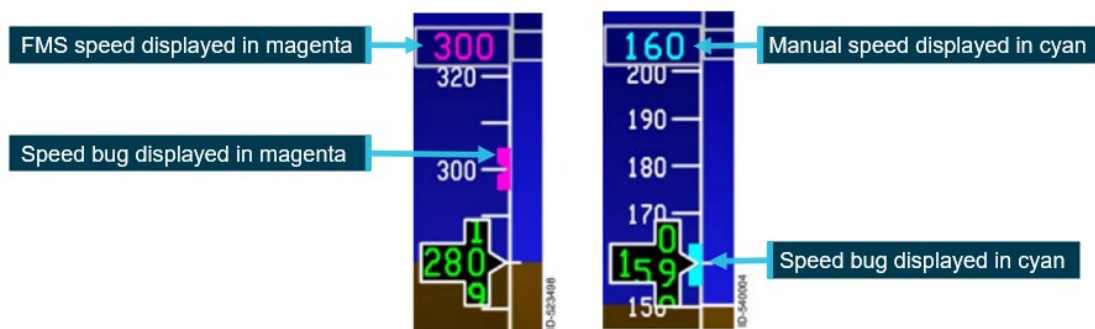
**Figure 2: FMS and manual speed displays**

In FMS mode, the airspeed selection was managed by the FMS. The airspeed was displayed on the PFD in magenta (Figure 2).

In manual mode, flight crew retained responsibility for airspeed control, by selecting the airspeed using the SPEED selector knob, which then displayed the selected airspeed on the PFD (Figure 2). This target speed was used by both the autothrottle and the autopilot. A manual selected airspeed was displayed on the PFD in cyan.

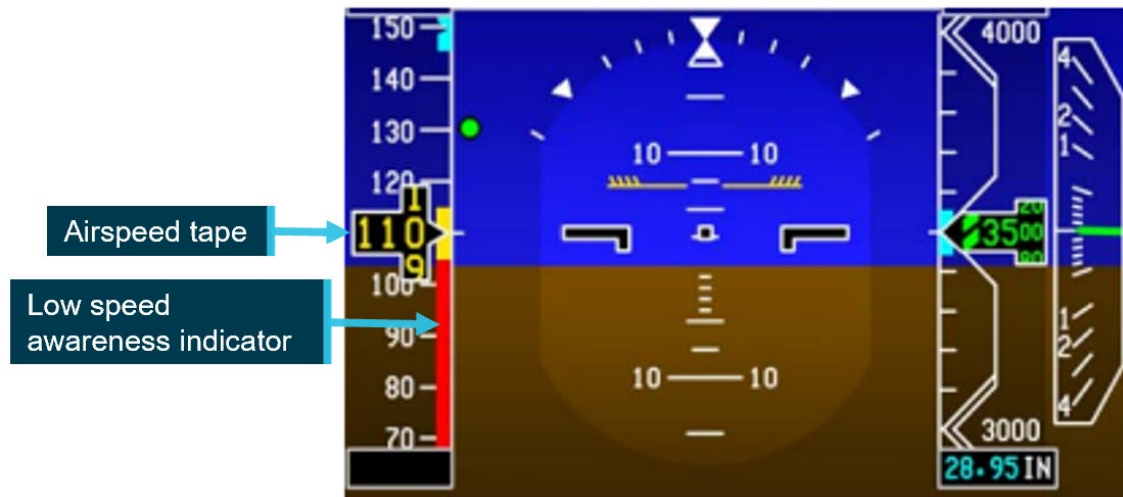
Figure 3: Low speed awareness indicator

If the speed enters the red range, the stick shaker will activate, and an audible alarm will sound. The speed displayed on the PFD will also change colour to red reverse video.

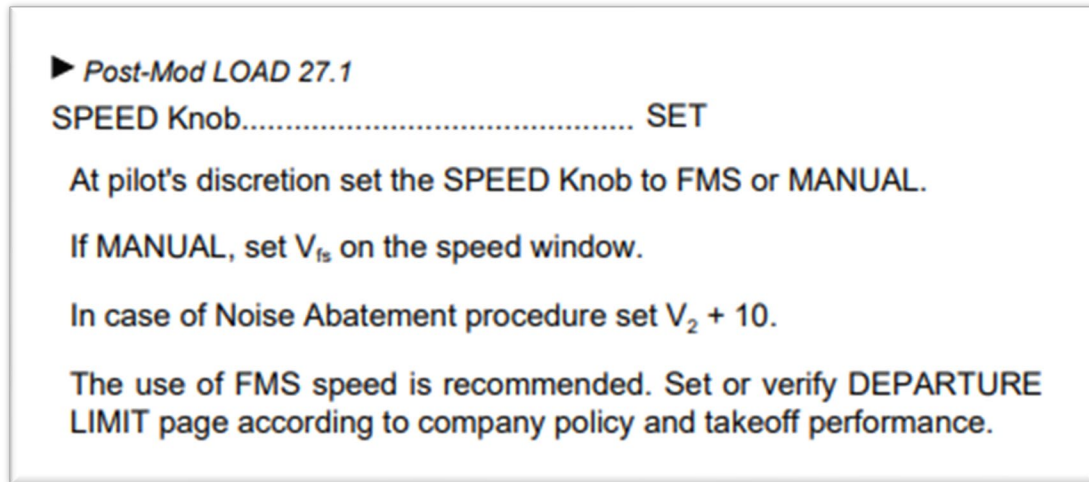
**Figure 5: Shortly before startup procedures**

Subsequently, **the Shortly before startup procedures (Figure 5), called for the speed selector knob to be set at pilot discretion, with FMS recommended for Load 27 aircraft (including VH-UYI).**

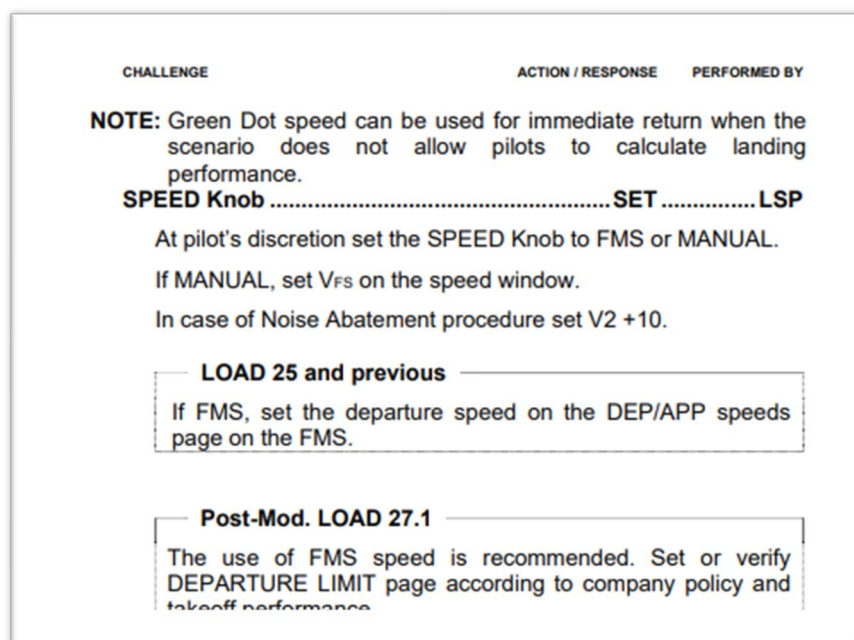
**Figure 6: Shortly before start procedures**

Unlike the AOM, the SOPM did not have a requirement to set the speed selector knob to manual in the *Before start* procedures. The first reference to speed selector knob was in the *Shortly before start* procedures (Figure 6), where the left seat pilot (LSP) was required to set it at pilot's discretion (with FMS speed recommended).

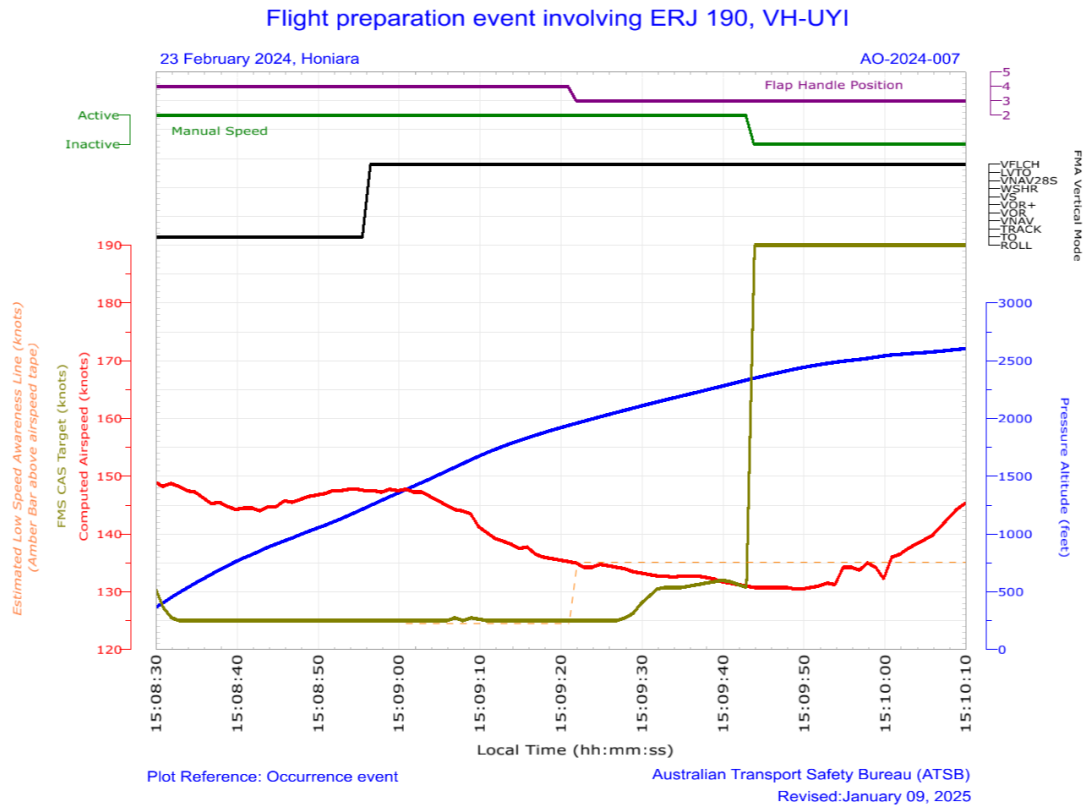
**Figure 7: QAR data during initial climb**

They advised that prior to the flap lever retraction from 4 to 3, the top of the amber band on the LSA was 124.5 kt. When the slats retracted, 20 kts prior to the target speed (F-bug), the upper value of the amber LSA indicator<sup>15</sup> increased to 135.1 kt.

The data showed that once VFLCH was engaged, the airspeed (red line) reduced towards the FMS target speed (green line) at 125 kt. When the flap lever was retracted (purple line), the low speed awareness indicator increased to approximately 135.1 kt (dotted orange line), which was above the current airspeed of 134 kt. The PLIs would have been displayed on the PFD at this stage. The target speed then increased when the speed mode was selected to FMS.
