# Incorrect configuration involving Embraer E190, VH-UYI

Near Honiara International Airport, Solomon Islands on 23 February 2024

ATSB Transport Safety Report Aviation Occurrence Investigation (Defined) AO-2024-007 Final – 3 April 2025 Cover photo: Morris Biondi, Jet photos

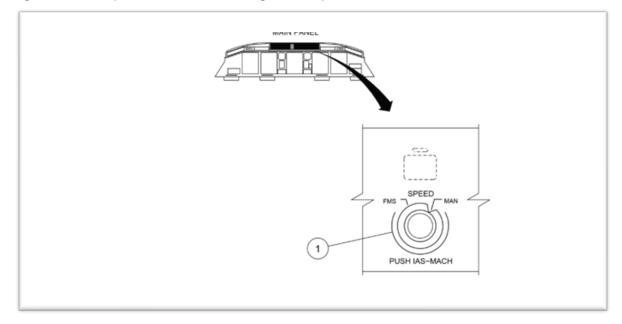
Figure 1: E190 speed selector knob on guidance panel

The flight crew had the option of selecting either of 2 speed management modes on the GP – FMS or manual mode (Figure 1).

In FMS mode, the airspeed selection was managed by the FMS. The airspeed was displayed on the PFD in magenta (Figure 2).

In manual mode, flight crew retained responsibility for airspeed control, by selecting the airspeed using the SPEED selector knob, which then displayed the selected airspeed on the PFD (Figure 2). This target speed was used by both the autothrottle and the autopilot. A manual selected airspeed was displayed on the PFD in cyan.

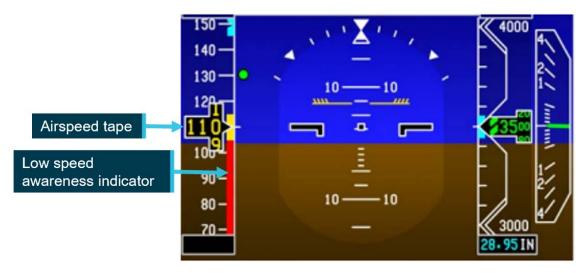
#### Figure 3: Low speed awareness indicator

If the speed enters the red range, the stick shaker will activate, and an audible alarm will sound. The speed displayed on the PFD will also change colour to red reverse video.

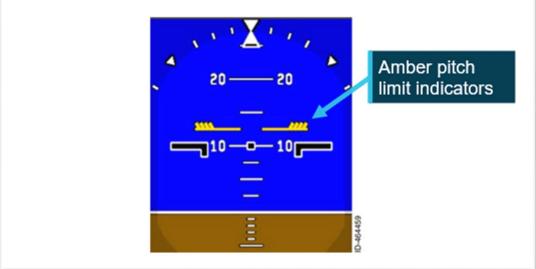
The PLI indicator is pitch-based. The PLI indicator is displayed with the ollowing conditions:

- When airspeed is higher than 1.2 VSTALL, the PLI is not displayed.
- When airspeed is less than or equal to 1.2 VSTALL but greater than 1.13 VSTALL, the LL is displayed in green.
- When airspeed is less than or equal to 1.13 VSTALL but greater than VSHAKER, the PLI is displayed in amber.
- When the airspeed is less than or equal to VSHAKER, the IPLI is displayed in red.

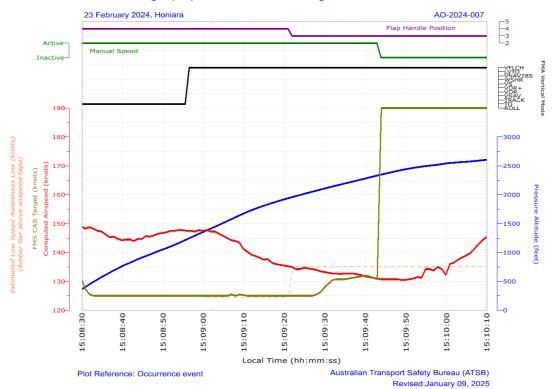
Flight preparation event involving ERJ 190, VH-UYI

They advised that prior to the flap lever retraction from 4 to 3, the top of the amber band on the LSA was 124.5 kt. When the slats retracted, 20 kts prior to the target speed (F-bug), the upper value of the amber LSA indicator<sup>15</sup> increased to 135.1 kt.
