# Unstable approach involving Embraer 190, VH-UZI

About 4 km north-east of Brisbane Airport, Queensland on 9 May 2024

## ATSB Transport Safety Report

AO-2024-030

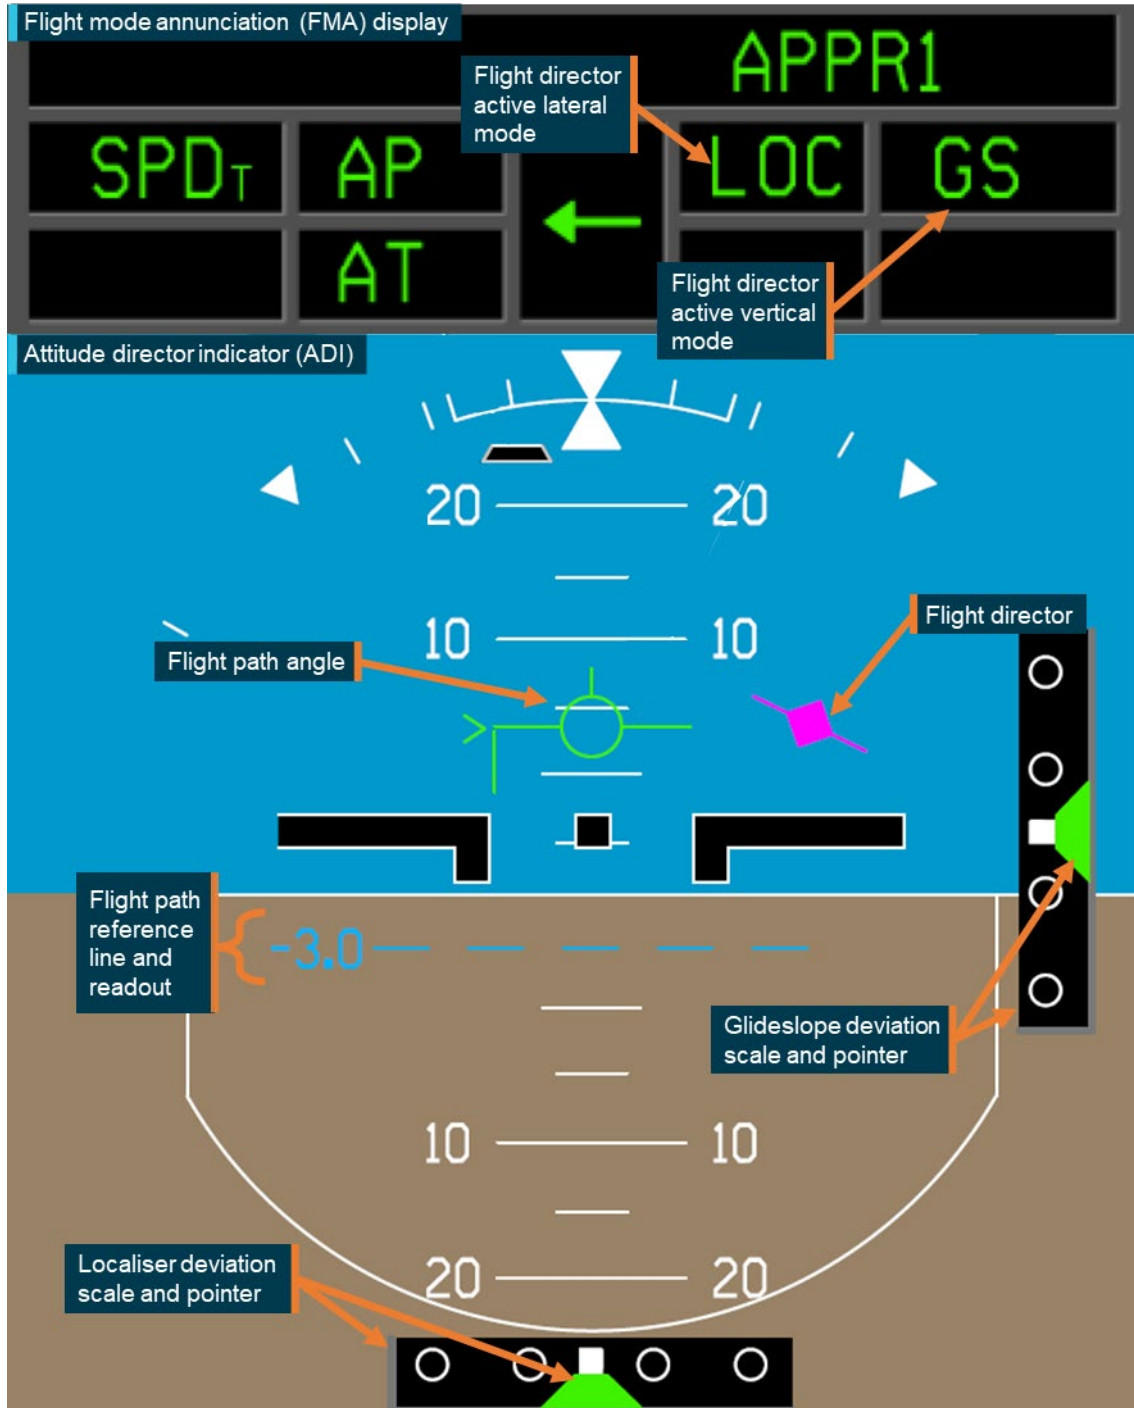
**Figure 2: E190 flight mode annunciation and attitude director indicator displays**

The ATSB found that, in response to a request from the captain to adjust the FPR line on their primary flight display, the first officer inadvertently pushed the flight path angle (FPA) button which selected the FPA mode and disengaged the aircraft's ILS approach mode. The first officer's action constituted a 'slip' type error where an individual's understanding of the situation is correct, but the wrong action is performed.

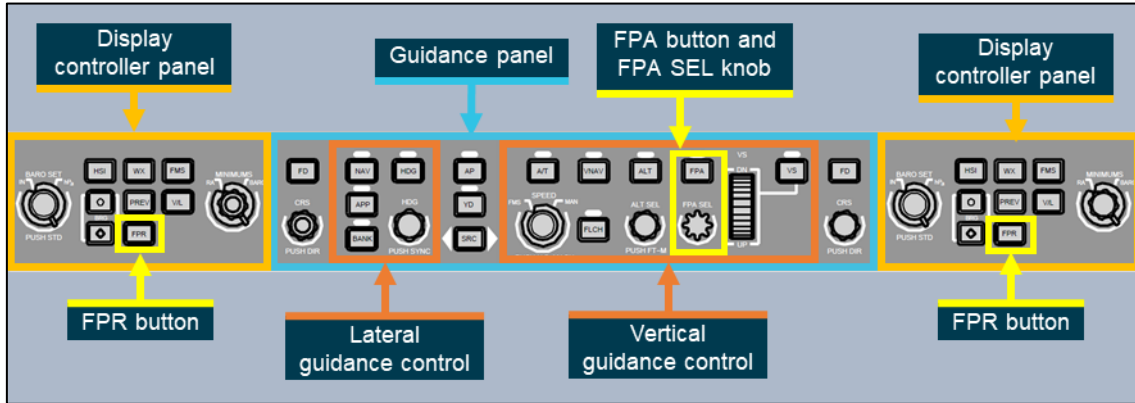
**Figure 3: Guidance panel and display controller panel**

Pressing the FPA button selected the flight path angle vertical mode and the aircraft roll hold (ROLL) lateral mode. When the FPA mode was active, it commanded the flight director to a flight path angle reference and the flight path reference (FPR) line was displayed as a solid line. The FPA SEL control knob was then used to manually select the desired flight path angle, represented by the FPR line.

The aircraft manufacturer advised the ATSB that it had not received any previous flight crew reports of a similar inadvertent selection of FPA instead of FPR as occurred during this incident.

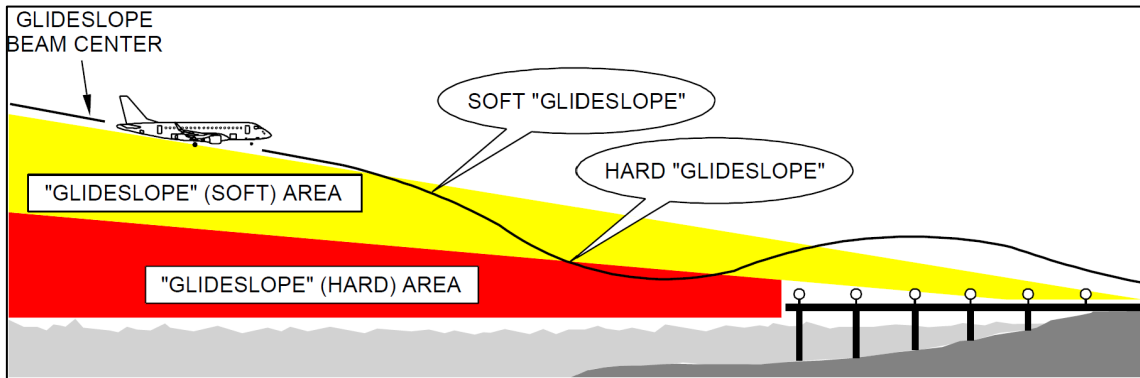
**Figure 4: EGPWS descent below glideslope alert**

The aircraft continued to descend below the glideslope, resulting in the EGPWS glideslope alert activating. Subsequently, the flight crew did not perform the required terrain avoidance manoeuvre, and instead continued the approach.

When the aircraft descended more than 1.3 dots below the glideslope while at a radio altitude less than 1,000 ft, an aural 'GLIDESLOPE' would be generated and an amber 'GND PROX' alert displayed on each PFD ('soft' glideslope alert). If the descent continued to less than 300 ft and the glideslope deviation was 2 dots below, the 'GLIDESLOPE' aural alert would be louder and faster ('hard' glideslope alert). The aural and visual alerts continued until the aircraft exited the alert envelope.

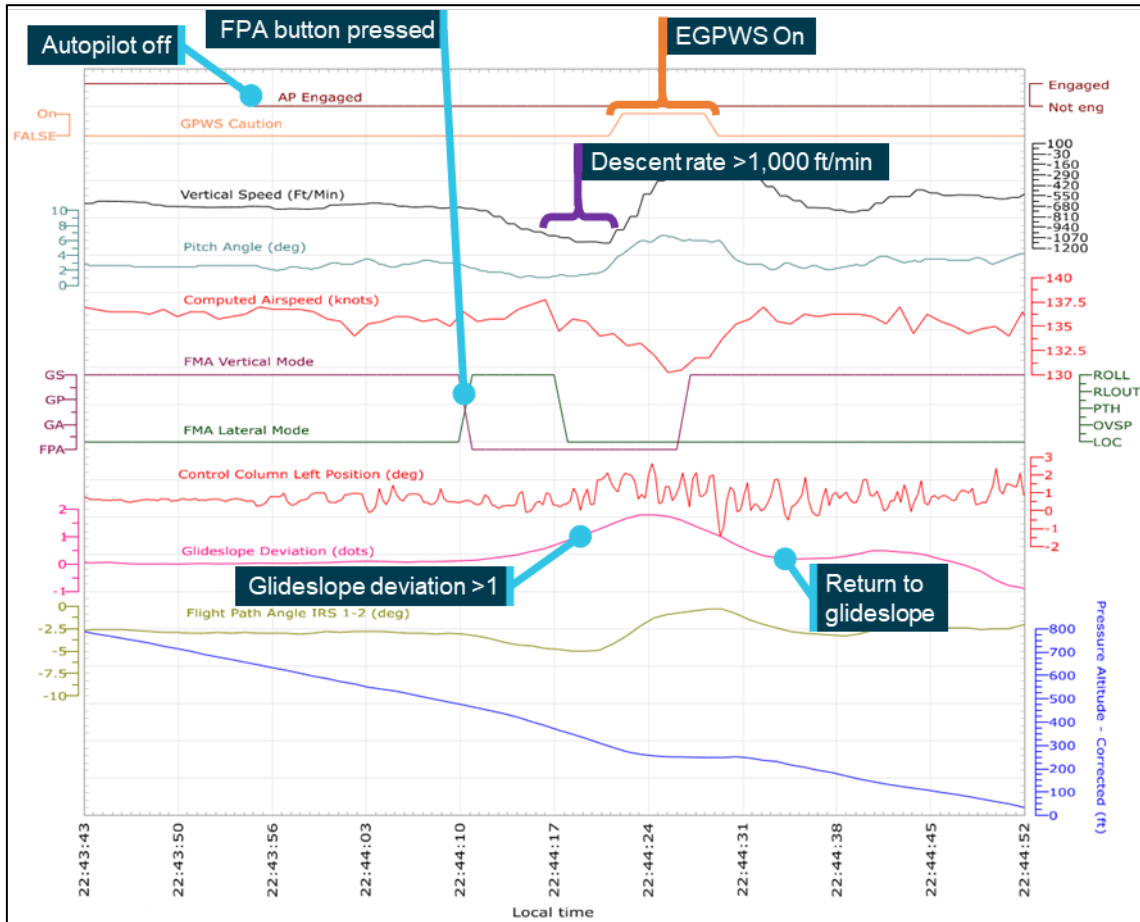
**Figure 6: VH-UZI recorded flight data during the approach**

The flight data from the aircraft's quick access recorder was analysed by the ATSB and the aircraft manufacturer, Embraer (Figure 6). The data showed that at 2243:57, the autopilot was disconnected, and the aircraft closely followed the glideslope until 2244:12, when the first officer inadvertently selected the FPA mode. At that time, the aircraft's flight path angle was 3.3° down with a pitch angle of about 2.5° up. Over the next 10 seconds, the control column pitch up input reduced, with a subsequent reduction in aircraft pitch up angle, and the descent rate and deviation from the glideslope both increased.

Between 2244:18 and 2244:23, the descent rate exceeded 1,000 feet per minute, reaching a maximum of 1,139 feet per minute at about 300 ft above ground level. This was outside of the EGPWS excessive descent rate activation envelope and, therefore, no 'SINKRATE' alert was generated. At 2244:21, the glideslope deviation reached 1.0 dot, and 2 seconds later, the captain pitched the aircraft up, with the EGPWS 'GLIDESLOPE' alert activating immediately after. Three seconds later, a maximum glideslope deviation of 1.8 dot was recorded and the EGPWS alert

deactivated after a further 5 seconds. The glideslope deviation reduced below 1.0 dot at 2244:31, and about 5 seconds later, the aircraft recaptured the glideslope at around the approach minima (220 ft AMSL). The maximum deviation below the glideslope was approximately 60–70 ft during the EGPWS activation.
