# Collision between container ship *Maersk Shekou* and tall ship *STS Leeuwin II*

Fremantle, Western Australia, on 30 August 2024

## **ATSB Transport Safety Report**

MO-2024-001

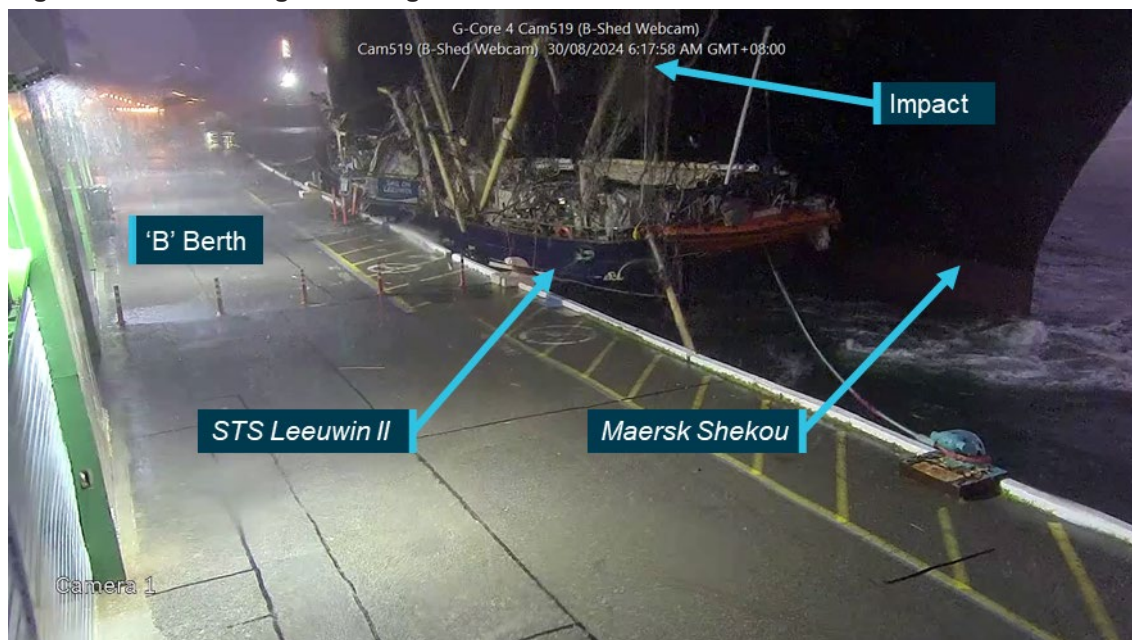
**Figure 4: CCTV footage showing collision between *Maersk Shekou* and *STS Leeuwin II***

Due to the action of the tugs and bow thrusters, the *Maersk Shekou* continued to maintain a port swing of about 10°/min, away from the direct path of the *STS Leeuwin II*. However, *Maersk Shekou* did not make a clear turn, and moments later, its starboard bow flare collided with the *STS Leeuwin II*, dismasting the latter (Figure 4). Two crew members, on board the sailing vessel at the time, escaped via its gangway just as the collision occurred.

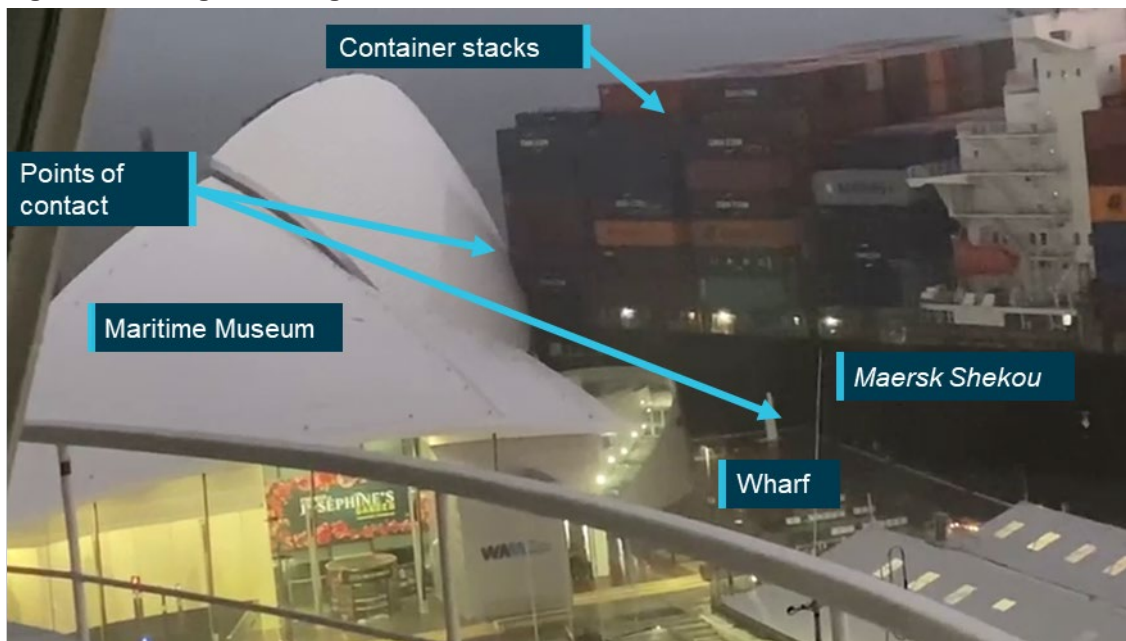
**Figure 5: Footage showing contact of *Maersk Shekou* with the shore**

At 0620:09 the helm was brought to midship, but the rudder momentarily moved to about port 12° for a few seconds before returning to amidships. This movement was later reported to have been due to a fouled towline from the *Svitzer Eagle*. The vessel's rate of turn continued to decrease to nearly zero, but its stern continued to drift towards the wharf. At 0620:23, the pilot ordered the bow thrusters to be put full to starboard, however, the outermost stack of containers on the *Maersk Shekou*'s poop deck collided with the roof of the museum, and the vessel's starboard quarter contacted the wharf (Figure 5).

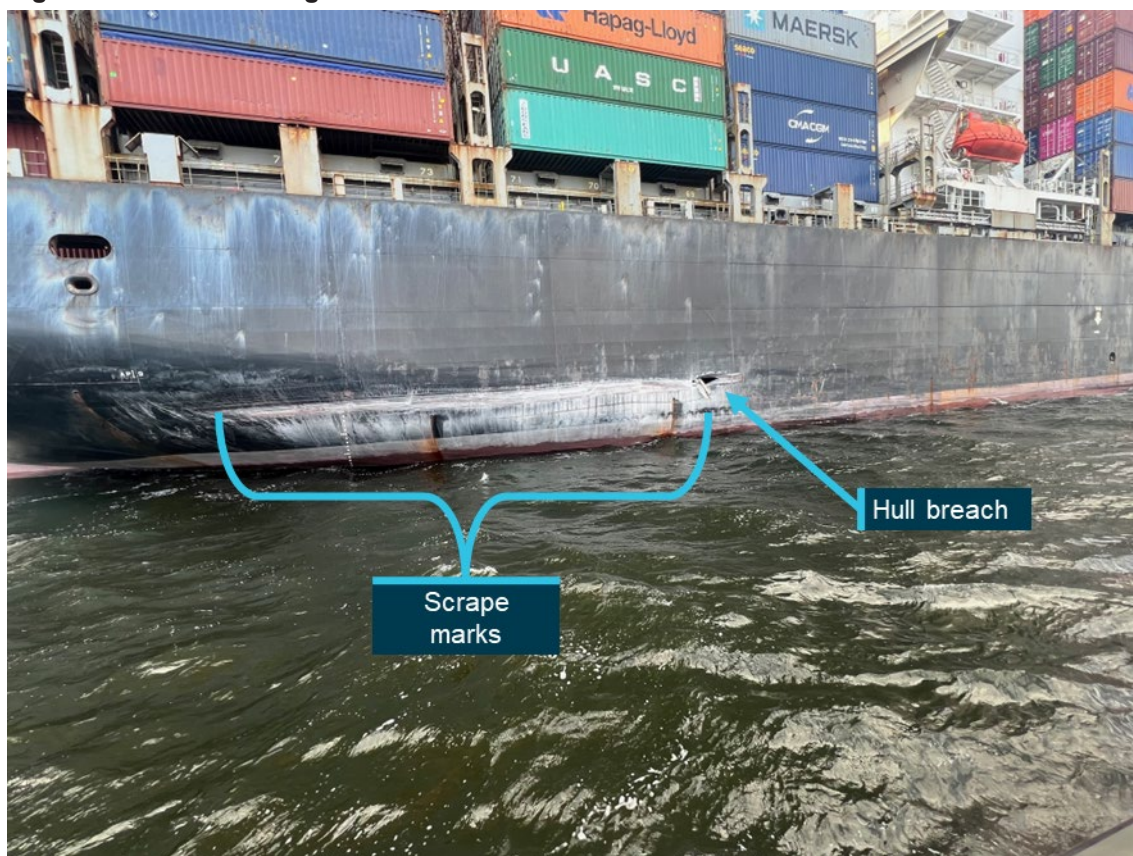
**Figure 6: Contact damage to *Maersk Shekou*'s hull**

Thereafter, the vessel developed a slight forward motion and starboard swing, resulting in the edge of the wharf scraping against and rupturing the vessel's hull by approximately 1.84 m x 0.51 m. The breach was situated above the waterline, and no ingress or egress resulted. Concrete and timber debris from the wharf lodged within the breached section of the hull as the vessel pulled away from the wharf (Figure 6).

The *Maersk Shekou* sustained minor damage. The *STS Leeuwin II* sustained substantial damage and 2 of its crew members sustained minor injuries during the incident.
