# Derailment of freight train 4MC2 and subsequent impact with passenger train 8630

Barnawartha, Victoria on 29 January 2020

**ATSB Transport Safety Report**

RO-2020-001

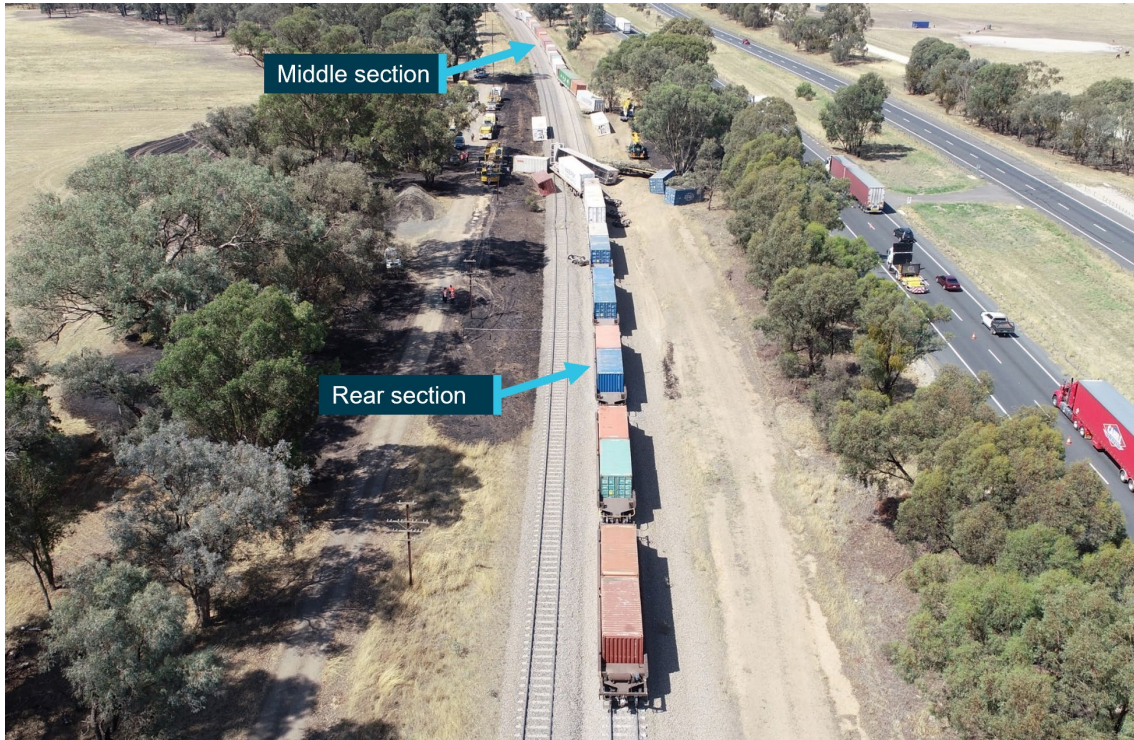
**Figure 2: The middle and rear separated sections of freight train 4MC2**

The locomotives with wagons 1 to 29 attached initially continued for over a kilometre. In this front section of the train, the trailing bogie of wagon 26 and the leading bogie of wagons 28 and 29 were derailed to the left in the direction of travel. It is likely that the trailing bogie of wagon 29 also derailed to the left before it then separated from its wagon at Frying Pan Creek bridge and the rear container from this wagon subsequently fell across both tracks (Figure 3).

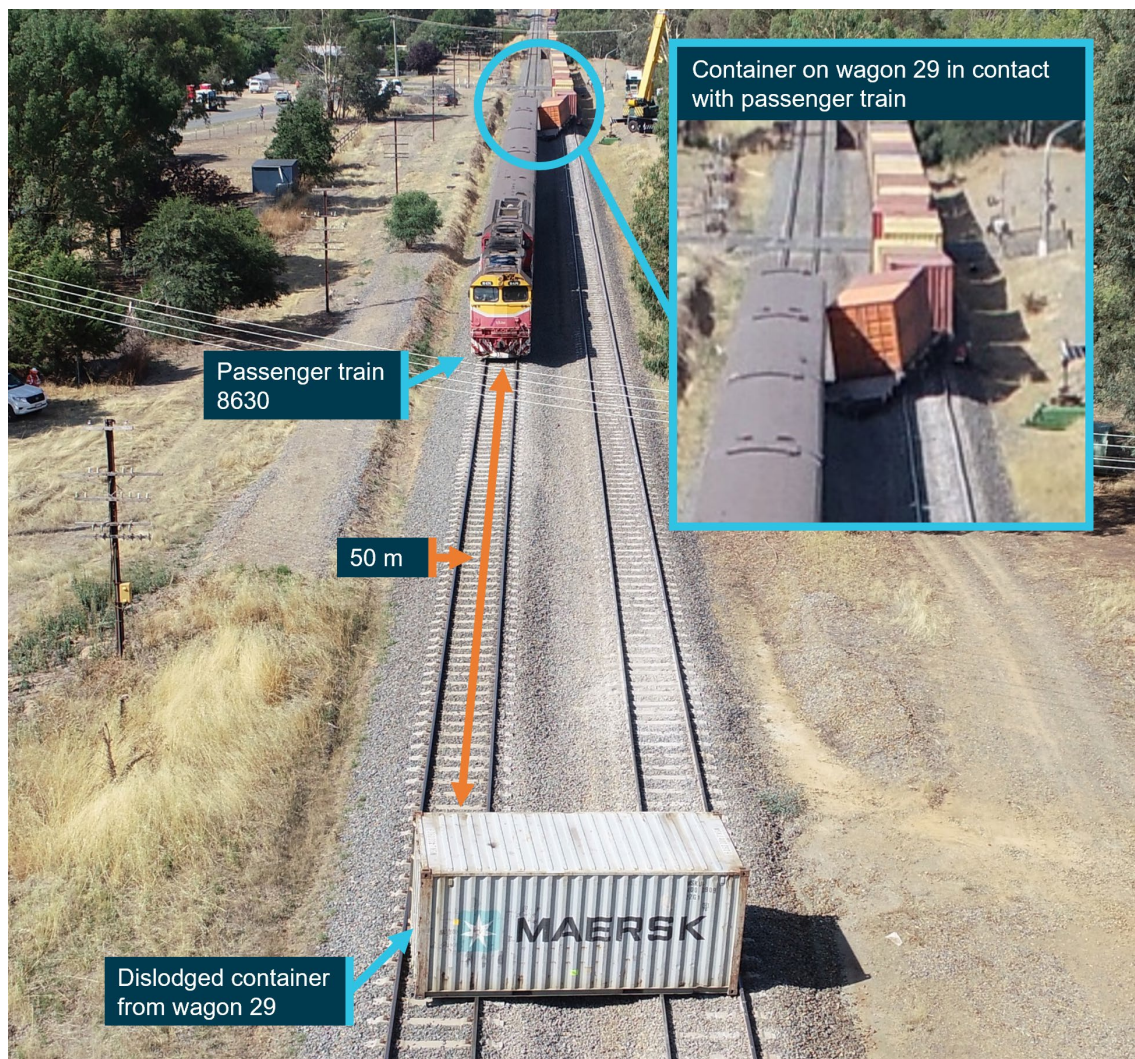
**Figure 4: Train 8630 passenger car in contact with container of derailed wagon of 4MC2**

The trains could not be stopped prior to passing which resulted in passenger train 8630 impacting a shipping container on a derailed wagon of 4MC2, sustaining minor damage. There were no injuries to passengers or crew. The passenger train stopped about 50 m short of another container that had fallen from the freight train and was obstructing both tracks.

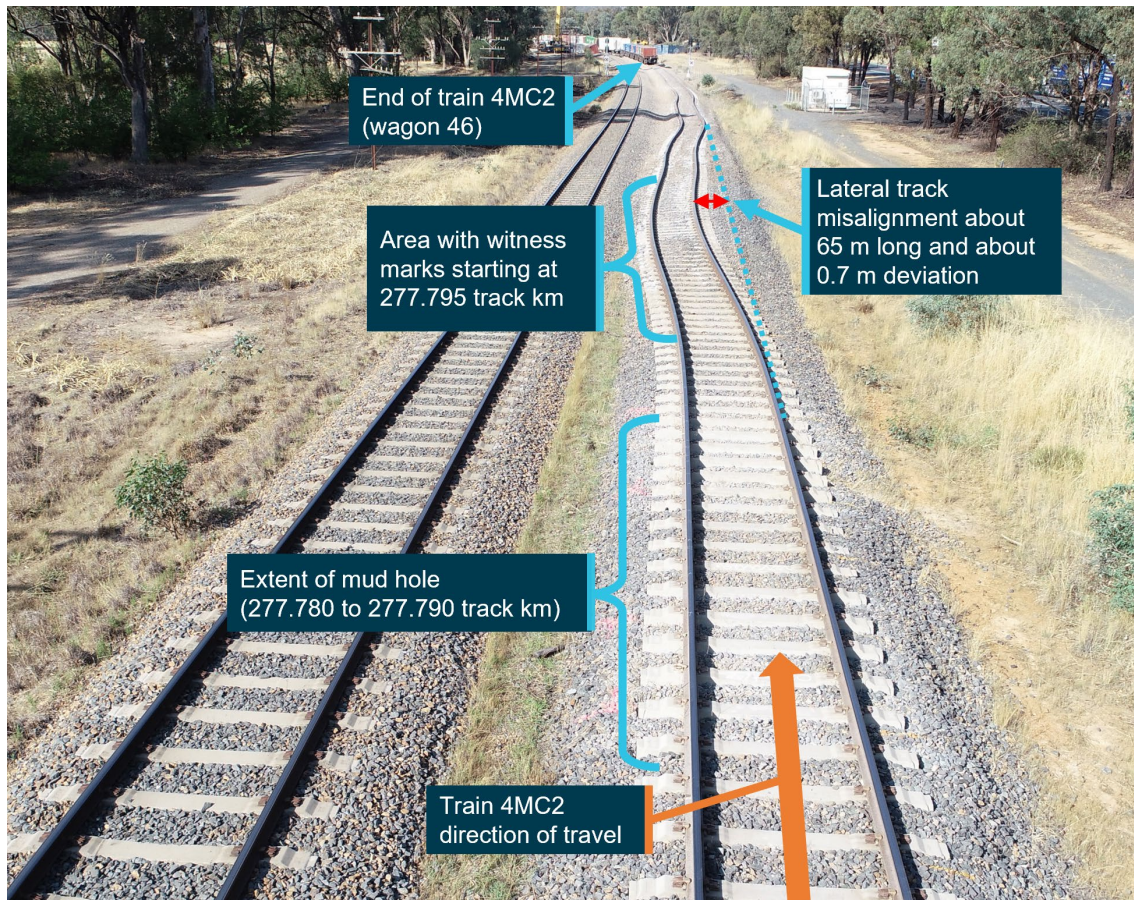
**Figure 6: Overview of derailment area**

The track at the derailment location was inspected the day after the derailment. A mud hole was observed within about 10 m of track between 277.780 track km to about 277.790 track km where there was contamination of ballast, a loss of ballast between sleepers, and loss of ballast profile at sleeper ends (Figure 6). A lateral track misalignment was also present, beginning at about the same location as the northern extent of the mud hole (277.790 track km). The visible length of misaligned track was about 65 m although the full extent of the misalignment was likely obscured by subsequent damage from derailed wagons. The misalignment was predominantly toward the left in the direction of travel and the greatest measured lateral deviation was about 0.7 m. Several sets of witness marks from the passage of wheels were identified on the rail head in the section of misaligned track.

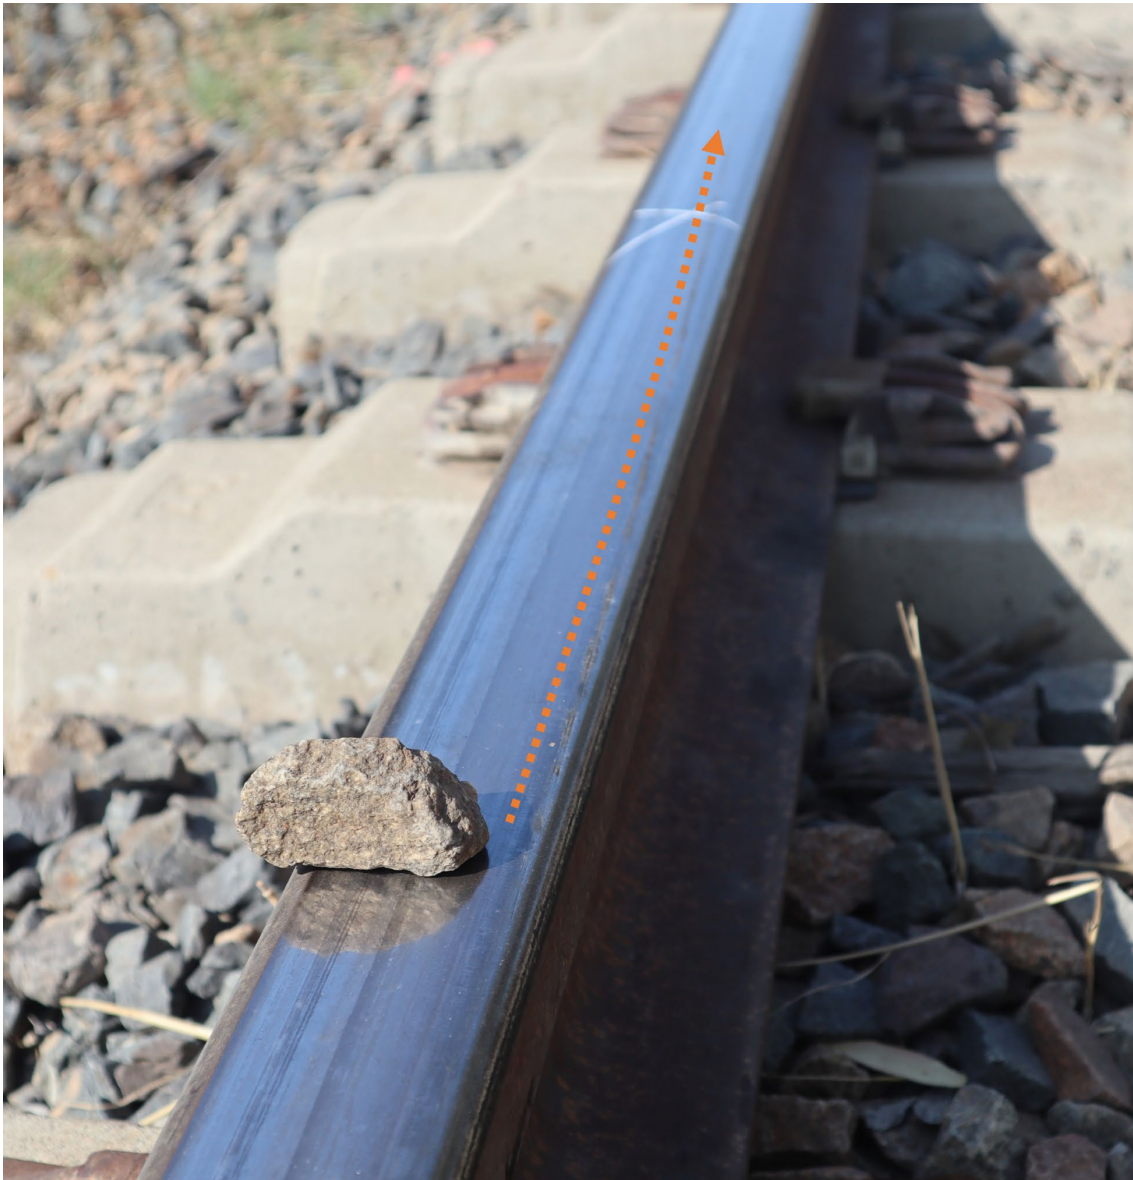
**Figure 7: Witness mark from a wheel flange climb**

The witness marks consistently indicated that left wheels had ridden up and over the left rail (Figure 7). Related marks were also observed where the corresponding right wheels had dropped between the rails, and where both wheels began contacting sleepers. It was not possible to ascertain which marks were associated with the first derailed wheelset.

Post-derailment inspection identified several locations of wheel flange climb over the rail head of the left rail in the direction of travel. Subsequent damage to sleepers was consistent with full wheelset derailment, the furthest south location identified was at 277.795 track km, about 5 m past an observed mud hole. The flange climb marks were consistent with the derailed states of wagons 26 (trailing bogie), 28 (leading bogie) and 29 (both bogies) being toward the left in the direction of travel. While it was not possible to conclusively determine which marks were associated with which wheel derailments, the observation of flange climb marks on the rail head indicate that the initial derailment was probably by the action of a flange climb.

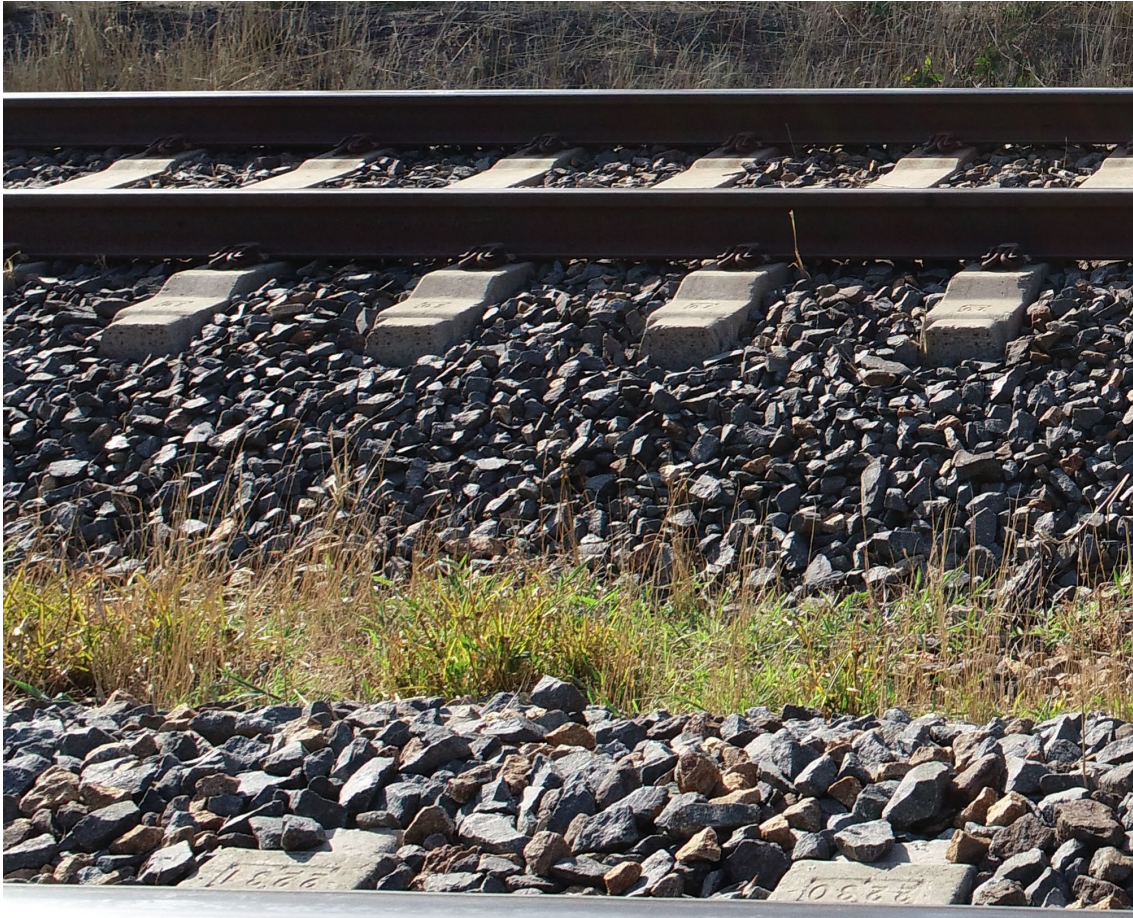
**Figure 8: Sleeper ends protruding from ballast (about 277.770 track km)**

Within the length of the track misalignment, the ballast had been disturbed by sleeper movement and the impact of derailed wheels. Therefore, the condition of the ballast shoulder could not be assessed. Undisturbed track was inspected at about 277.770 track km. In this area sleeper ends were visible, suggesting that ballast shoulders were less than full (Figure 8).

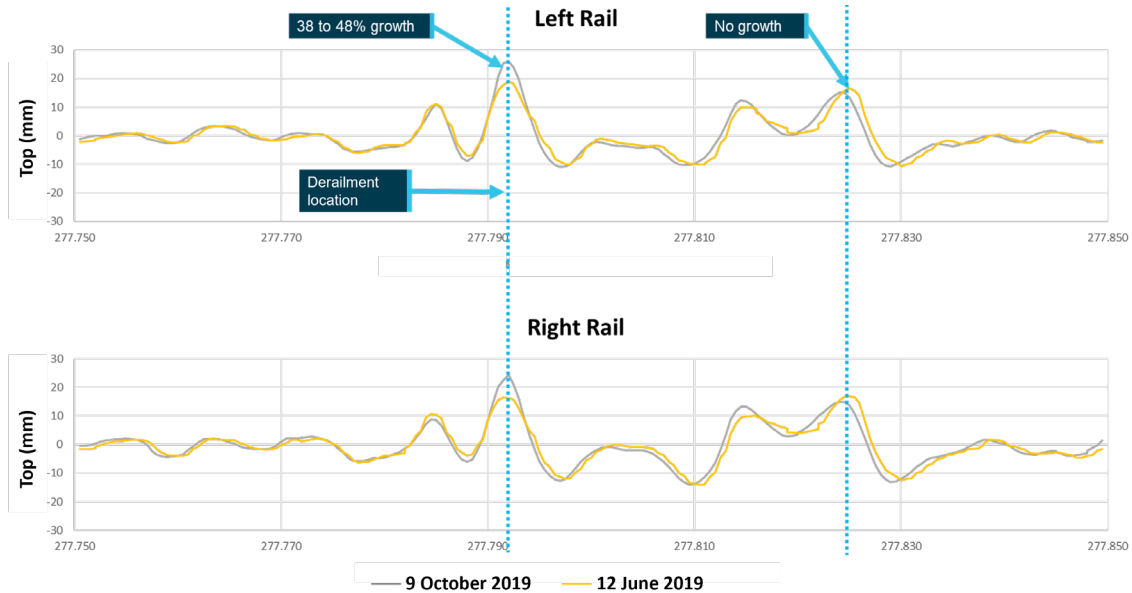
**Figure 9: Surface (top) deviation, between June and October 2019 measurements**

The data from the 12 June 2019 measurement was compared to the 9 October 2019 measurement (Figure 9). The comparison showed consistent waveforms between the two sets of measurements and significant growth (38% on the left rail and 48% on the right rail) at the 277.792 km location.

The growth of the irregularity in the preceding 4 months (120 days) suggested that it was likely that the defect would have continued to grow in the subsequent period up to the occurrence date (113 days). However, the size of the defect at the time of the occurrence cannot be inferred from this as the growth rate is unlikely to be linear, instead dependent on several factors including prevailing weather and traffic density.

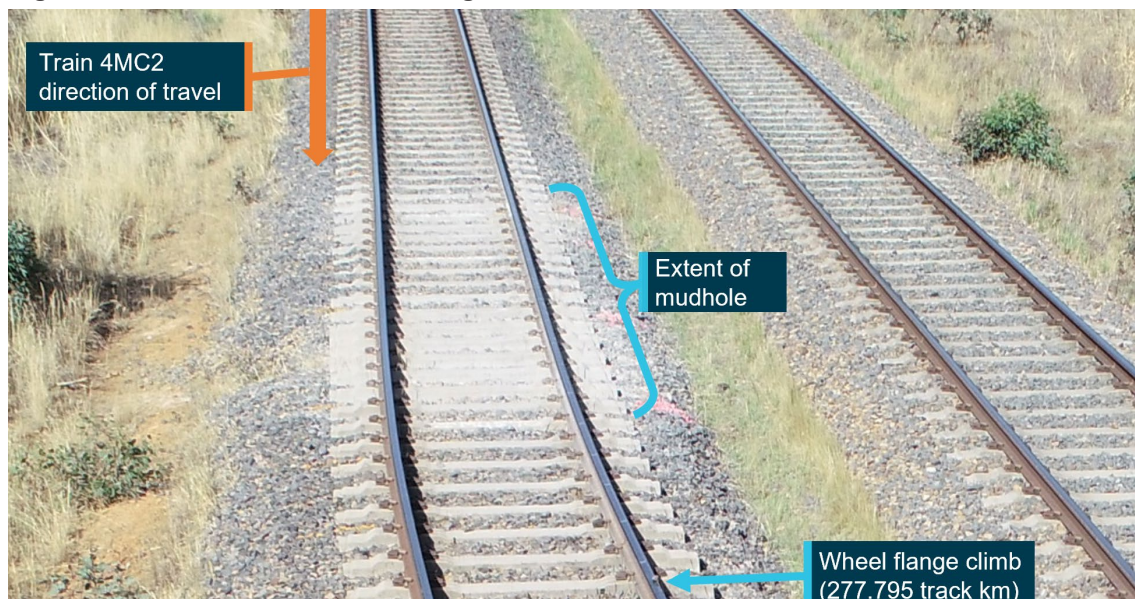
**Figure 10: Extent of mud hole and light-coloured ballast**

A mud hole had been identified during inspection and was recorded in ARTC's Ellipse maintenance system. It was first identified in 2014 when it was 1 m long and was monitored intermittently through track inspection. The most recent update was on 8 February 2019, at which time the mud hole was listed as a P4 priority defect between 277.780 track km and 277.790 track km (10 m). A defect assigned a P4 priority was to be addressed within 12 months.<sup>7</sup> At the time of the derailment the defect was less than 2 weeks from exceeding this but had not yet been addressed.

The track proximate to the derailment had not been identified by ARTC as a location requiring ballast rectification. A mud hole was observed in post-derailment inspections that included sections with deficient ballast (Figure 10). The mud hole was about 10 m long, sufficient length for the CoP to require a response due to ballast deficiency.

ARTC has made several changes to procedures and standards relating to track misalignment, track geometry defects and mud hole management. These safety actions seek to improve ARTC's capacity to identify locations that may become vulnerable to track instability. In addition, ARTC has undertaken to review available technology to improve its stress-free temperature testing capability. ARTC has also changed its processes relating to the selection of track speed used to set the appropriate limits for track geometry assessment.

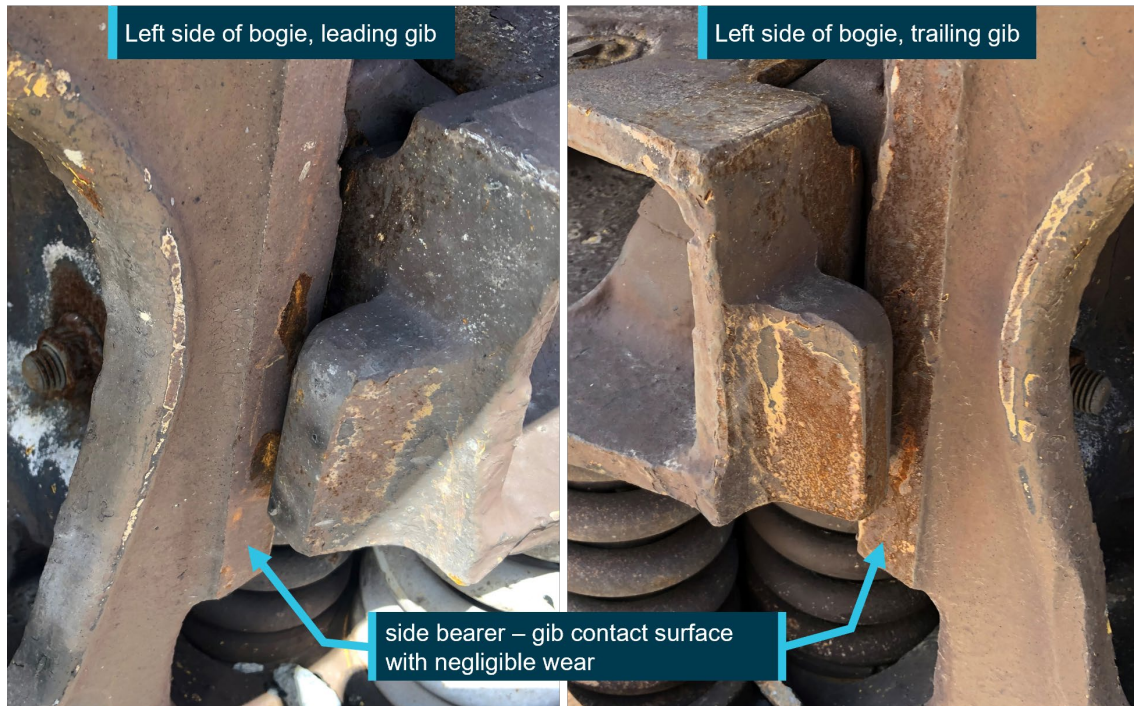
**Figure 11: Wagon 28 lead bogie gib condition**

The inspection of wagon 28 identified that there was a gap between the side bearer on the left side (in the direction of travel) and the wagon body of the leading bogie. Shims were missing from above the side bearer wear plate creating the gap. Missing side bearer shims could reduce the speed at which the wagon was susceptible to hunting. However, it was not determined whether the shim was missing before the derailment and other indicators of hunting were not present, such as wear on gib<sup>26</sup> contact surfaces (Figure 11).

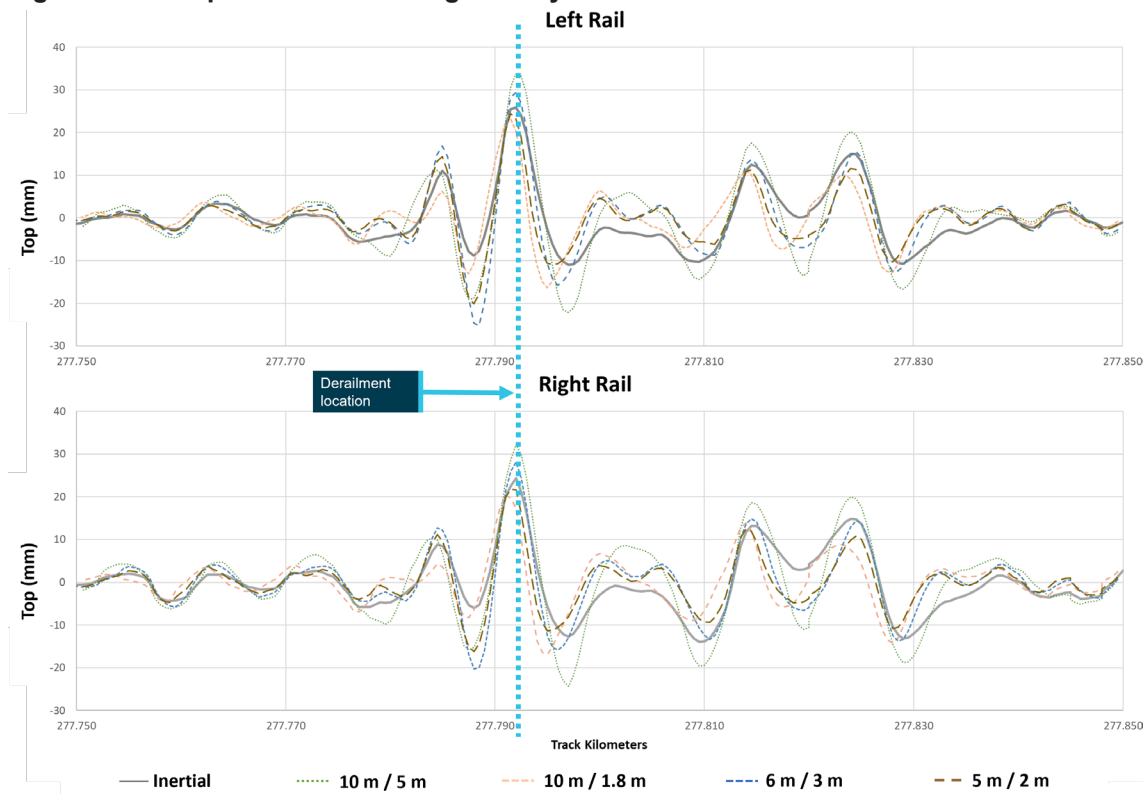
**Figure B1: Comparison of vertical geometry results – Left rail**

The inertial vertical geometry measured on 9 October 2019 was reprocessed into the chord offsets relating to each standard. Each result was compared to the defect limit and maintenance response criteria of the applicable standard. Further detail is provided in Appendix B. In all cases this resulted in a defect at the 277.792 track km location with a required response that was more

- The long chord criteria in AS 7635 required action (repair or further assessment) within 24 hours.
- The short chord criteria in AS 7635 required action (repair or further assessment) prior to the passage of the next train.
- The RailCorp standard required action (repair or further assessment) within 24 hours for both long and short chords.
- The V/Line standard required an immediate speed restriction and repair within 7 days.
