# Safety Advisory Notice

Number: AO-2018-053-SAN-004

## Alerts and guidance for unreliable airspeed indications on take-off

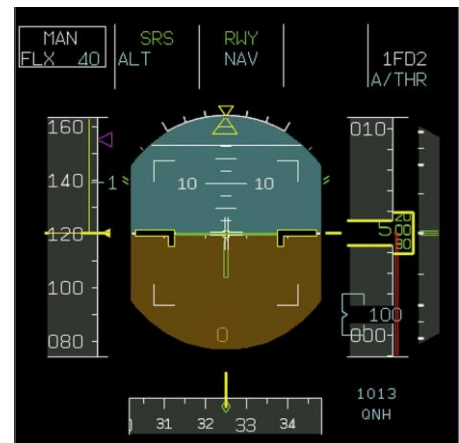
On the night of 18 July 2018, an Airbus A330 commenced take-off from Brisbane, Queensland with covers left on the aircraft's three pitot probes (airspeed sensors). The primary flight displays showed red speed flags in place of the airspeed indication early in the take-off, and either speed flags or unrealistically low airspeeds for the remainder of the flight. The standby airspeed display was also invalid throughout the flight.

The flight crew did not see or respond to the speed flags until the aircraft's speed was too high for a safe rejection of the take-off. The take-off was continued and the aircraft returned to Brisbane.

**AO-2018-053-SAN-004:** The Australian Transport Safety Bureau encourages all manufacturers and operators of larger air transport aeroplanes to consider what types of unreliable airspeed events can occur, how the information is presented to flight crews, and what responses are the safest in different phases of the take-off and in a range of potential situations. Aircraft alerting systems, flight crew procedures, and flight crew training should be designed to provide sufficient assurance that flight crews become aware of and understand how to appropriately respond to unreliable airspeed on take-off in a timely manner.
