Fuel starvation and forced landing involving Cessna 310R, VH-DAW

About 5 km south-east of Derby Airport, Western Australia on 20 June 2023

ATSB Transport Safety Report

AO-2023-029

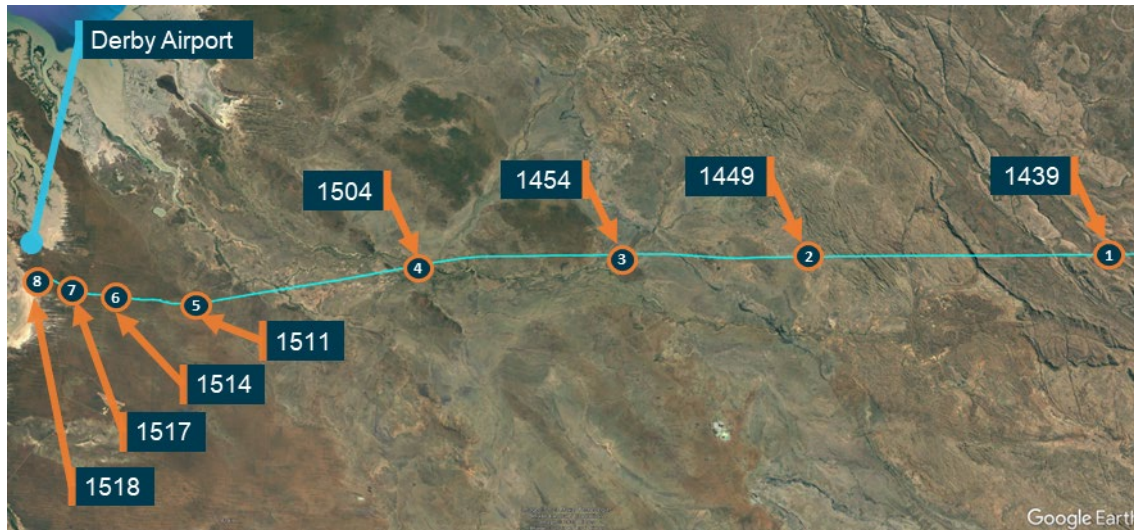
Figure 2: VH-DAW flight path

1. Change from main tanks to auxiliary tanks; 2. Change the left engine from auxiliary tank to main tank; 3. Right engine surge – changed the right engine to right main tank; 4. Right engine surge – crossfeed right engine off left main tank; 5. Inbound call for Derby Airport; 6. Dual engine surge; 7. Mayday call; 8. Accident site.

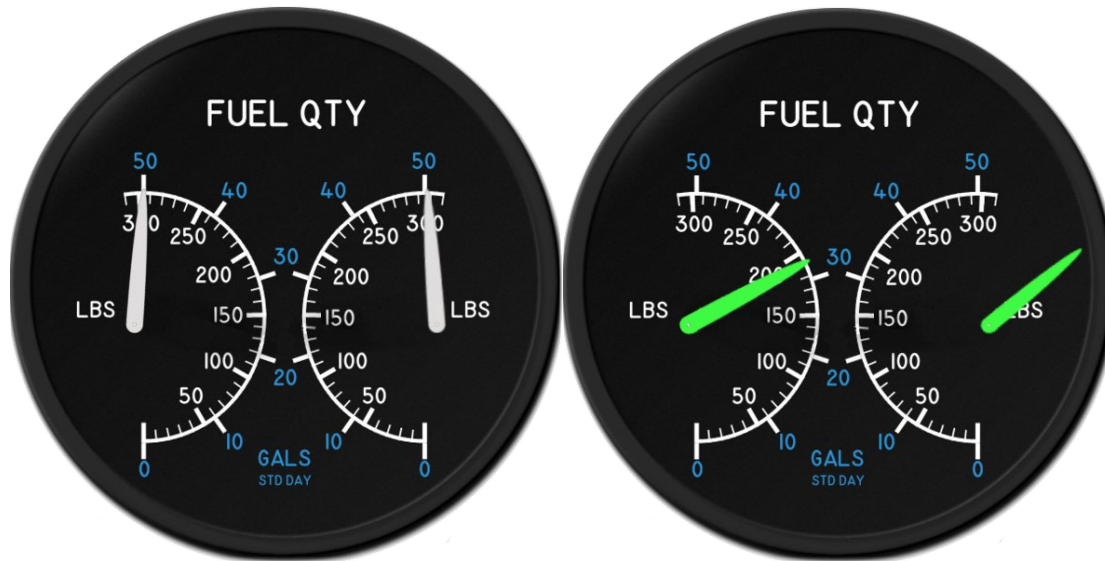
Figure 6: VH-DAW main tank fuel gauges

would exceed full scale deflection, while the left main tank display would under-read by approximately 64 L (105 lbs) (Figure 6).

Left image – expected fuel gauge indications for main tanks when full; right image – the reported fuel gauge indications for main tanks when full.

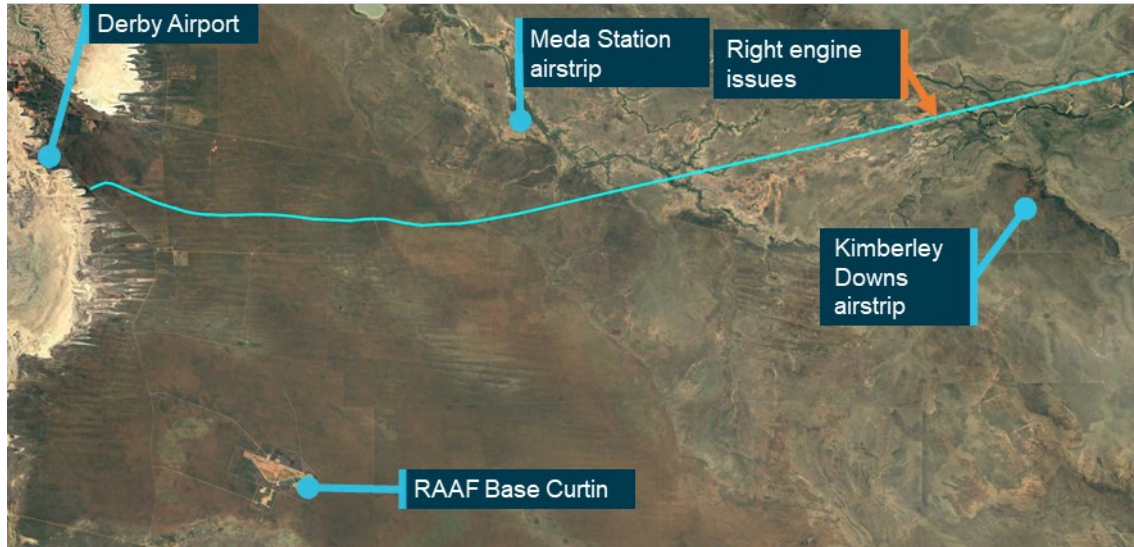
Figure 15: Diversion locations

At this point in the flight, the aircraft was located between 2 nearby diversion airstrips of Kimberley Downs Station, located approximately 5 NM to the south-east, and Meda Station located approximately 16 NM west (Figure 15). The pilot noted they were familiar with the location of the airstrips, however they had never operated from them and were unaware on their suitability and condition. The pilot stated that because of these unknowns that they believed the only suitable airstrip was Derby Airport.

The pilot did not consider diverting to RAAF Base Curtin.
Source: Google Earth, annotated by the ATSB
