Fuel starvation and forced landing involving Cessna 310R, VH-DAW

About 5 km south-east of Derby Airport, Western Australia on 20 June 2023

ATSB Transport Safety Report

AO-2023-029

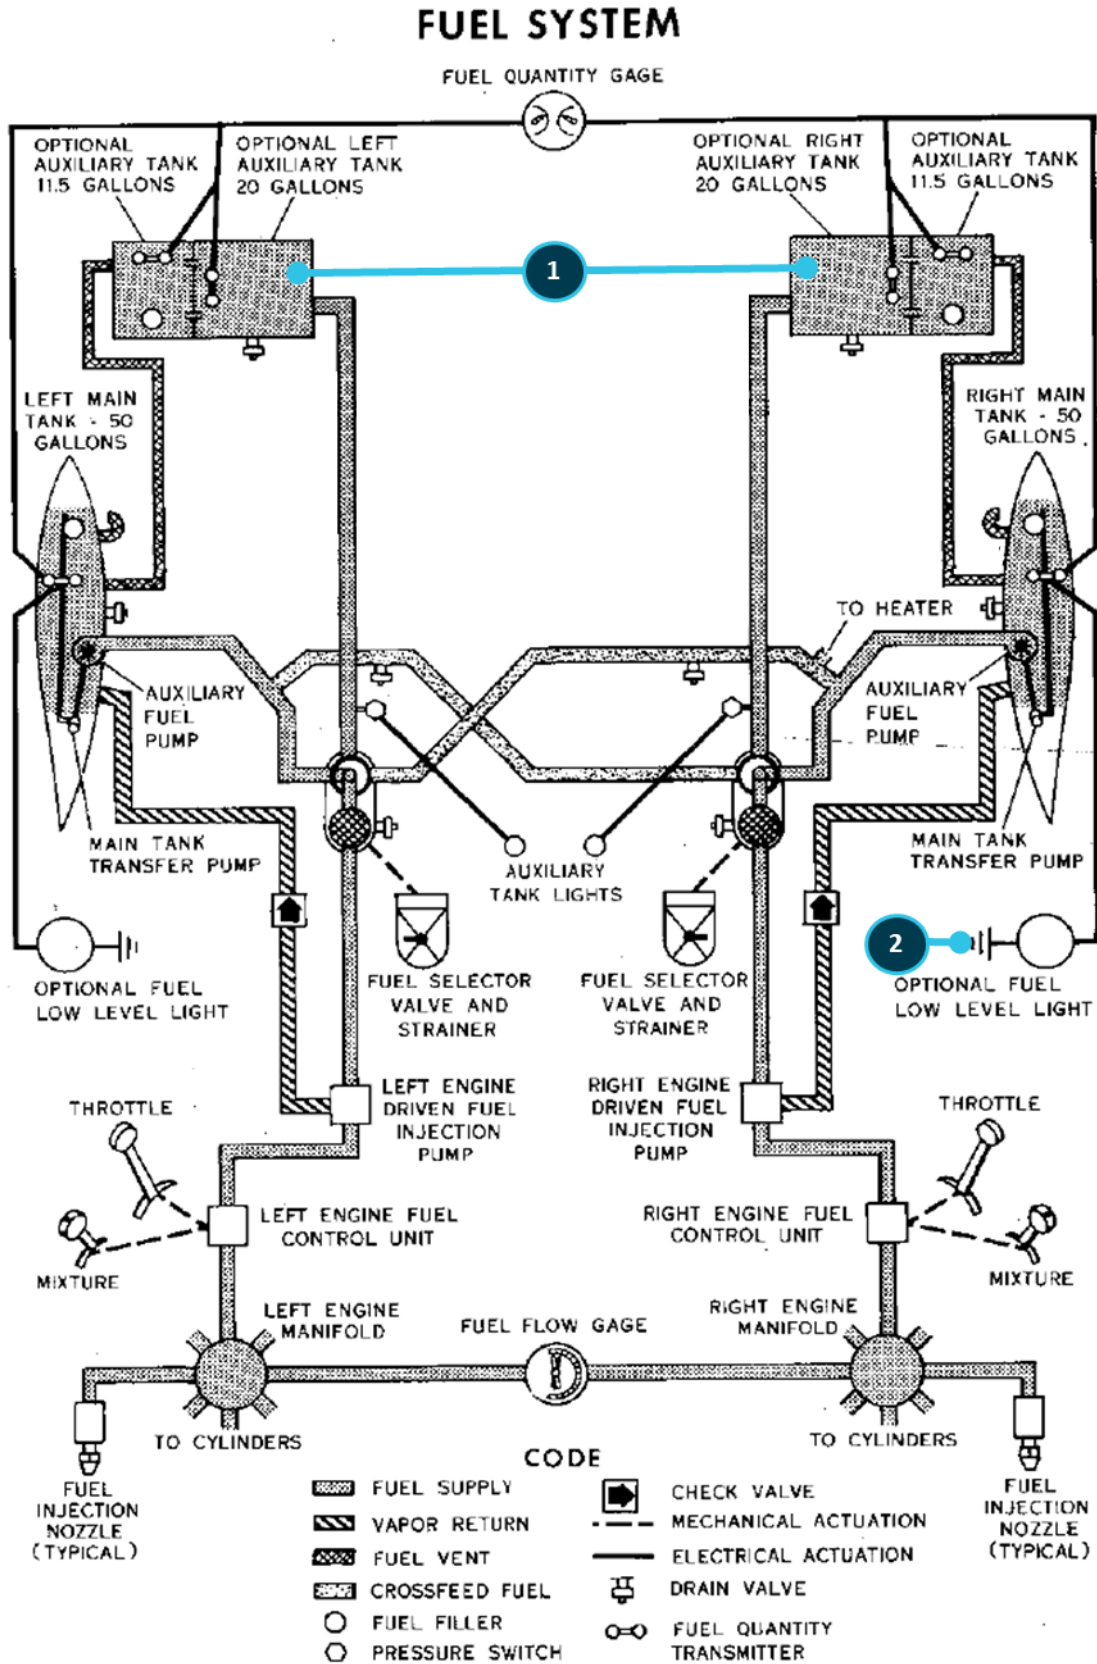
Figure 3: VH-DAW Fuel System

1. VH-DAW was fitted with both optional auxiliary tanks, totalling 31.5 US gallons on each side; 2. The aircraft did not have the optional low level fuel light fitted.

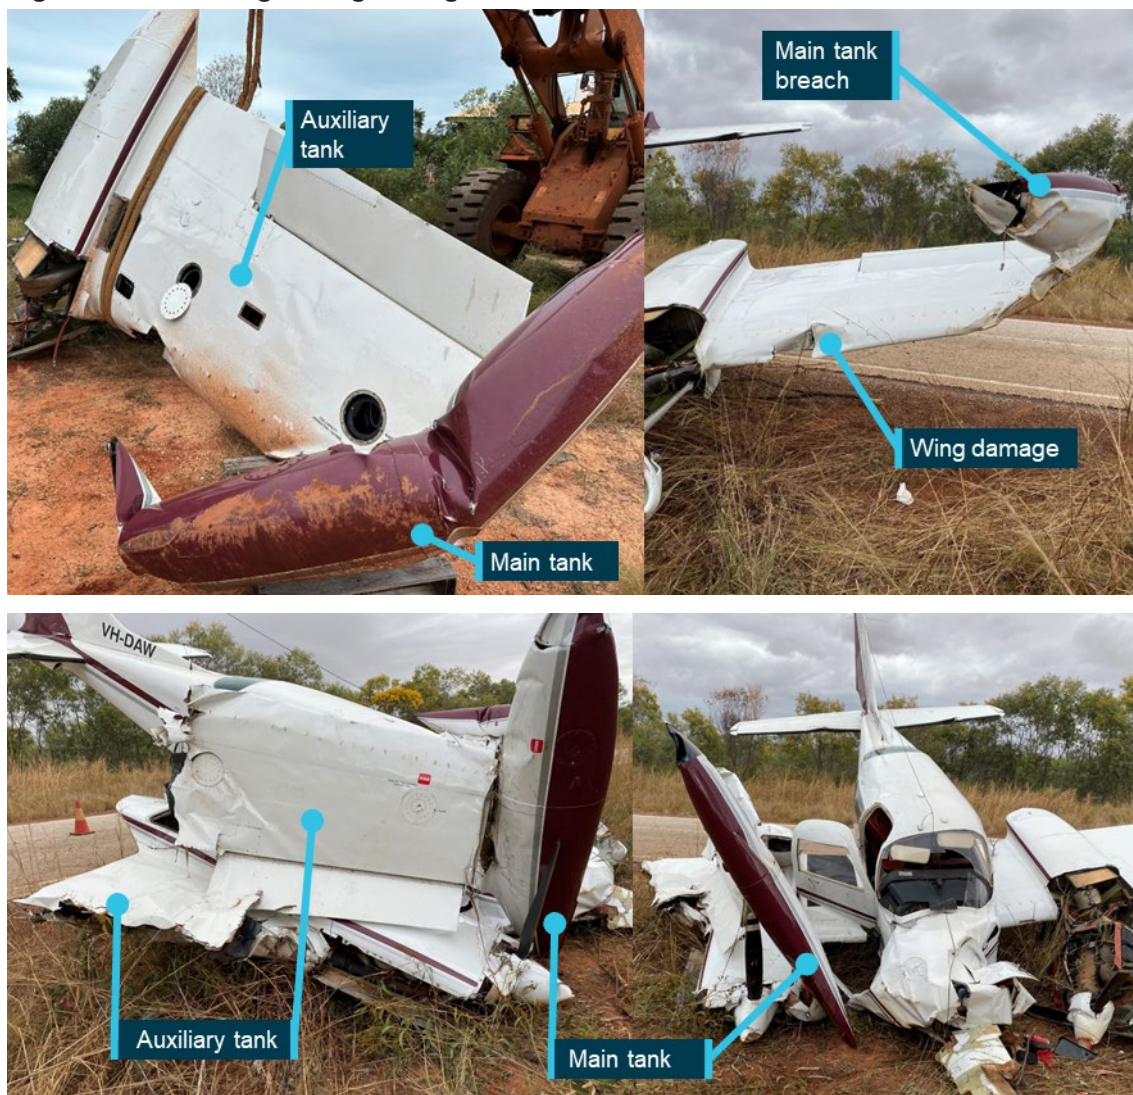
Figure 5: Left and right wing damage

Top image – left wing; bottom image – right wing.
 Source: Western Australia Police Force, annotated by the ATSB

While reviewing the video footage taken by the police onsite, the left landing light circuit breaker was found to have tripped. The ATSB could not verify if this occurred due to ground impact forces or during the flight.

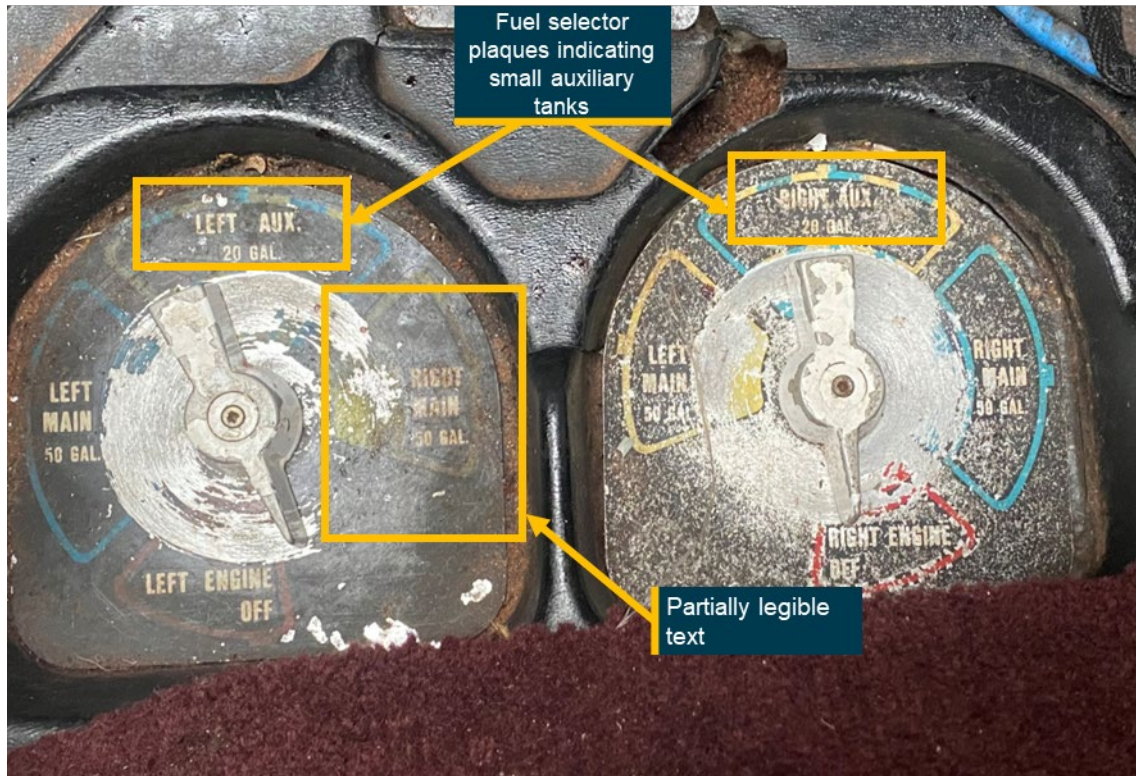
Figure 10: VH-DAW fuel selector plaques

The fuel selectors had plaques stating the amount of fuel in each tank in US gallons. On inspection, it was noted that the auxiliary tank capacity for both sides incorrectly indicated that small auxiliary tanks (20 US gallons) were fitted to the aircraft (Figure 10).

The fuel selector placards had last been replaced on 24 October 2008, prior to the aircraft being registered to Broome Aviation. The installed placards were the incorrect part number and as such displayed the incorrect size of the auxiliary tanks. The ATSB was unable to determine if the plaque relating to the 90 minutes on mains had been removed previously or never installed.
