Aircraft separation issue during take-off involving Lancair, VH-VKP, and De Havilland Aircraft of Canada Limited DHC-8-315, VH-TQZ

Mildura Airport, Victoria, on 29 September 2023

ATSB Transport Safety Report
Aviation Occurrence Investigation (Defined)
AO-2023-050
Final – 30 May 2025

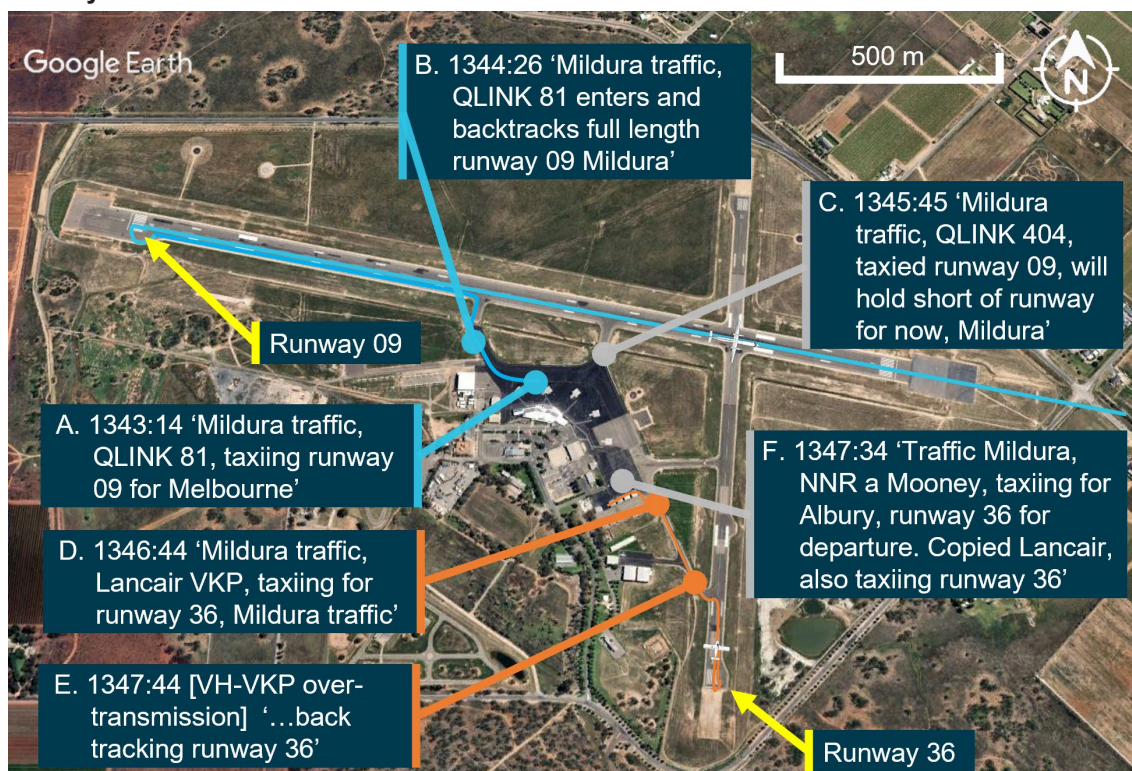
Figure 2: Sequence of events while the Dash 8 and Lancair taxied to their respective runways

Radio data collected from Mildura Airport CTAF recordings (Appendix A) are overlaid on a Google Earth image of the airfield (Figure 2). These showed that the crew of the Dash 8 (call sign QLINK81) made a taxi call for runway 09 at Mildura (A), with a further entering and backtracking call 72 seconds later (B). The crew of a second Dash 8 (QLINK 404) called taxiing for runway 09 and held short of runway 09 (C).²

The Dash 8 flight crew were backtracking on runway 09 while making a series of calls with the pilot of a Tecnam aircraft, about 11 km north of Mildura and a Cessna joining the circuit overhead the aerodrome. The Dash 8 flight crew spent about 11 minutes communicating with the Cessna to establish deconfliction. It was during this time that the pilot of the Lancair made their taxi call on the CTAF (D).

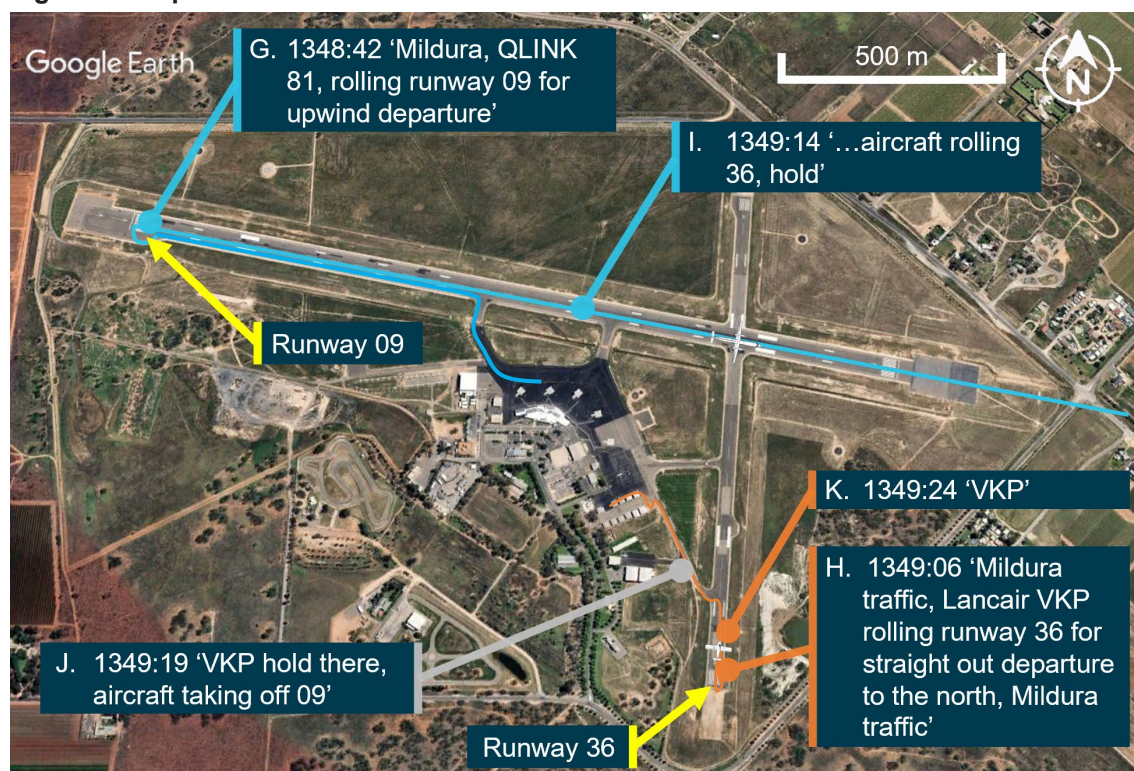
Figure 3: Sequence of events after Dash 8 commenced take-off

Subsequent events are shown in Figure 3. After reaching the end of the runway, at 1348:42, the Dash 8 gave a rolling call on 09 for departure (G). After a short backtrack along runway 36, the Lancair gave a rolling call on runway 36 at 1349:06 (H). The Dash 8 first officer immediately responded with 'aircraft rolling 36, hold' (I). The Lancair pilot did not recall hearing any calls from the Dash 8.

Believing that the Dash 8 crew's call may not have been heard by the Lancair, the Mooney pilot relayed to the Lancair that there was another aircraft rolling on runway 09 (J). The Lancair pilot acknowledged and aborted their take-off at 1349:24 (K) as they had not yet begun to roll, at which point the Lancair was stationary at the end of runway 36, about 730 m from the runway intersection. As the Dash 8 had already passed V_1 ,³ the flight crew continued the take-off.

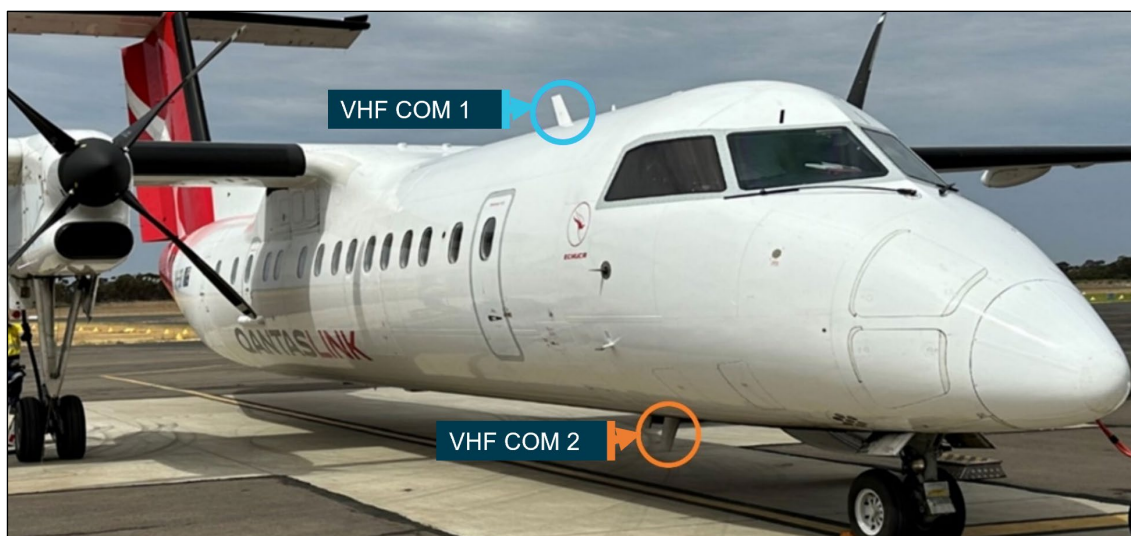
Figure 4: Dash 8 antenna position

- Number 1 VHF COM antenna (VHF COM 1) mounted on the roof of the aircraft forward of the wings.
- Number 2 VHF COM antenna (VHF COM 2) mounted on the belly of the aircraft (Figure 4).

The VHF COM 2 antenna was installed onto VH-TQZ on 1 March 2018 with the last reported C-check⁴ conducted on VH-TQZ on 1 August 2023. There was no reported corrosion present under the VHF COM 2 antenna and the only recent defects in the previous 6 months related to the VHF COM 2 screen and frequency knob on the head unit inside the cockpit which were subsequently returned to service.

De Havilland Aircraft of Canada Limited further identified that due to the lower mounted aerial position of VHF COM 2, that base plate corrosion due to moisture wicking, if not drained correctly, could degrade signal strength. Additionally, antenna damage from foreign objects may also have the same effect.

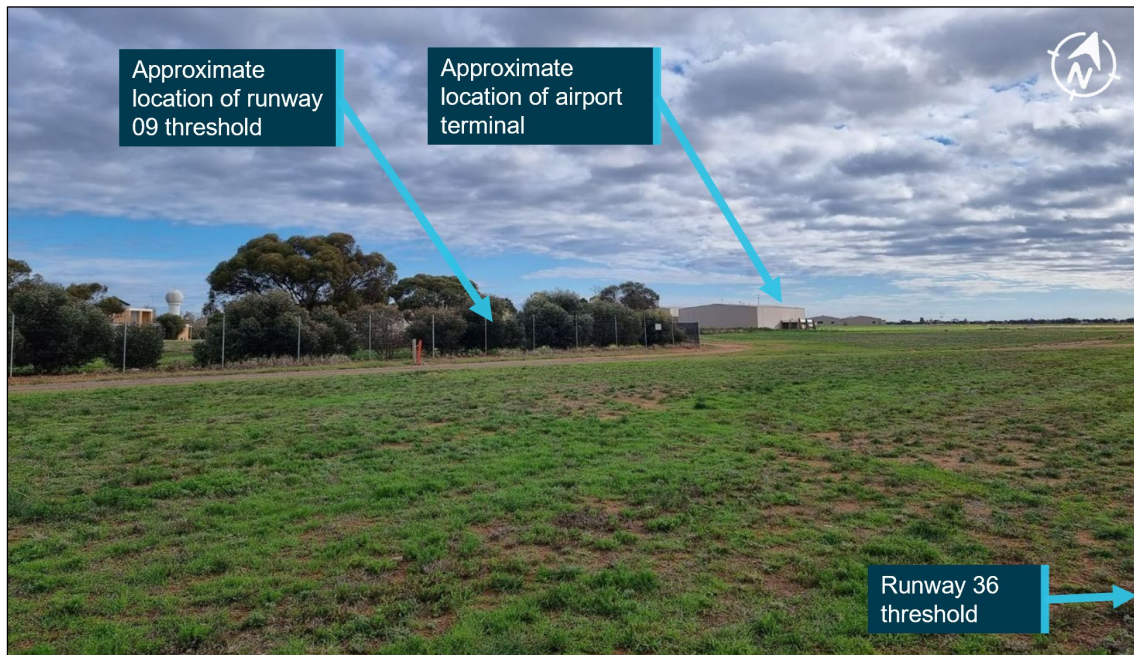
Figure 6: View from threshold runway 36

ATSB inspection of Mildura Airport established that from the threshold of runway 36, the threshold of runway 09 was visually obscured by the terminal buildings (Figure 6). The threshold of runway 36 was similarly not visible from the threshold of runway 09.

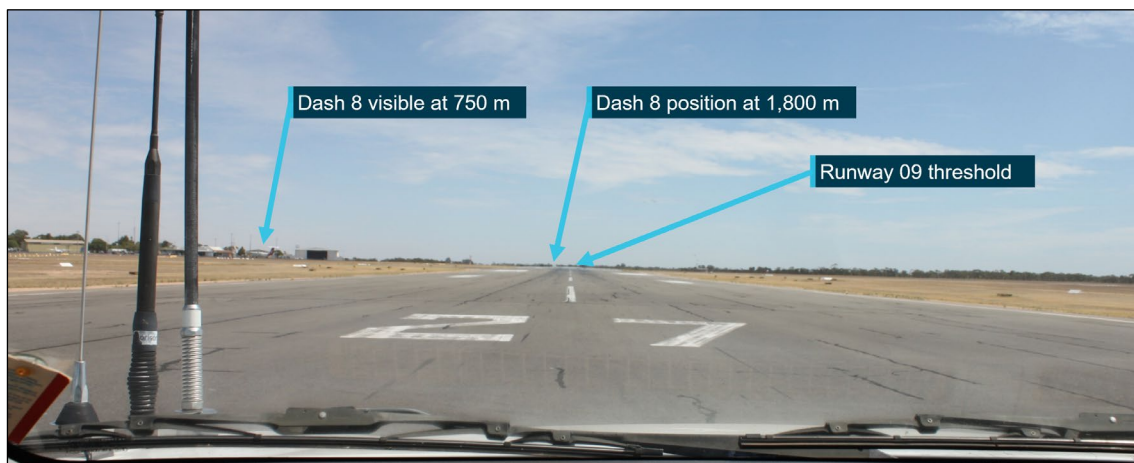
Figure 7: View from threshold of runway 27

The ATSB site inspection also identified a lack of line of sight between the thresholds of runway 09 and 27 (either end of the same physical runway about 1,800 m away) when viewed from the occupant height of a road vehicle. This was due to raised terrain along the runway between the two ends (Figure 7).

Dash 8 not clearly visible at other end of runway.
Source: ATSB

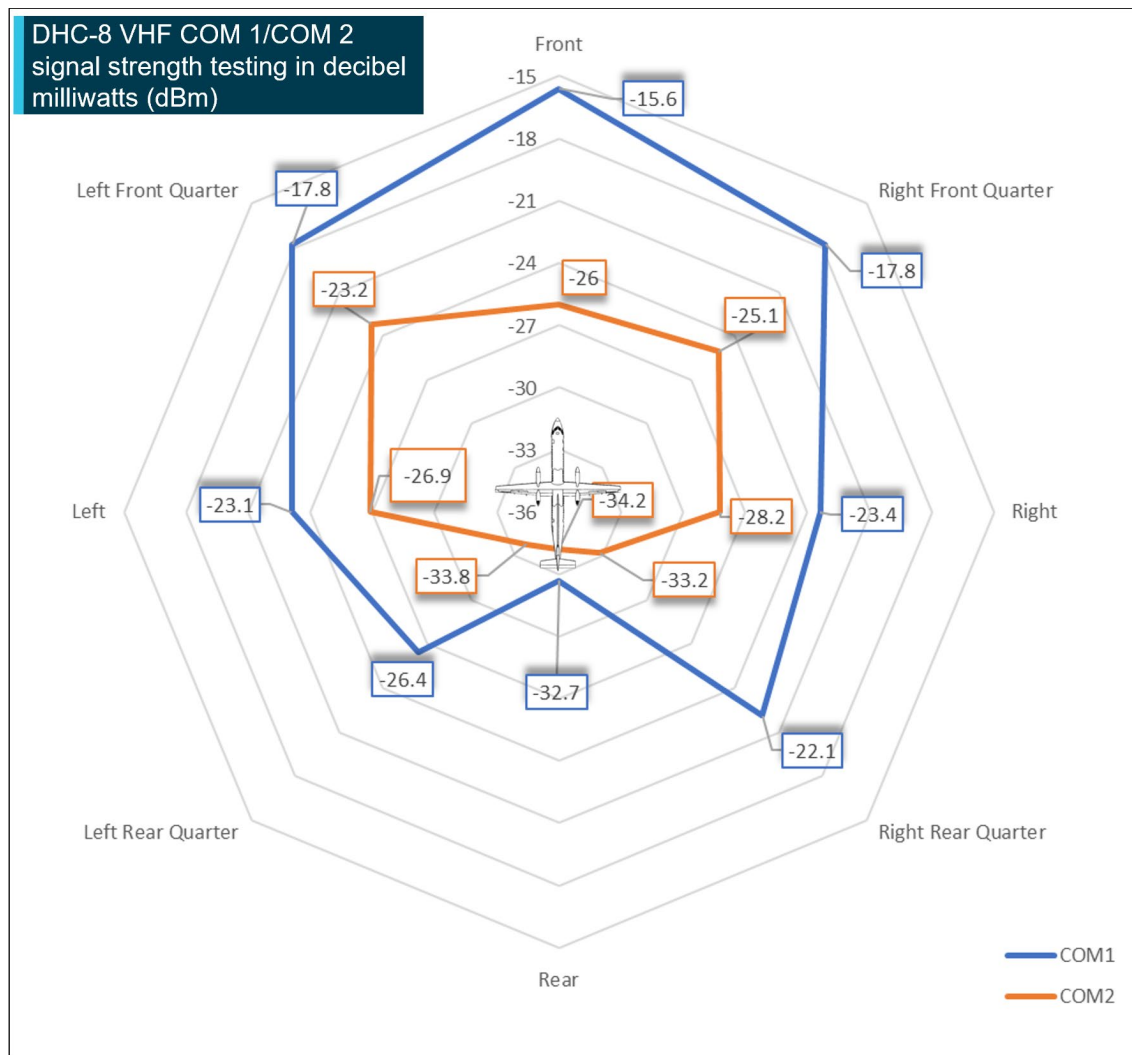
Figure 9: Dash 8 airframe signal strength and shielding testing

The testing was conducted on the Mildura apron, adjacent to parking bay 3, with VH-SBI facing towards the terminal (nose in), simulating the startup position with engines running. An ATSB investigator was also present on the flight deck with operator's crew. ATSB and ACMA staff conducted a ground-based signal strength and readability test from the tarmac at about 20 m distance from the aircraft at 8 cardinal points around the aircraft (Figure 9). The testing was restricted to close proximity testing and possible results from a greater distance may vary. However, the magnitude of variation even at close distance was considered significant.

Testing conducted by ATSB and ACMA measured the transmission power pattern of the VHF COM 2 (via the lower antenna) on the ground and identified that signal reception exhibited significant directional variation, with the average signal strength forward of the aircraft being about 8.5 dB stronger than the average signal strength behind and to the side of the aircraft. Depending on the external physical environment and other factors, this can lead to signal degradation or loss.

The FOSLs were released on 6 December 2024 for the Dash-8-100/200/300 (DH8-SL-23-008A) and Dash-8-400 (DH8-SL-23-020A). Details included a description of the limitations of VHF line of sight communications and the recommendation that VHF COM 1 may provide a better signal (receiving and transmitting) to other stations on the ground, or nearby in the air.
