Turbulence event and cabin crew injury involving Boeing 737, VH-VYK

36 km south-east of Brisbane Airport, Queensland, on 4 May 2024

ATSB Transport Safety Report

AO-2024-032

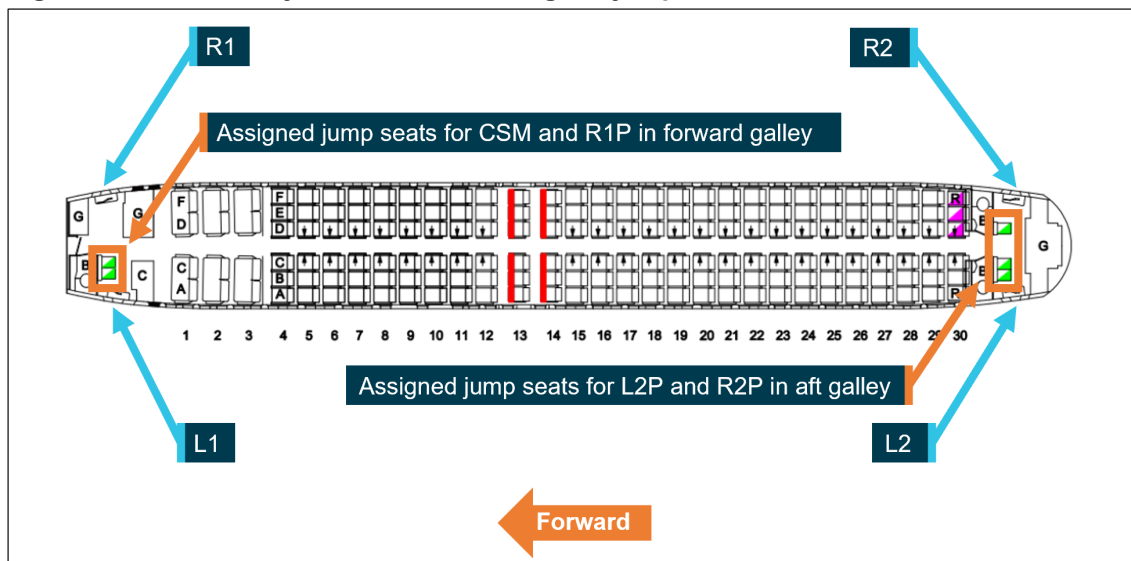
Figure 1: 737 Cabin layout, doors and assigned jump seats for cabin crew

The cabin crew on board was comprised of a complement of 4 members, with their assigned jump seats located in the forward and aft galleys. Each cabin crew member was responsible for one of the 4 main cabin doors (Table 1) during critical phases of flight, with their assigned jump seat (Figure 1) located immediately next to their assigned door. The cabin crew were under the supervision of the customer service manager (CSM) who was responsible to the captain for administration of in-cabin service and liaison with the crew for all service and safety related matters.

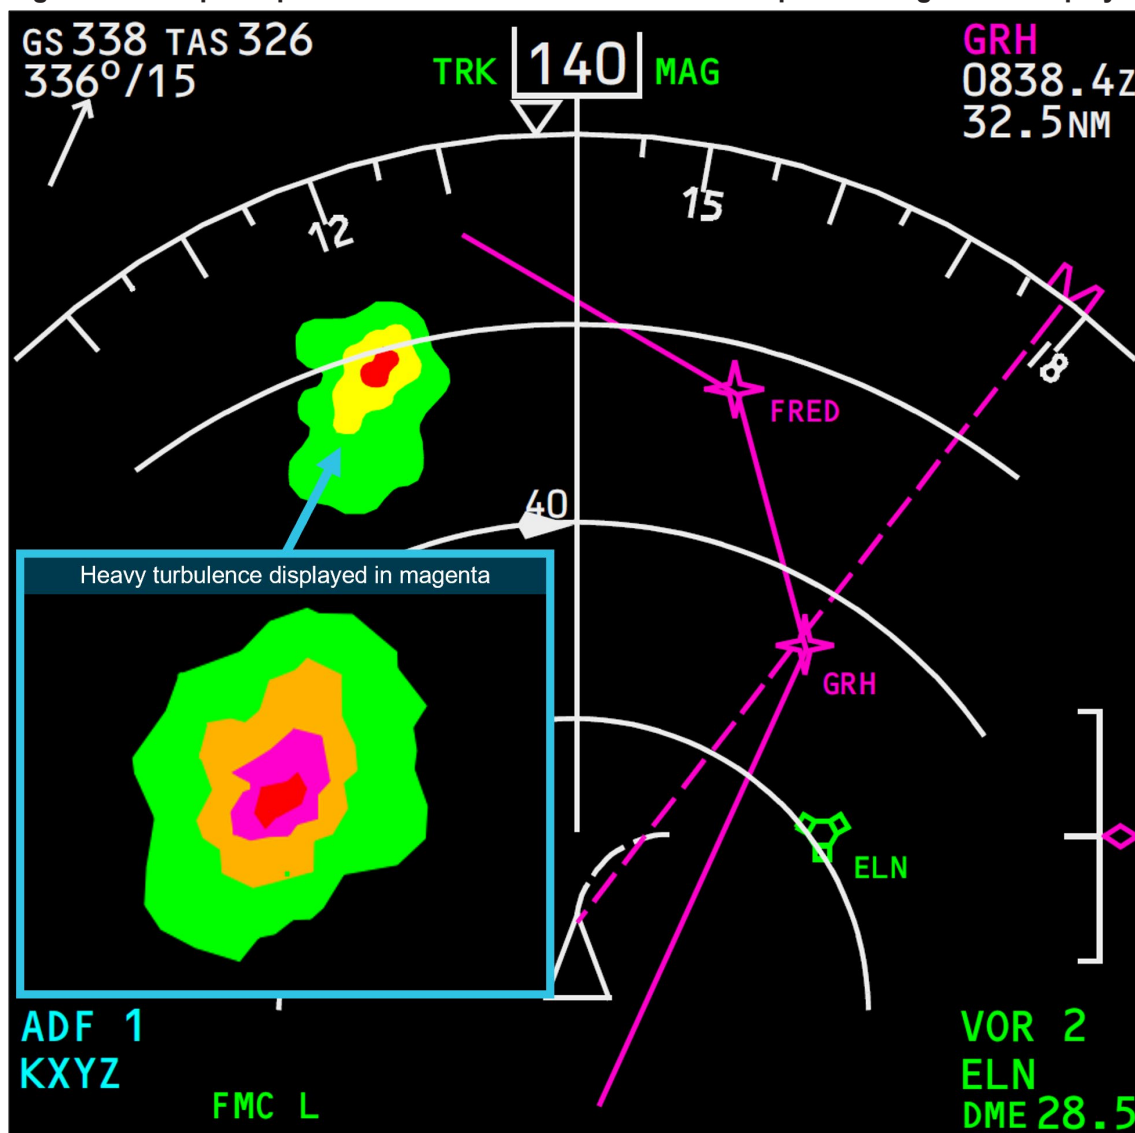
Figure 2: Example depiction of 737 weather radar returns on pilot's navigational display

The turbulence mode displays normal precipitation and precipitation associated with turbulence. When the radar detects a horizontal flow of precipitation with velocities of 5 or more metres per second toward or away from the radar antenna, that target display becomes magenta. These magenta areas are likely associated with heavy turbulence.

The captain did not recall identifying areas of turbulence on the weather radar on descent or report that they were experiencing any difficulties operating the weather radar. Neither the captain nor the operator reported that the weather radar fitted to the aircraft was unserviceable during this occurrence.

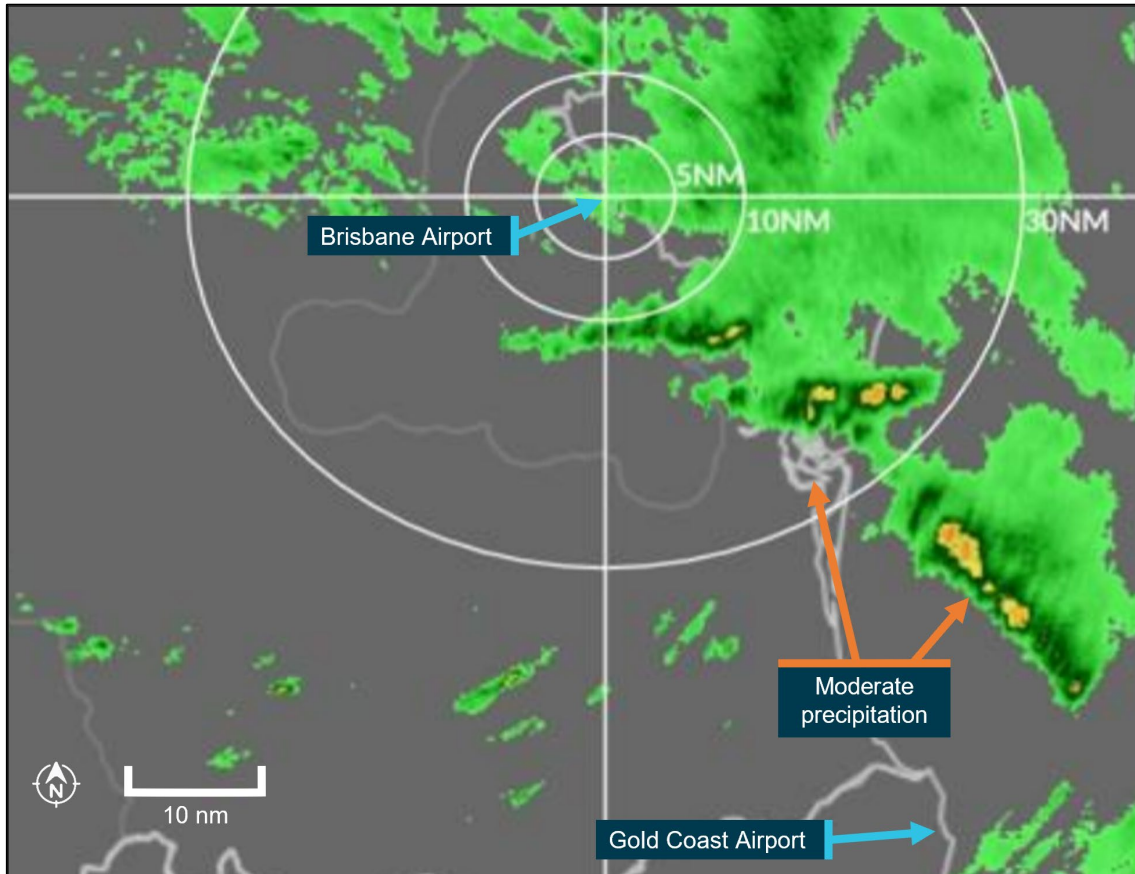
Figure 4: Brisbane Airport weather radar overlay on 4 May at 1200 local time (time of departure)

Prior to departure from Sydney, the flight crew conducted their pre-flight planning and reviewed the weather briefing package. The crew recalled that the weather briefing package contained forecast light showers and some cloud in the vicinity of Brisbane and that the forecast weather for departure at Sydney was worse.

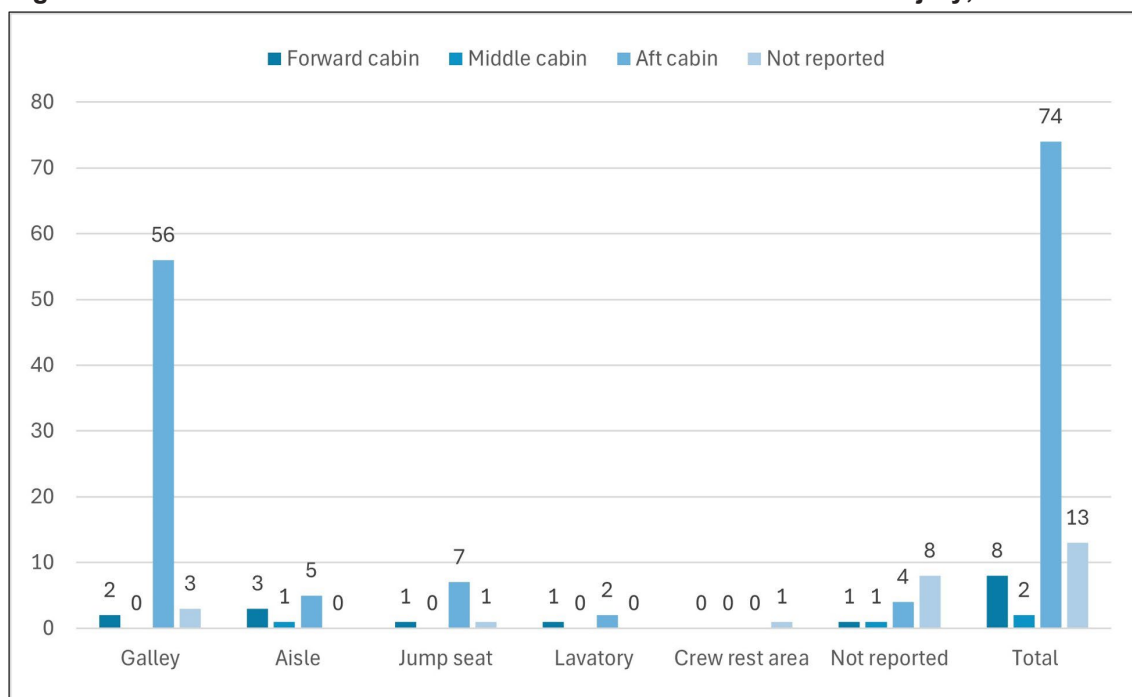
Figure 6: Location of cabin crew at time of turbulence-related serious injury, 2009–2018

The distribution of cabin crew injuries found most occurring in or near an aft galley (Figure 6), which likely reflects that the service-related duties of cabin crew often require

During this occurrence, the R2P and L2P sustained the most severe injuries while unrestrained in the aft galley as they prepared the cabin for landing, which is consistent with research on turbulence-related injuries.
