**Australian Transport Safety Bureau**

# Collision with terrain involving Cessna 172N, VH-SQO

near Mulgathing, South Australia, on 27 June 2024

AO-2024-037

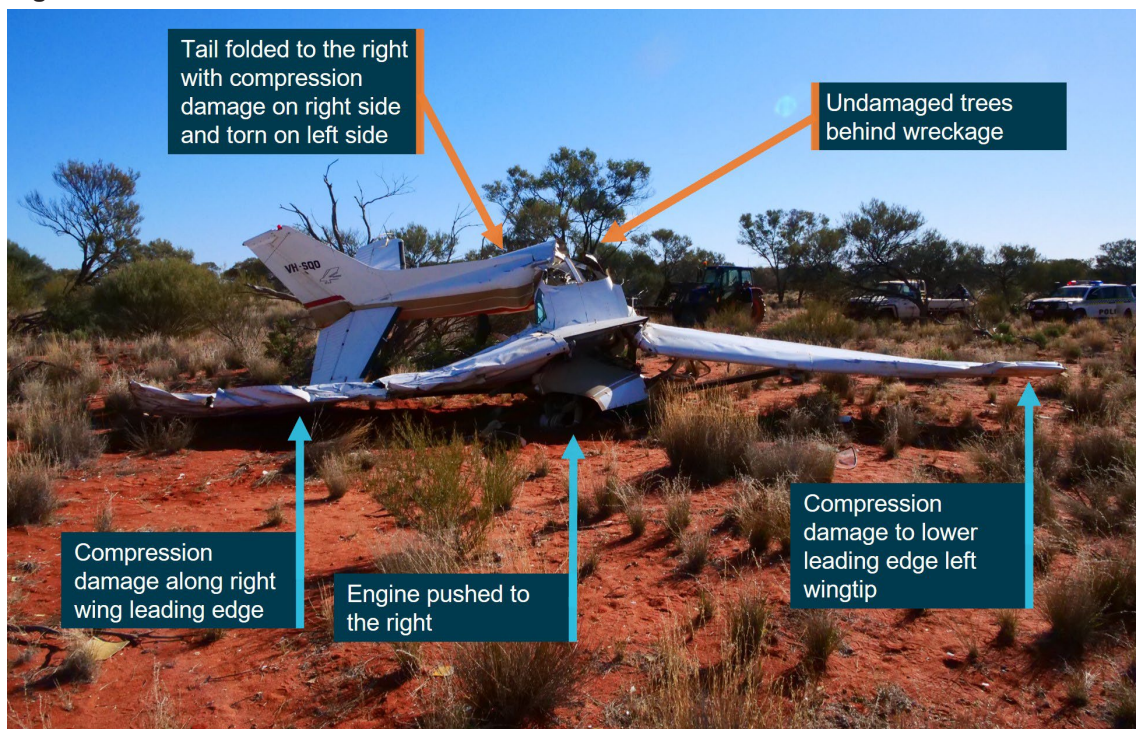
**Figure 2: VH-SQO accident site**

The ATSB's onsite examination found that the aircraft impacted with terrain at about a 70° pitch down attitude with undamaged trees behind the wreckage. Ground impact marks were directly under the wreckage indicating no forward momentum.

The engine was deflected to the right of the longitudinal axis by about 25° (Figure 2). The crank case had fractured in overload, which separated the propeller from the engine. The underside of the left wingtip leading edge exhibited compression damage, which was also evident along the span of the right wing leading edge. The aft fuselage had folded towards the right with compression damage evident on the right side. The flaps were in the full retracted position.

The aircraft's flight controls and structure did not identify any pre-existing faults or pre-impact defects or failures, and no evidence of a birdstrike was observed. Additionally, one of the propeller blades showed significant rotational abrasion damage and chord-wise twisting indicating that the engine was driving the propeller under significant power at the time of impact.

be limitations to witness recollections, the key points made by the witness were that the angle of climb was steeper than the angle of descent, and that the exit height was greater than the entry. These aspects were consistent with a loss of control during the exit of the dive. The steep climb-out from the dive likely resulted in a rapid decay of airspeed and increase in the angle of attack that made the aircraft susceptible to a power-on stall/spin situation. Furthermore, the onsite examination showed that the aircraft impacted terrain in about a 70° nose-down attitude with no forward momentum with both the engine and tail sections deflected to the right.

Both the observations made by the witness and the condition of the wreckage were consistent with the aircraft stalling and entering a left spin. The Pilot's Operating Handbook indicated that this occurred at a height from which the stall and spin was not recoverable, resulting in the impact with terrain.

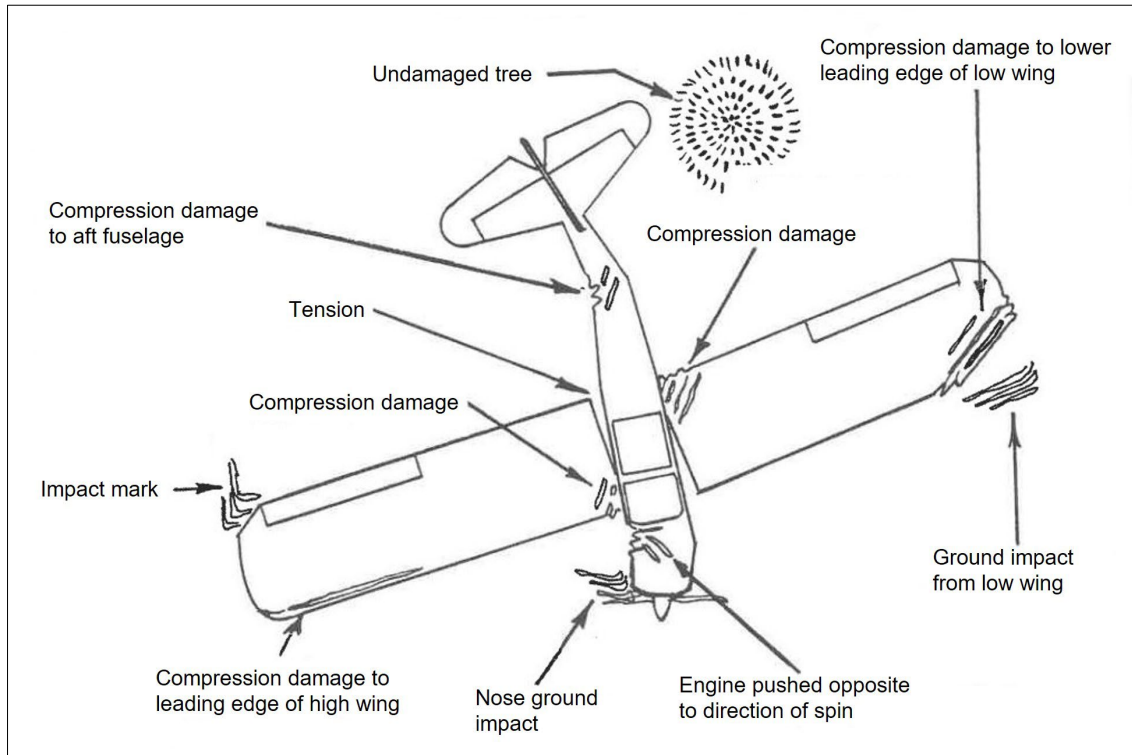
**Figure 3: Example wreckage pattern from a spin**

Wood and Sweginnis (2006), *Aircraft Accident Investigation – 2nd edition*, provides the following description of the wreckage from an aircraft that had spun into the ground, with reference to Figure 3:

There is little or no evidence of forward motion. Although the fuselage probably impacted at a steep nose down attitude, it is likely that there is evidence of a wing tip striking the ground before the nose. The down-going wing will normally strike the ground before the up-going wing, providing one clue as to the direction of the spin. Both the fuselage and the wings will probably have damage which reflects both a high sink rate and yaw. Tall thin objects on the ground, like trees and fence posts, are likely to penetrate the airplane almost from bottom to top, reflecting the almost vertical trajectory of the airplane. Undamaged objects may be found immediately behind the trailing edges, again indicating the vertical path of the airplane.
