# Loss of control in flight involving Leonardo Helicopters AW139, VH-EXK

19 km east of Longford Heliport, Victoria, on 2 August 2024

## ATSB Transport Safety Report

AO-2024-045

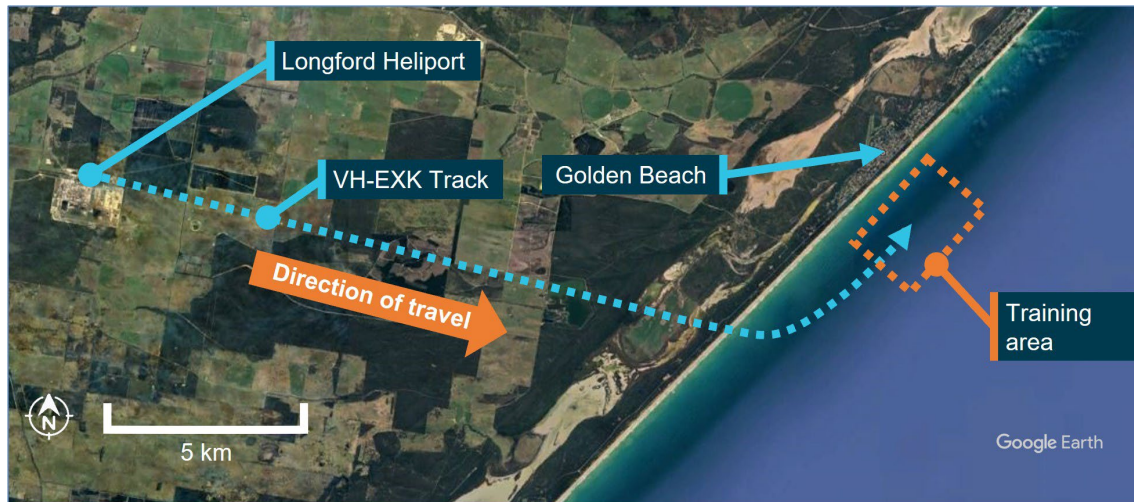
**Figure 1: EXK track and key locations**

On 2 August 2024, a Leonardo Helicopters AW139, registered VH-EXK and operated by Esso Australia, departed Longford Heliport, Victoria at 0816 local time for a hoisting training exercise. The crew consisted of the captain, a flight instructor, a check aircrewman, and a hoist operator. The captain was initially the pilot flying (PF)<sup>1</sup> and was under the supervision of the instructor who was acting as pilot monitoring (PM).<sup>2</sup> The hoisting exercise took place near Golden Beach, Victoria (Figure 1) and was conducted under visual flight rules (VFR).<sup>3</sup> The crew crossed the coastline at 0821 and selected a training area approximately 2 km offshore. The exercise involved retrieving a training aid amidst large swells, sea spray and encroaching fog from the north-west. The training aid was deployed, and the exercise commenced at about 0825.

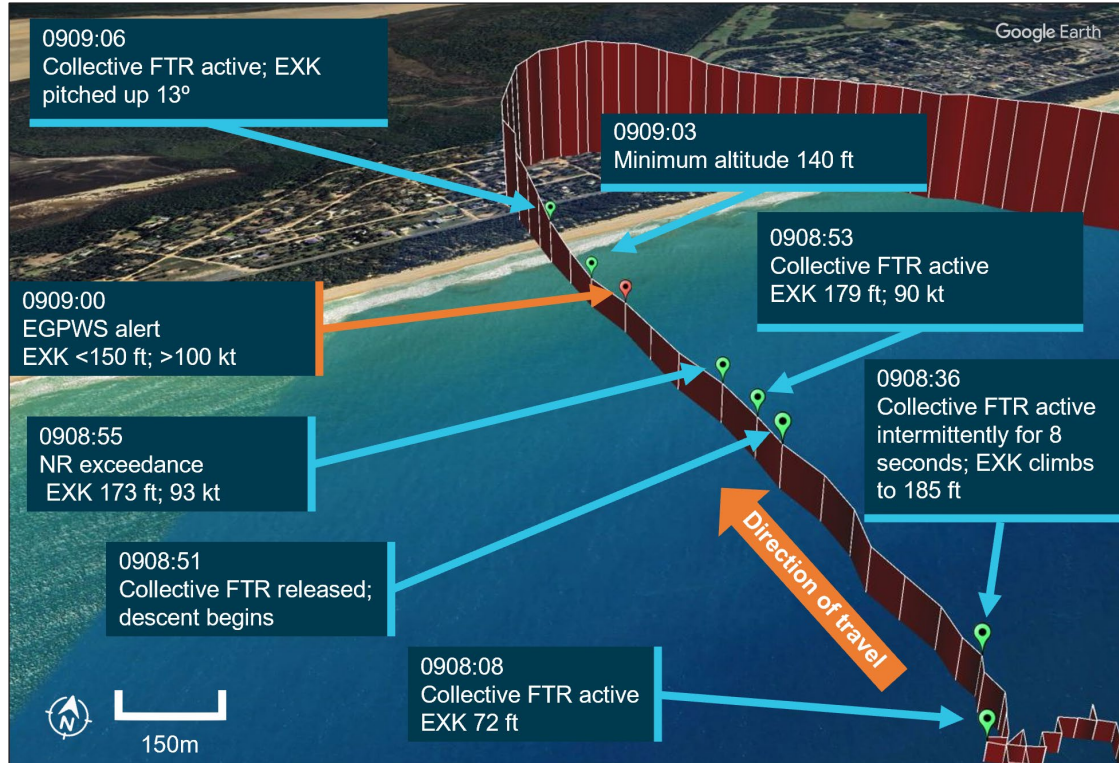
**Figure 2: EXK flight track and enhanced ground proximity warning system alert**

At about this time, the helicopter inadvertently entered instrument meteorological conditions (IMC),<sup>6</sup> and the instructor announced their intention to move forward to depart. The check aircrewman objected via the intercom to departing with the hoist still extended, as the post-hoist procedures requiring the aircrew to secure the hoist cable and cabin had not yet been completed. Despite their objection, the instructor proceeded with the departure to regain visual meteorological conditions (VMC).

The instructor accelerated and continued to climb, reaching an altitude of 185 ft and an airspeed of 72 kt before beginning a shallow descent. The instructor who was PF noticed the increasing airspeed but took no actions to arrest this trend. As the helicopter continued accelerating, the captain observed on the primary flight display (PFD) a nose-down attitude and airspeed increasing through 80 kt, which exceeded the operational speed for the hoist operation. The captain announced '80 kt' to draw the attention of the instructor to the increasing airspeed. The airspeed continued to increase above 90 kt, which resulted in an airspeed exceedance with the RPM (NR) at 102%, despite the captain's attempt to set the RPM switch<sup>7</sup> to 100% to avoid this exceedance. As the helicopter accelerated through 100 kt it exceeded the maximum airspeed for the right main cabin door in the open and locked position.

At 0909, the helicopter had descended to 147 ft above sea level with an airspeed of 101 kt, triggering caution and warning alerts from the enhanced ground proximity warning system

(EGPWS). In the 10-second period preceding the EGPWS warning, the collective FTR was active for 5 seconds while it was engaged and disengaged 3 times. The instructor recalled climbing and using the collective beep trim and collective FTR. However, they did not recall engaging the collective FTR after the negative vertical speed developed. The captain later noted that the collective FTR could be activated instinctively while manipulating the collective due to the switch's position, requiring discipline to avoid unintentional activation.

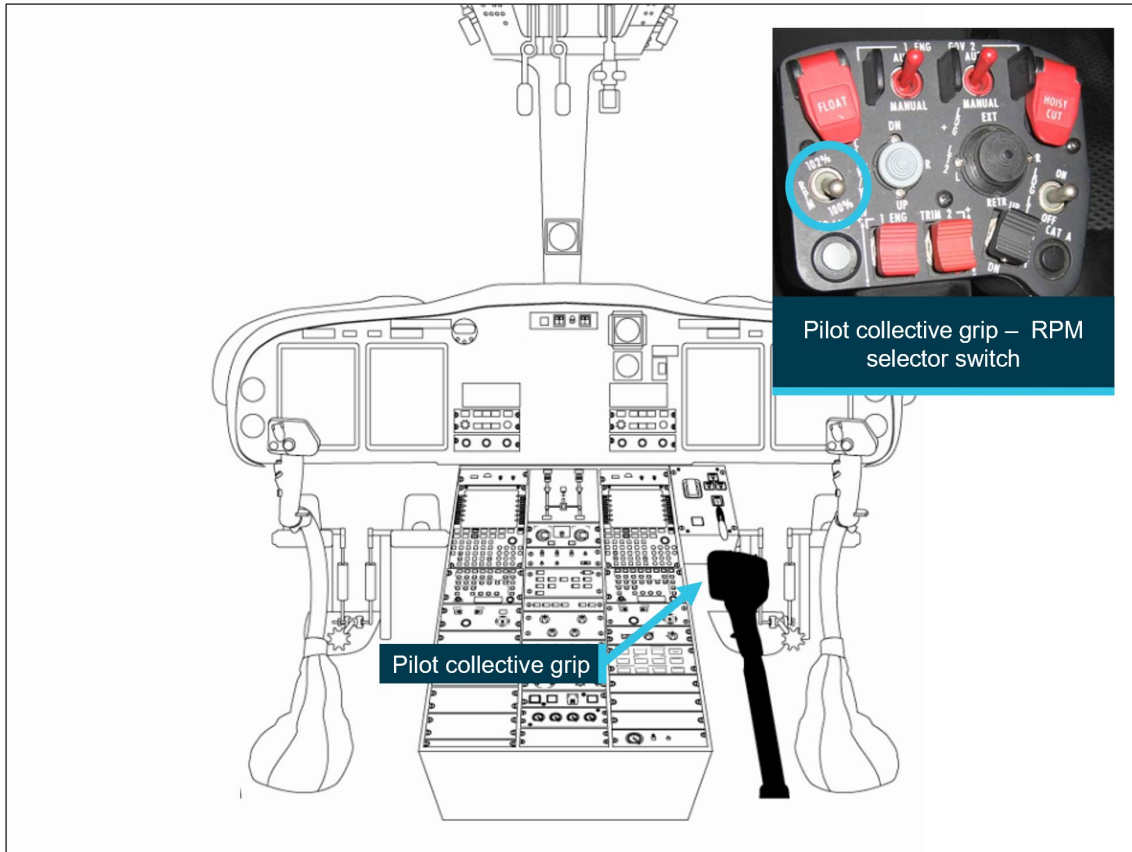
**Figure 3: Pilot RPM selector switch**

For Category A<sup>12</sup> operations below 80 kt, rotor RPM (NR) is set to 102%, enabling optimal performance in the event of an engine failure, allowing for either continued safe flight or a controlled landing. Real-time rotor RPM is monitored on the multi-function display with the maximum airspeed set to 90 kt at 102% NR to protect the rotor system from excessive stress.

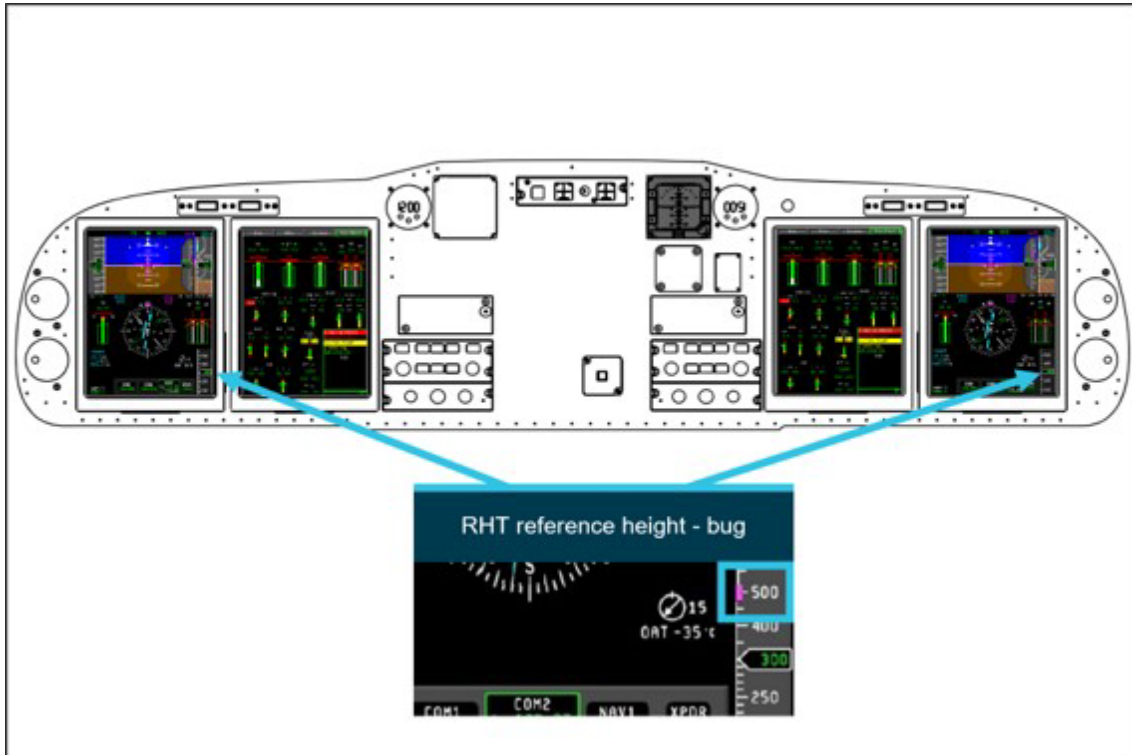
**Figure 4: RHT reference height**

The helicopter flight manual stated that during hoist operations, that pilots should consider the effect of the use of the RHT function in flight and to monitor the helicopter performance closely when used.

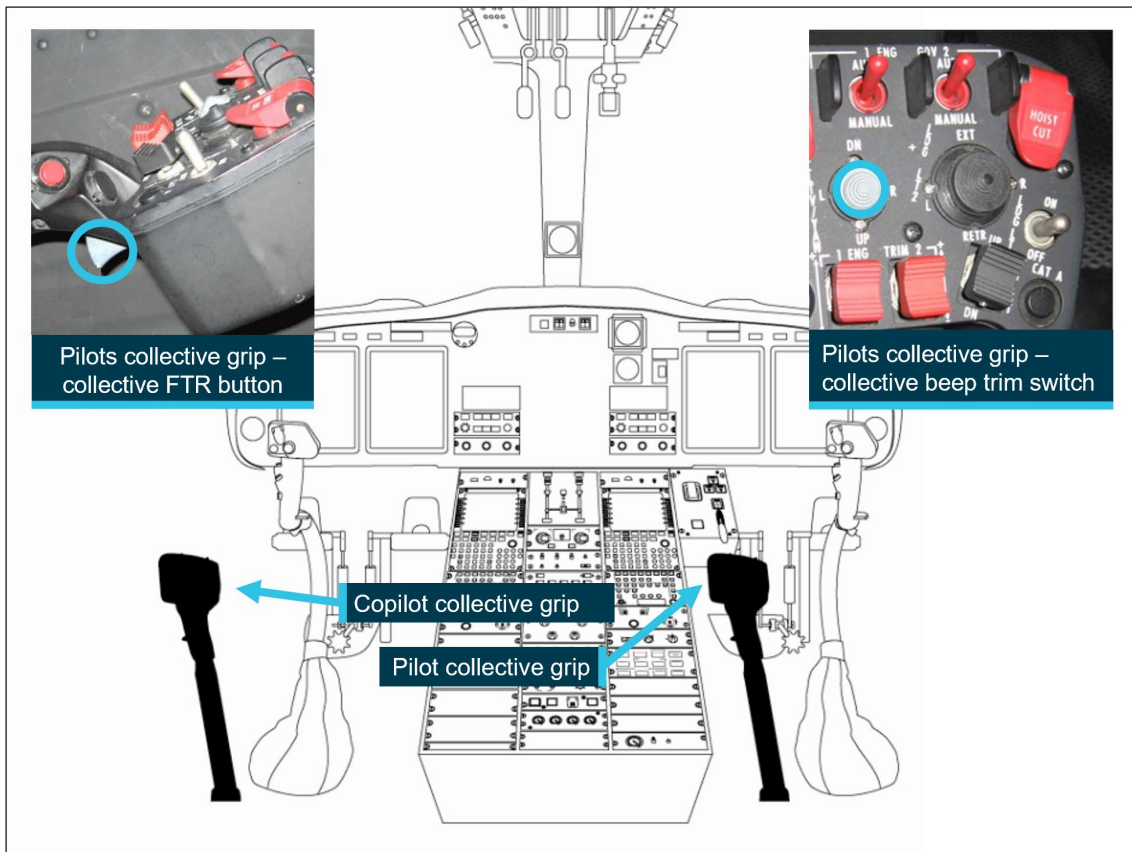
**Figure 5: Crew collective grips, collective FTR button and collective beep switch**

<sup>13</sup> A dual action spring permits force-feel hands on flying while the force trim is engaged. A pilot moving the flight controls without releasing the force trim results in full hands-on controllability with control force feedback to the pilot. As the pilot releases the control to resume hands-off flying, the spring returns the collective to its neutral position against the force trim.

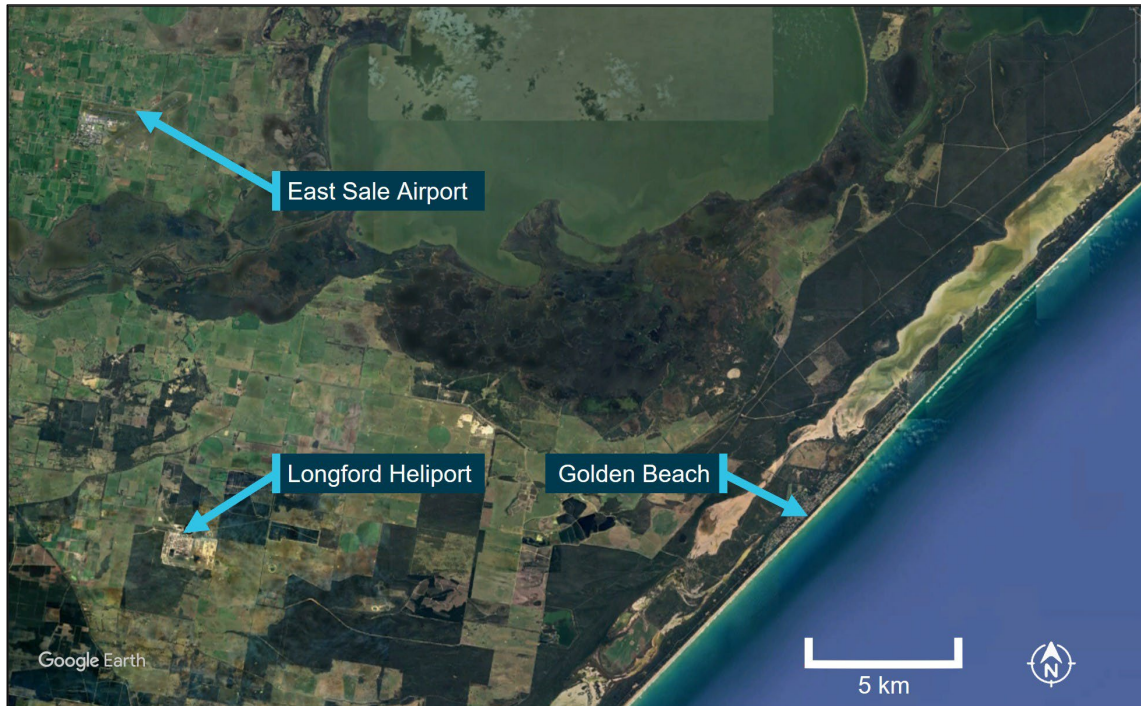
**Figure 6: Weather reporting locations**

By 0930 local time, conditions were expected to improve to greater than 10 km visibility with light winds. A 30% chance of mist, reducing visibility to 1,000 m was also forecast between 0900 and 1000. A special report (SPECI) at 0800 recorded calm conditions, with freezing fog reducing visibility to 200 m with scattered clouds at 100 ft.
