**Australian Transport Safety Bureau**

# Runway excursion involving GippsAero GA8, VH-IDM

Whitsunday Airport (Shute Harbour), Queensland on 2 November 2024

AO-2024-056

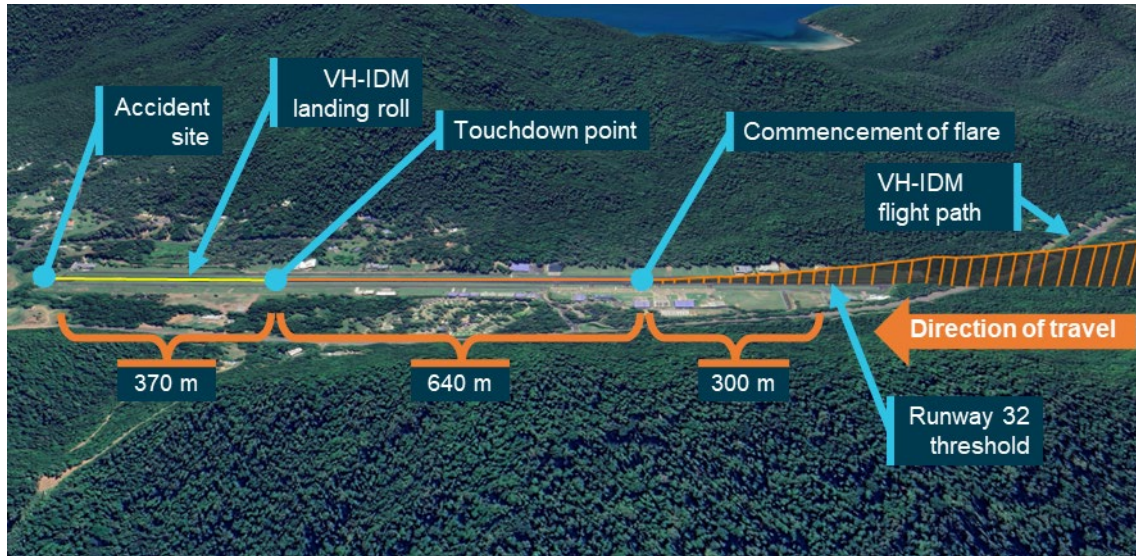
**Figure 2: VH-IDM flight path and landing roll**

The aircraft continued the approach (Figure 2), remaining above the desired approach path while the airspeed varied between 85–95 kt. The aircraft passed over the displaced threshold of the runway at approximately 100 ft AGL. The pilot commenced the flare about 300 m beyond the displaced threshold, at an airspeed of approximately 90 kt. The aircraft then floated for about 640 m before touching down at a groundspeed of 65 kt with 370 m of runway remaining. The pilot recalled that throughout the approach and landing they did not consider conducting a go-around<sup>3</sup> and were focused on landing the aircraft.

After the commencement of the flare, the aircraft floated for approximately 640 m. During the float, the aircraft decelerated and with about 560 m of runway remaining was at the landing approach speed of 71 kt (see the section titled Landing Performance). Subsequently, the main wheels contacted the ground with approximately 370 m of runway remaining at a groundspeed of 65 kt. The aircraft took 18 seconds to reach the end of the runway, during which the groundspeed slowed from 65 kt to 24 kt.

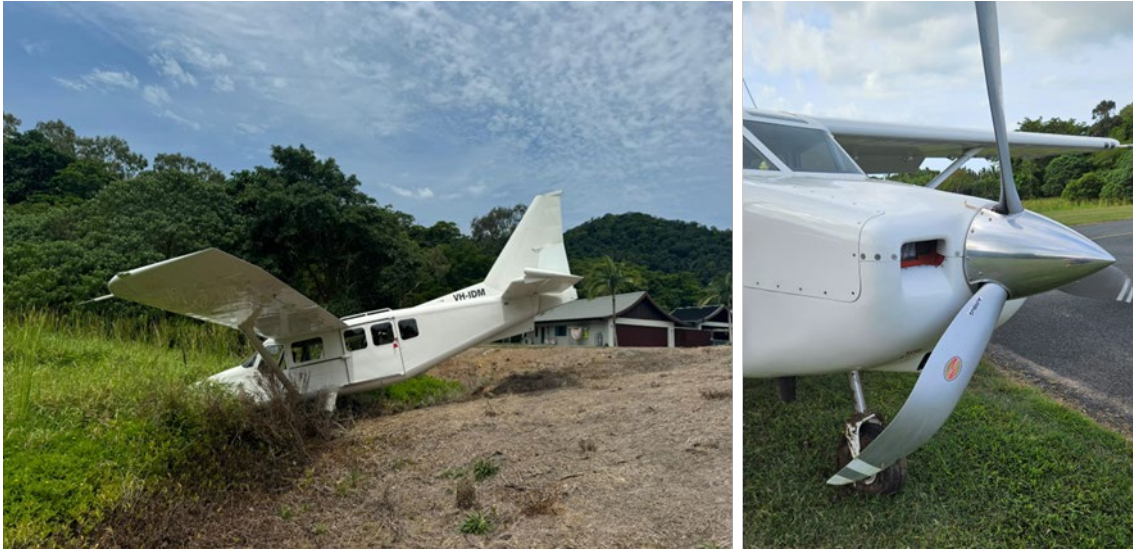
**Figure 3: VH-IDM damage**

After touching down, the pilot retracted the flaps and recalled attempting to apply full braking pressure. They further recalled that the brakes did not perform as expected and they were unable to bring the aircraft to a stop. Subsequently, veering slightly right, the aircraft departed the end of the runway at a groundspeed of 24 kt. The aircraft travelled briefly across grass before entering marshy ground and coming to rest in a ditch, as the propellor struck the ground. Neither the pilot nor any of the passengers were injured and the aircraft received damage to the propellor and firewall (Figure 3)

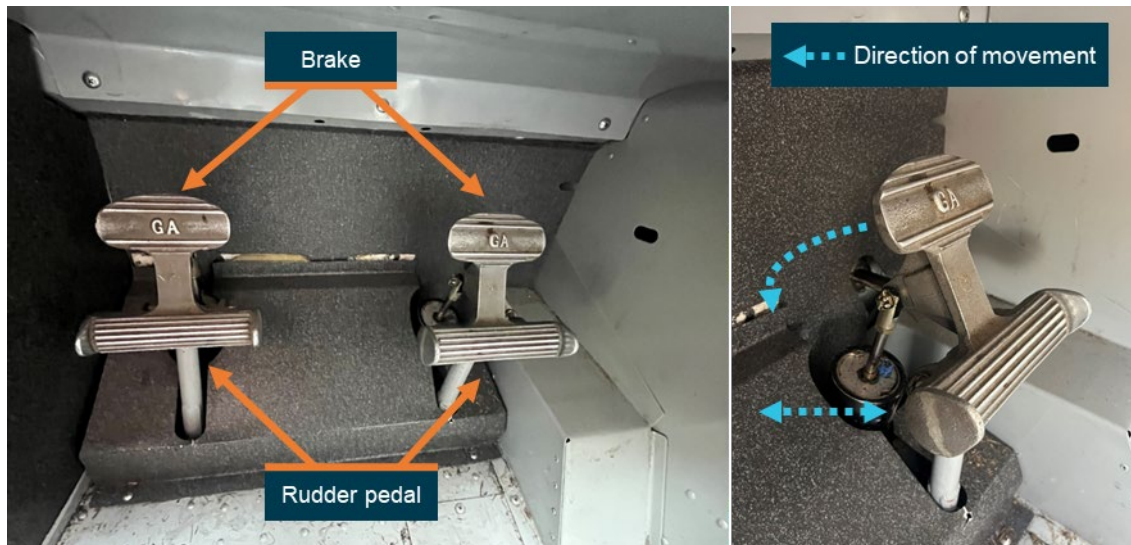
**Figure 4: GA8-TC rudder pedals and brakes**

The aircraft's brake system included toe brakes incorporated into the rudder pedals. Each rudder pedal was connected hydraulically to a brake unit on the corresponding main landing gear wheel and was engaged by applying pressure to the top of the pedal (Figure 4). During flight, a pilot's feet rested on the floor in contact with the lower part of the rudder pedals to control the rudder. On the ground, a pilot would move their feet up on the pedal so that the top of the foot could be used to apply brake pressure. The heel was then used to maintain rudder control and nosewheel ground steering.

The pilot did not report any issues with the braking performance of the aircraft prior to take-off, and the ATSB was advised that no fault was found with the brakes during the post-accident inspection. Additionally, there were no marks observed on the runway to indicate that the wheels had locked up and the aircraft had skidded. The pilot also advised that their seat position had been adjusted appropriately and that all controls, including the rudder pedals, could be used effectively.

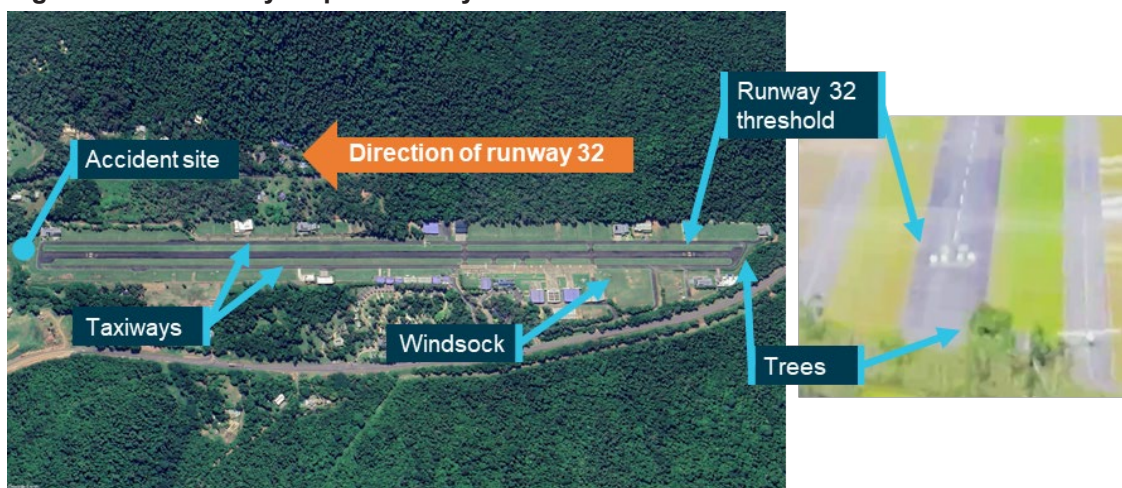
**Figure 5: Whitsunday Airport runway environment**

Whitsunday Airport (Shute Harbour) was a privately-owned, uncertified airport (aircraft landing area) located in hilly terrain onshore from the Whitsunday Islands. The airport had a single sealed runway 14/32, which was 1,410 m long and 15 m wide (Figure 5). Runway 32 had a displaced threshold due to trees in the undershoot, which reduced the runway available for landing to 1,310 m. The displaced threshold and departure end of the runway were at elevations of approximately 80 ft and 20 ft respectively, giving it a downslope of approximately 1.4%.

The pilot advised that landing on runway 32 required modifications to a standard approach. Firstly, as described in the pilot's guide, high terrain to the south-west required an oblique approach before aligning with the runway centreline to maintain terrain clearance. Secondly, trees near the arrival end of the runway necessitated a higher approach and could result in visual contact with the displaced threshold being lost. Lastly, due to the downslope of the runway it was necessary to touch down as early as possible to avoid an extended float. The pilot advised that due to the combination of the trees and the downslope they were required to get over the trees and then 'chop the power'. The pilot of the trailing company aircraft provided similar advice regarding these considerations when landing on runway 32.

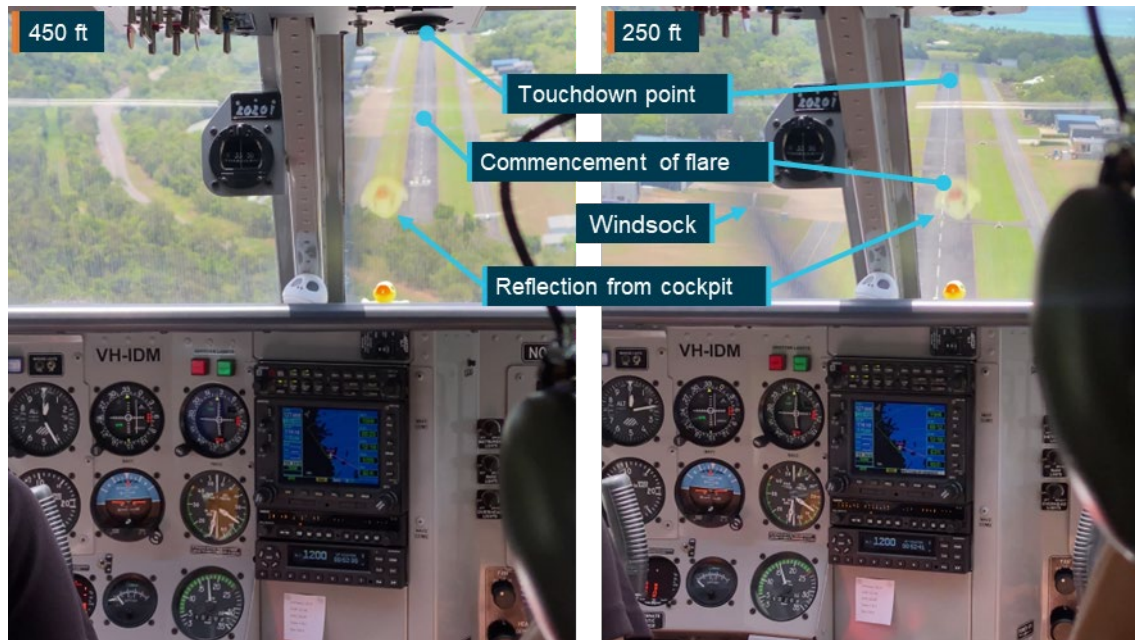
**Figure 6: Passenger video footage**

From the passengers' videos, the ATSB was able to determine the flight path and speed of the aircraft throughout the approach and landing. While the pilot advised their intended aim point was just past the displaced threshold, the aircraft maintained an average descent path of approximately  $7^\circ$  towards a landing spot 300 m beyond the displaced threshold. Overhead the displaced threshold, the aircraft was approximately 100 ft above ground level. Throughout the approach, the navigation unit displayed the groundspeed as between 90–95 kt. The airspeed indicator was also periodically visible and showed readings up to 95 kt.

The pilot was observed to reduce the throttle at several points during the final approach with the last reduction observed just prior to the flare. This indicated the approach was conducted with some power. The pilot was also observed to interact with the radio unit during the final approach, which was likely when responding to the trailing aircraft. The video confirmed that the flaps were set to  $38^\circ$  for landing and were retracted immediately upon touchdown. Also on touchdown, the pilot's feet moved upwards on the rudder pedals and pressure was applied against the pedals during the landing roll. However, it could not be ascertained whether the pressure was maintained throughout the landing roll, or whether the pressure was being applied to the top of the pedals to apply brakes or to the bottom of the pedals for rudder and steering.
