Engine malfunction involving Airbus A330-202, VH-EBQ

1,370 km west-south-west of Los Angeles International Airport, United States of America, on 4 December 2024

ATSB Transport Safety Report

AO-2024-063

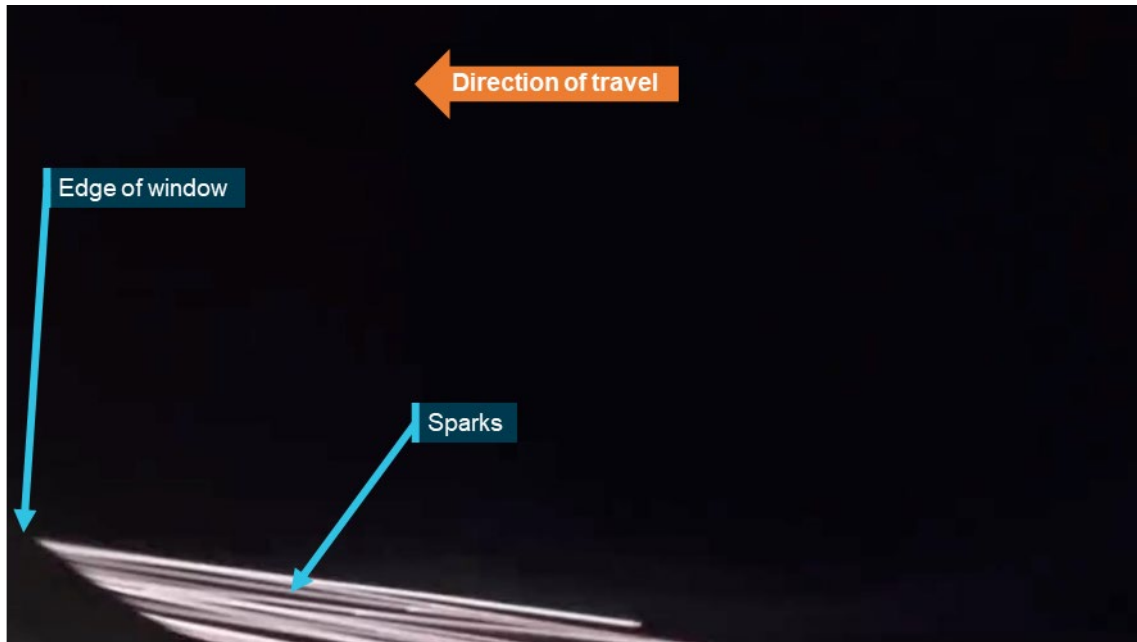
Figure 1: Still image from passenger video showing sparks from right engine

At about 0637, the remaining flight crew received further clearance from ATC to climb to FL 340. After top of climb, a passenger report of sparks emanating from the right engine was relayed to the flight crew by the cabin crew. Second officer B went to the passenger's seat, observed the engine from the window, noted a couple of intermittent sparks, and returned to the flight deck to talk to the captain. The captain and second officer B also reviewed video footage of the sparks recorded by the passenger during the climb (Figure 1).

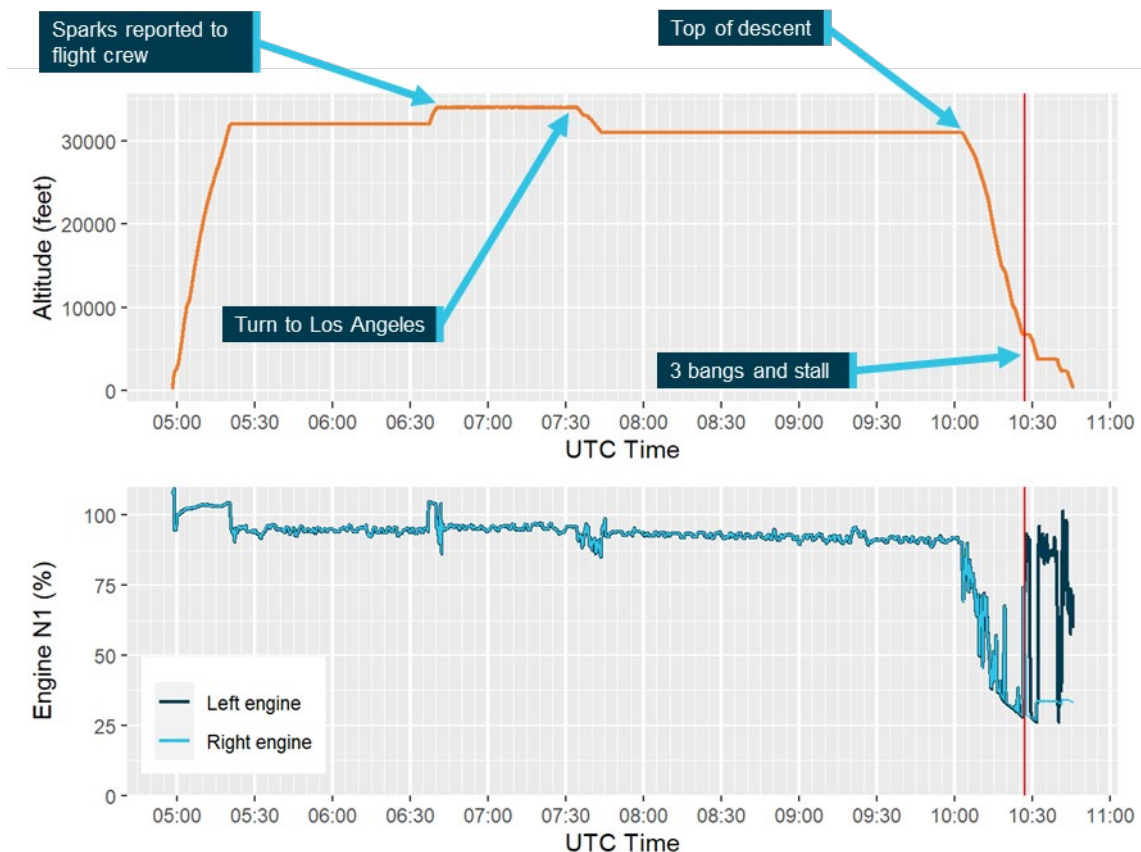
Figure 2: Altitude and N1 speed for the right and left engines

The aircraft was equipped with a cockpit voice recorder, which recorded audio from the flight deck, and quick access recorder, which recorded aircraft and engine performance data. The altitude of the aircraft and the N1 speed for both engines was extracted from the quick access recorder (Figure 2). The data showed that the engine speed for the left and right engines was consistent up until the time of the 'bangs' and compressor stall, around 1027. After this, the right engine was brought back to idle and the N1 speed remained around 33%.
