# **Safeworking irregularity involving V/Line passenger train 8076**

Gisborne, Victoria, on 11 March 2025

Rail Occurrence Investigation

RO-2025-002

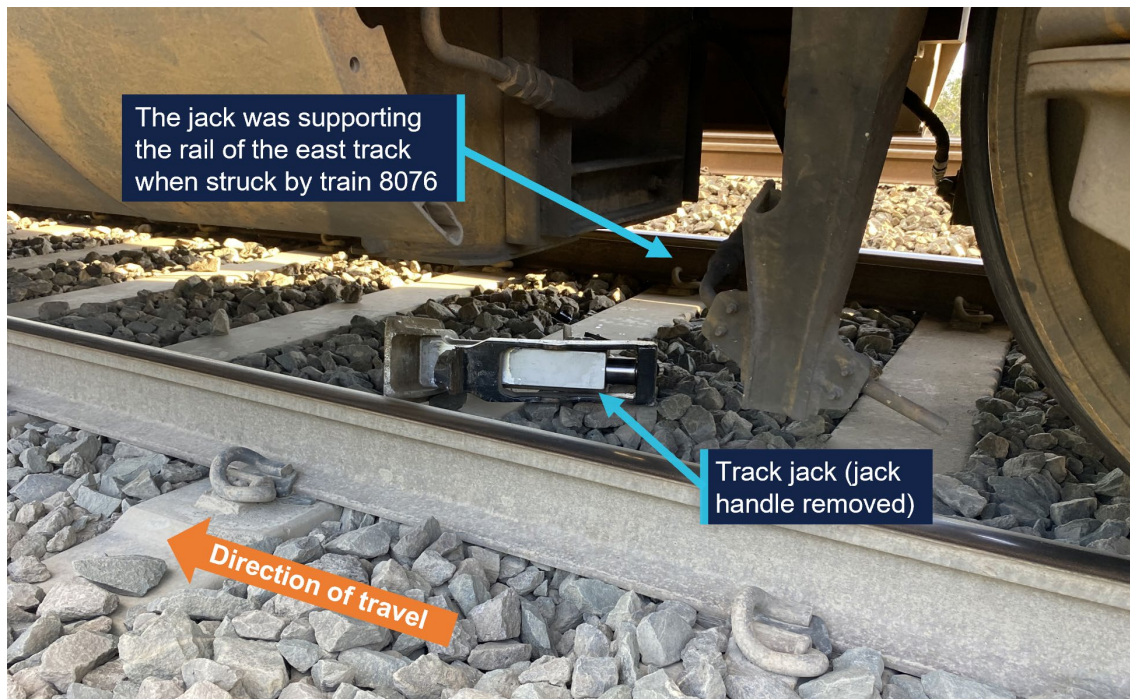
**Figure 2: Track jack under train 8076**

At about 1749, the driver of train 8076 sighted the workgroup about 240 m ahead, working at about 65.8 km. In response the driver sounded the horn and applied the emergency brake. The train was travelling at 80 km/h when the emergency brake was applied.

The workgroup cleared the track as the train approached. A track jack, being used by the workgroup, remained under one of the rails and was struck by the train. The train came to a stand about 70 m past the worksite. There were no injuries and the train remained on the rails. There was minor damage to the underside of the train.

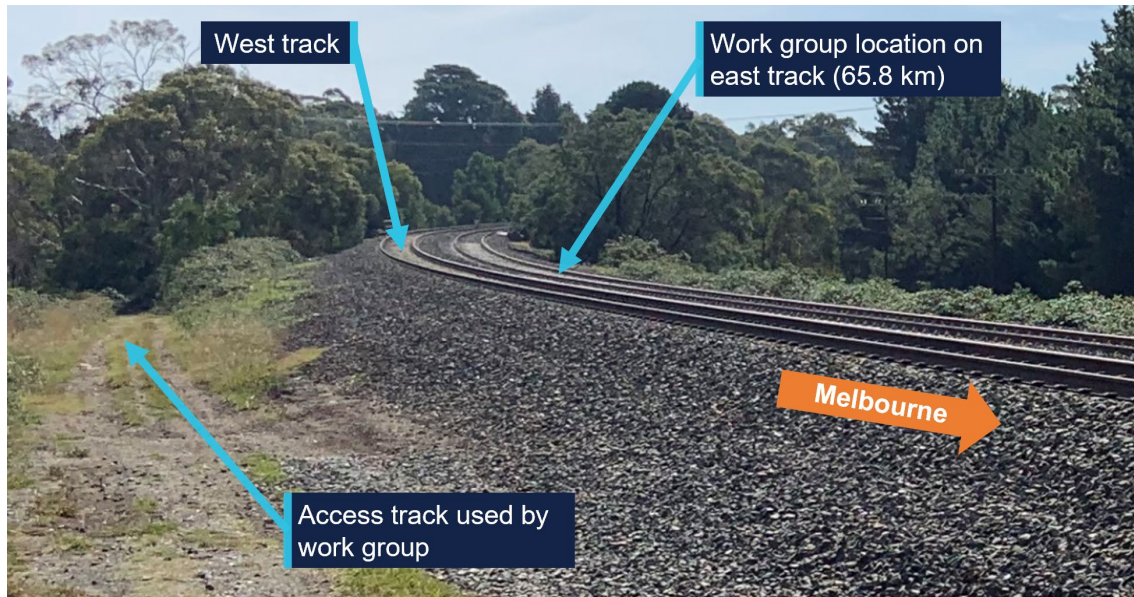
**Figure 3: Work site location**

The railway at the incident location consisted of 2 adjacent lines, referred to as the east and west tracks, both permitted bi-directional running. The maximum permitted speed for VLocity passenger trains travelling along the east track was 130 km/h and on the west track was 160 km/h. The worksite was located on a track curve (Figure 3).

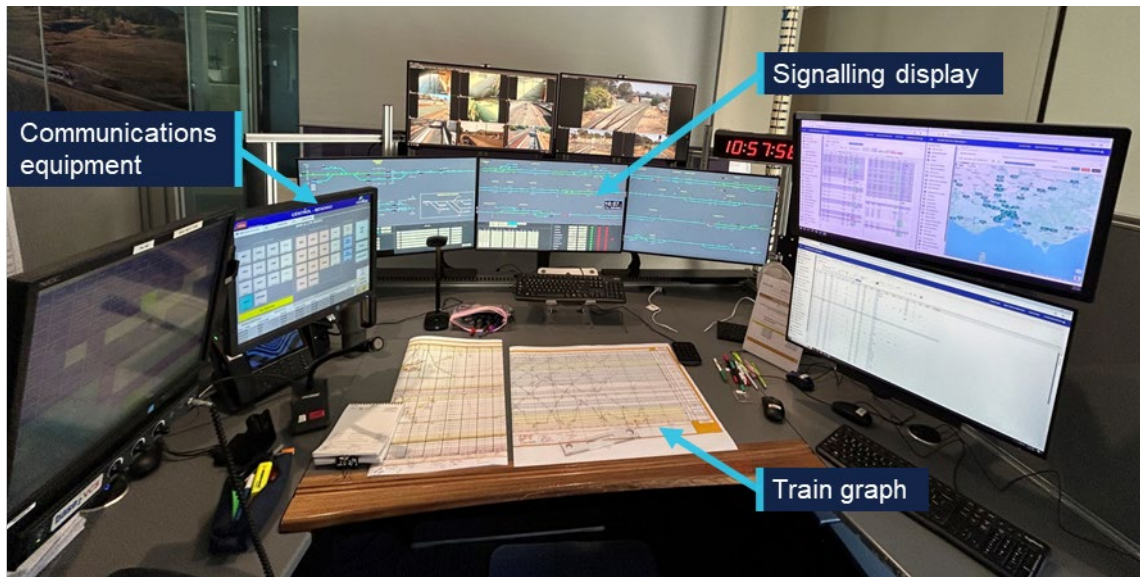
Figure 4: Control train control room for the Bendigo line

The room at Control used to oversee operations on the Bendigo line was equipped with signal panels that allowed train controllers to set signals and identify the approximate location of trains. Communication equipment in the room allowed train controllers to communicate with train and infrastructure maintenance staff. Train controllers used paper train graphs to record the location of trains and infrastructure maintenance staff (Figure 4).
