Midair collision involving Jabiru J430, VH-EDJ, and Piper PA-25-235, VH-SPA

Caboolture Airfield, Queensland, on 28 July 2023

ATSB Transport Safety Report

AO-2023-036

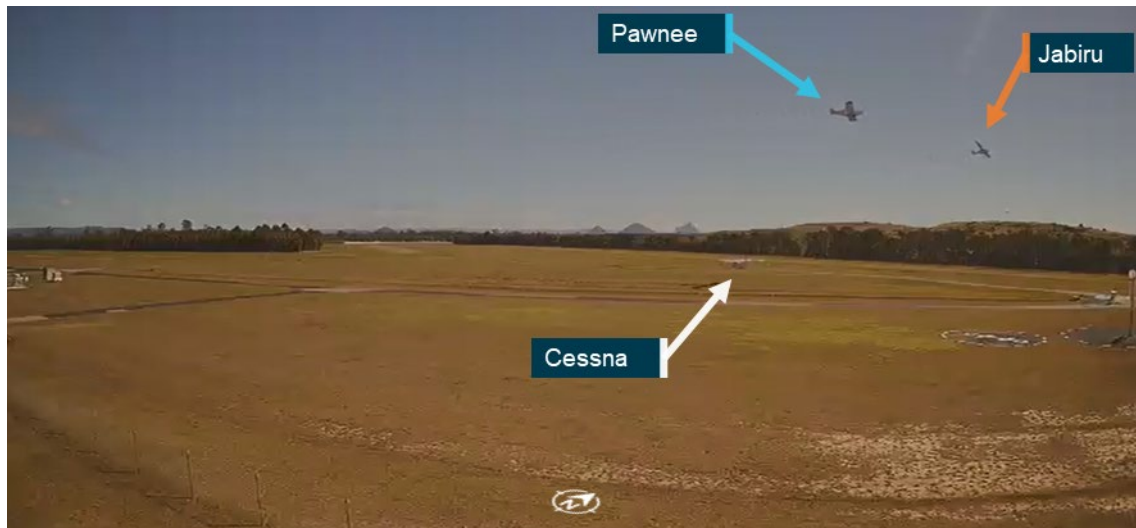
Figure 4: CCTV still image at 1031:06, from a camera south of the runway intersection, showing the 2 aircraft converging as the Jabiru turns left

focusing on their climb rate, concerned about clearance between the trailing tow rope and the Cessna.⁸ At about 1031:24, while the 2 aircraft were climbing at similar rates on converging tracks, the Jabiru pilot commenced a steep left turn (Figure 4). Given the steepness of the turn, and the low altitude, this was likely an attempt to avoid a collision. The Pawnee pilot reported not seeing the Jabiru until immediately after the impact, when they momentarily saw something behind the Pawnee's left wing as they leant over to fully retract the flaps.

At 1031:30, the 2 aircraft collided on similar tracks above runway 06, just north-east of the 06/11 intersection, at a height of about 130 ft. The leading edge of the Pawnee's inboard left wing struck the Jabiru's right wing at the outboard trailing edge, resulting in separation of the Jabiru's right wing tip and part of the right aileron.

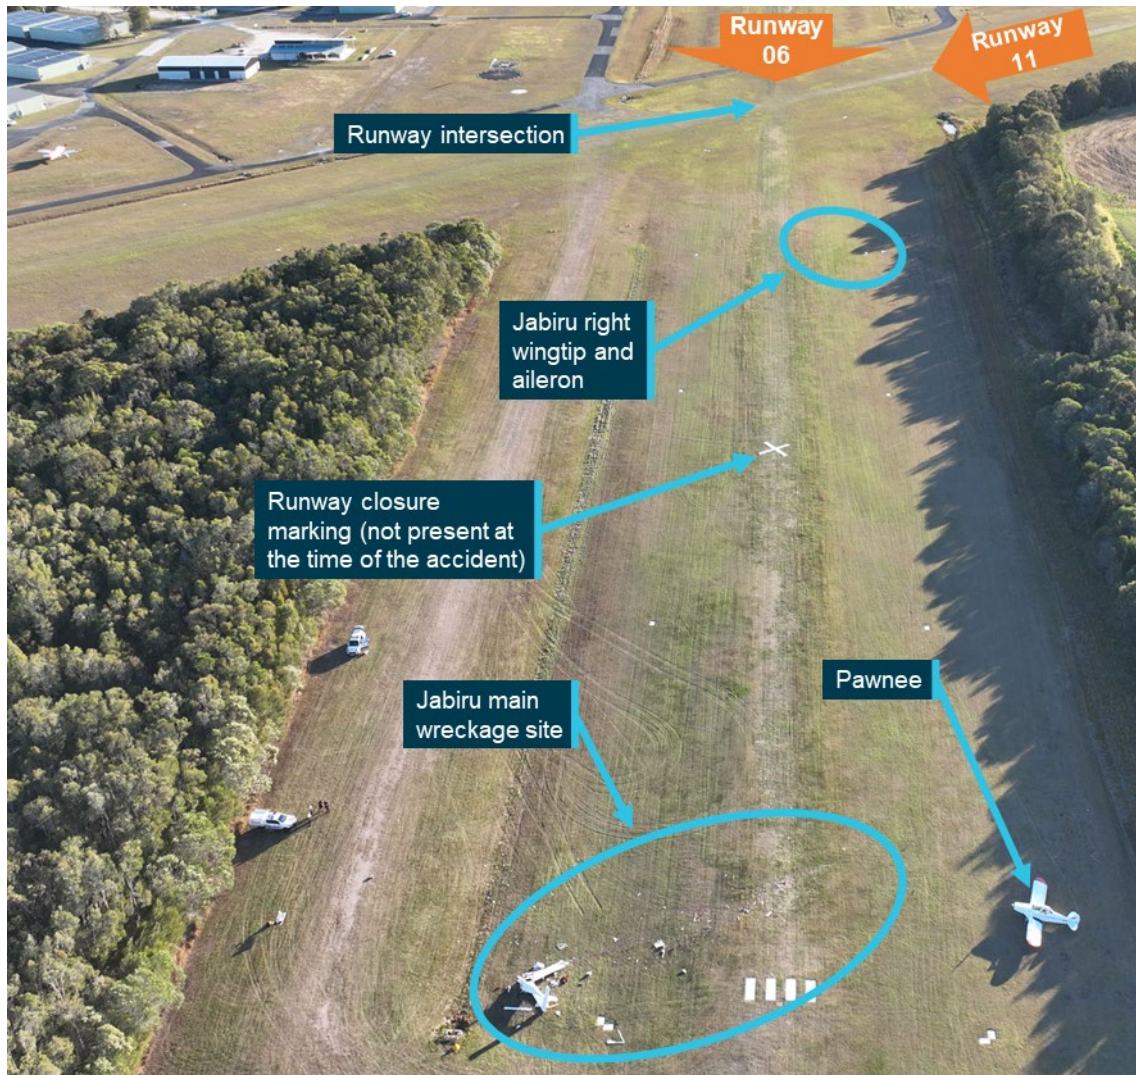
Figure 5: Locations of aircraft and wreckage after the Pawnee had landed

Based on the damage to each aircraft (described below), and the aileron and wing tip found near the runway intersection, the ATSB determined that the Pawnee's left wing leading edge collided with the Jabiru's right wing trailing edge. Damage signatures indicated that the relative angle between the 2 aircraft was about 30° in roll (Figure 6). There was no impact with the Pawnee's propeller.

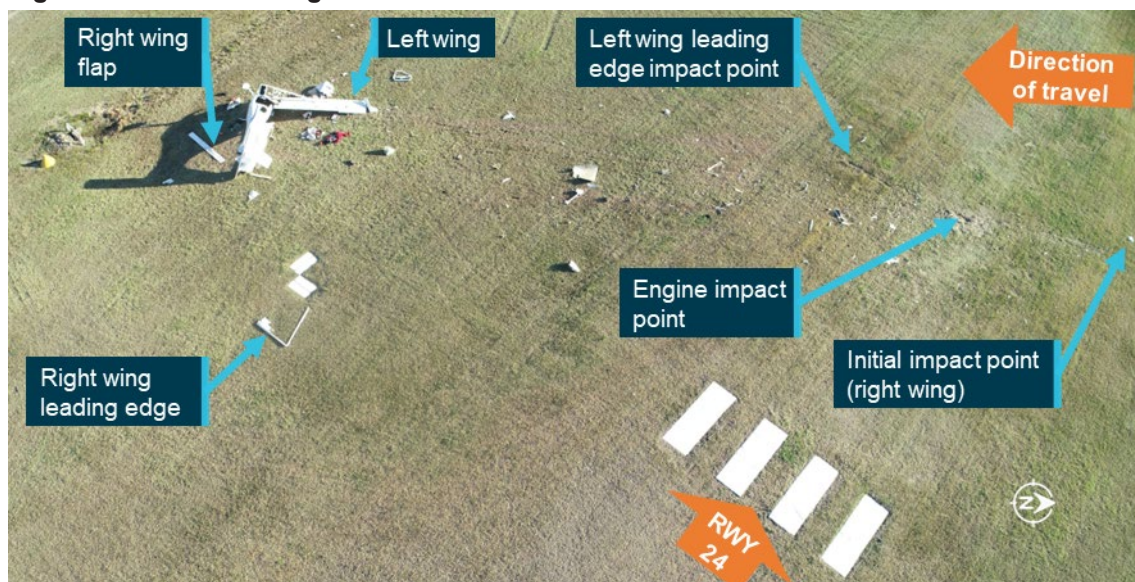
Figure 7: Jabiru wreckage trail

The Jabiru's impact point was about 212 m beyond the separated wing tip and aileron (Figure 7). The right wing impacted the ground first, followed by the propeller and engine. The aircraft tumbled across runway 06/24 for about 42 m in a direction almost parallel to runway 11, coming to rest next to the runway threshold.

Based on measurements of the ground scarring and the chord-wise symmetry of the right wing damage, it is likely that the Jabiru impacted terrain right wing first, in a nose-down attitude of about 85°.

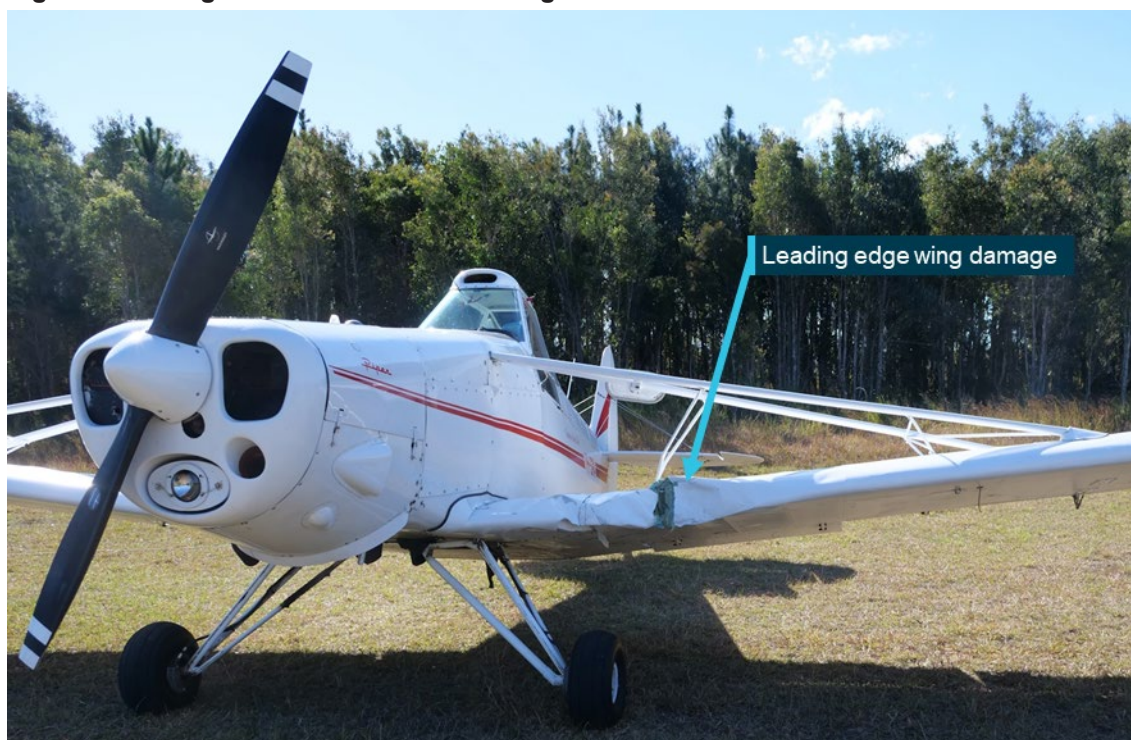
Figure 8: Damage to the Pawnee's left wing

The Pawnee remained intact after the collision (Figure 8). The tow rope stayed attached. Heavy impact damage occurred on the left wing leading edge, between about 0.25–1.2 metres from the wing-fuselage interface. Other impact damage was identified:

- on the wing strut, directly above the damage to the leading edge
- on a fuselage cowling panel located above the left wing
- on the left wing lower surface, including a small piece of fibre-reinforced plastic, caught between 2 panels, which appeared consistent with the skin of the Jabiru.

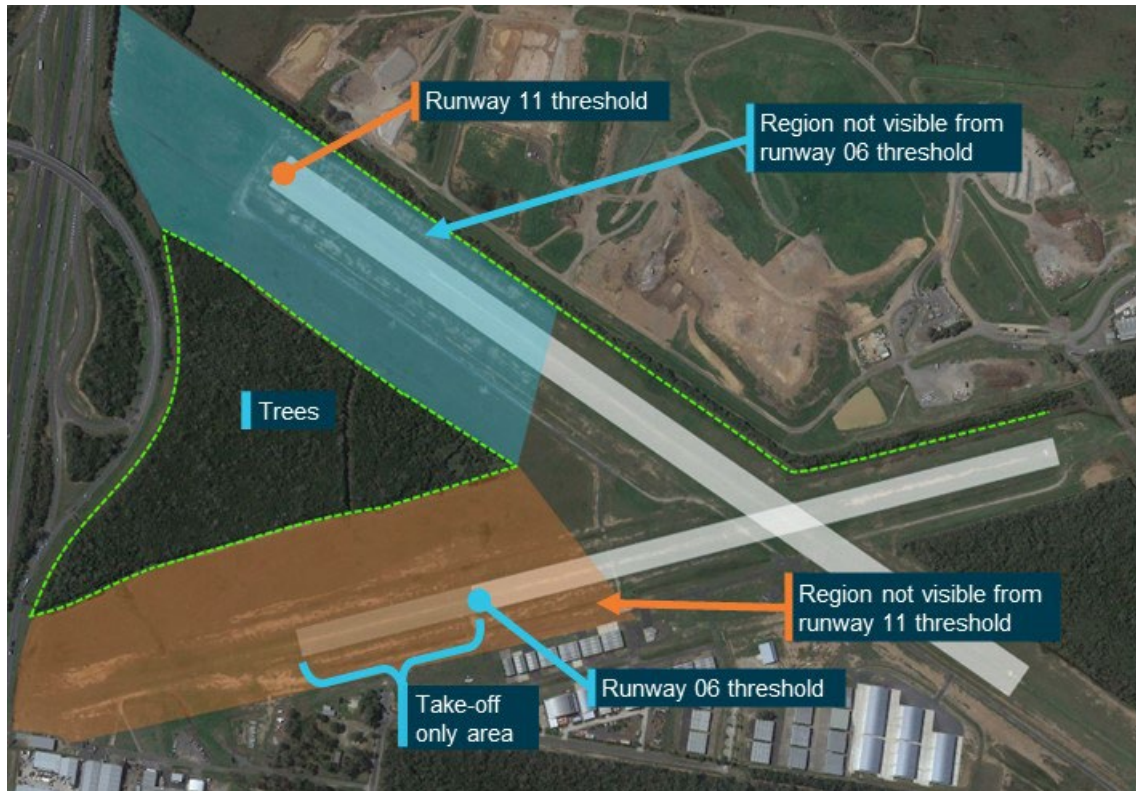
Figure 10: Obscured parts of the adjacent runway from the thresholds of runways 11 (orange) and 06 (blue) while at ground level

Two different stands of evergreen trees were established between the intersecting runways (Figure 10). The stand between the arrival ends of runway 06 and runway 11 was dense and it was not possible to see through it. Site measurements found that at its eastern-most point, the trees were at a height of about 9.5 m, but elsewhere, the trees were approximately 14 m high (the terrain itself is relatively flat). The northern border of the aerodrome was marked by a fence and a line of trees. Hangars, training schools and other administrative buildings stood to the south of the 2 runways. From the perspective of any of the 4 runway thresholds, the trees and buildings around Caboolture Airfield prevented pilots from being able to see either end of the intersecting runway (Figure 11 and Figure 12).

The ATSB estimated that the first 460 m of runway 11, and the first 180 m of runway 06, would not be visible from the other runway's threshold. Visibility between the runways was significantly more affected if an aircraft was using the 250 m section prior to the runway 06 threshold (which was permitted for take-off only) (Figure 10, Figure 11, and Figure 12).

The shaded areas illustrate the areas that would not be visible from the threshold of the other runway.
Source: Google Earth, annotated by the ATSB

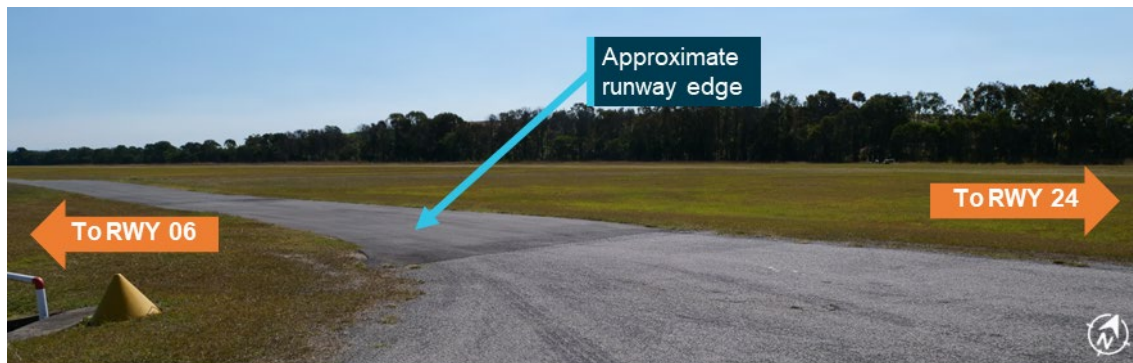
Figure 13: Taxiway across runway 06/24 without hold point markings

taxiway was repaved as part of the resurfacing (Figure 13). At the time of the occurrence, these lines had not been repainted. Hold point markings were still present on runway 11/29 (Figure 14).

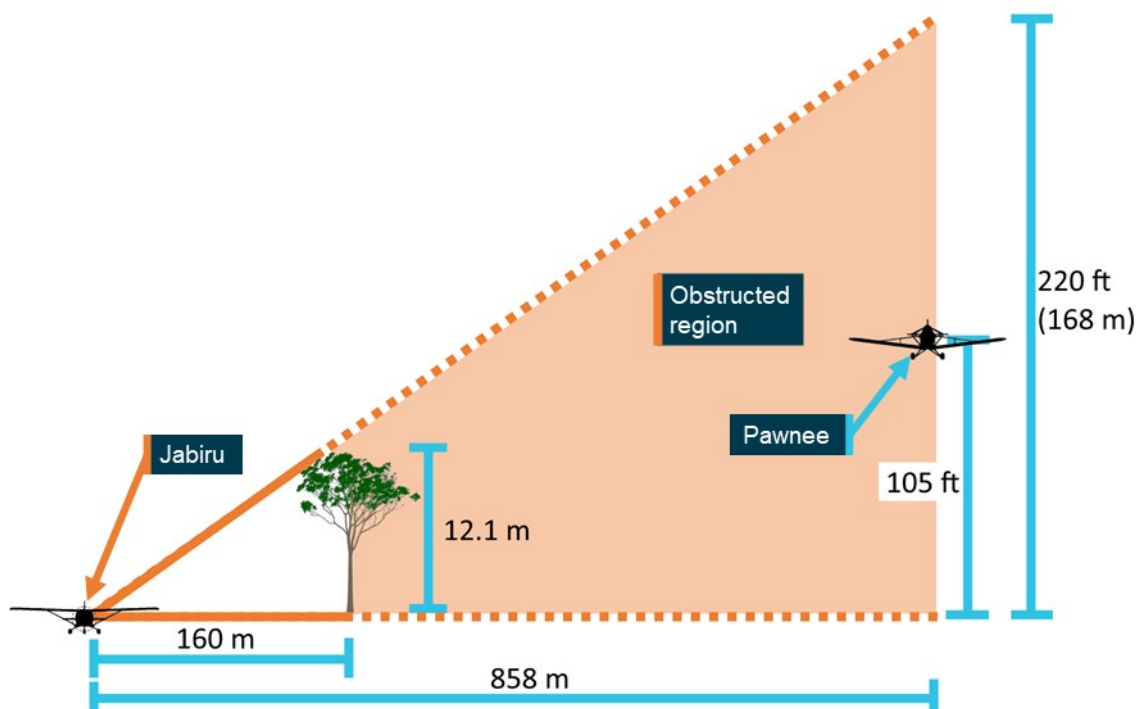
Figure 18: Tree line obstruction height calculation when the Jabiru began its take-off roll

At the time the Jabiru had commenced its take-off roll, the Pawnee (on final approach) would have descended to about 105 ft and the trees would have obstructed line of sight from this point onwards. This was determined using a trigonometric calculation based on the assumptions described above (Figure 18). The trees would also have obscured line of sight from earlier than this, possibly from when the Pawnee descended below about 220 ft (a more precise estimate could not be made due to uncertainties about the Pawnee's height and location on the downwind and base legs of the circuit). If the Pawnee's descent rate had been constant throughout the final descent, it would have likely descended below 220 ft at about 1030:29, when the Jabiru was likely taxiing towards the runway.

Not to scale. This calculation shows that the Jabiru and the Pawnee were not visible to one another when the Jabiru began rolling on runway 11. The Pawnee was estimated to be 105 ft high at this point. Assuming the Jabiru pilot's view was 2 m above the ground, the 14.1-m trees blocked the Jabiru's view up to 220 ft.

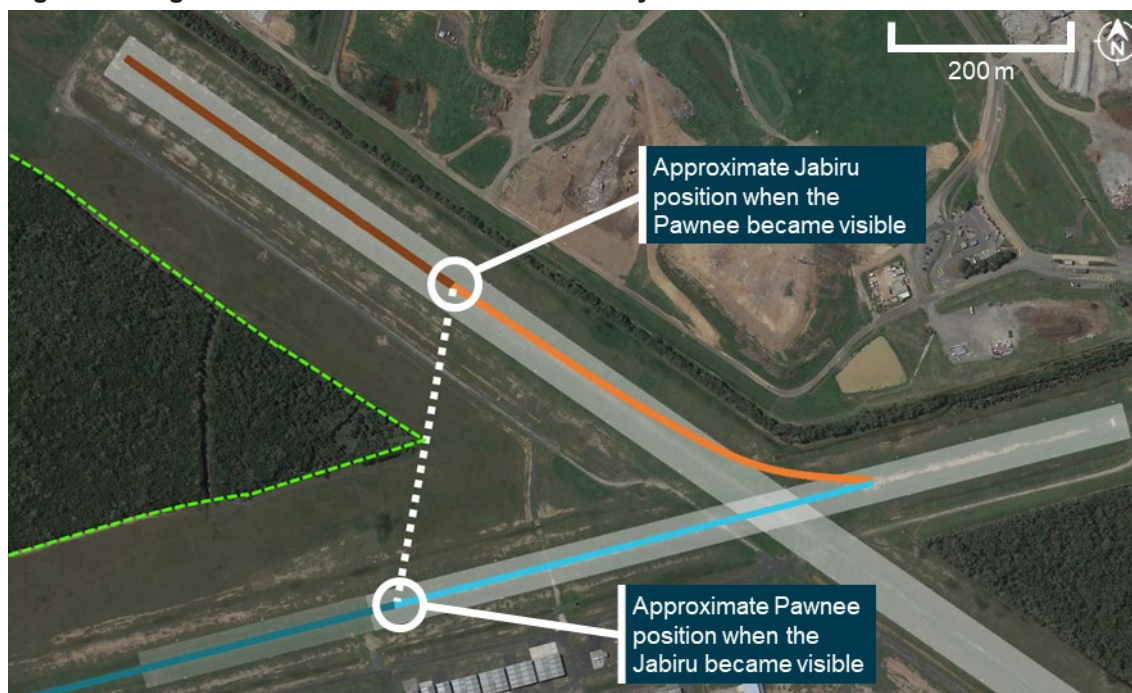
Figure 19: Sightlines between the 2 aircraft as they climbed from the aerodrome

The trees would have prevented the 2 pilots from observing one another up until they were over their respective runways and had passed the end of the stand of trees, at approximately 1031:15. At this point, the Jabiru had only just lifted off the ground, and the Pawnee was just about to begin climbing, having almost touched down prior to commencing the go-around. The point in time that the line of sight was regained is illustrated in Figure 19. At this time, the Pawnee was about 75° to the right of the Jabiru's heading, and the Jabiru was about 55° to the left of the Pawnee's heading.
