# **Loss of control and in-flight break-up involving Robinson R66, VH-KFT**

Near Hawks Nest, New South Wales on 26 October 2023

## **ATSB Transport Safety Report**

AO-2023-051

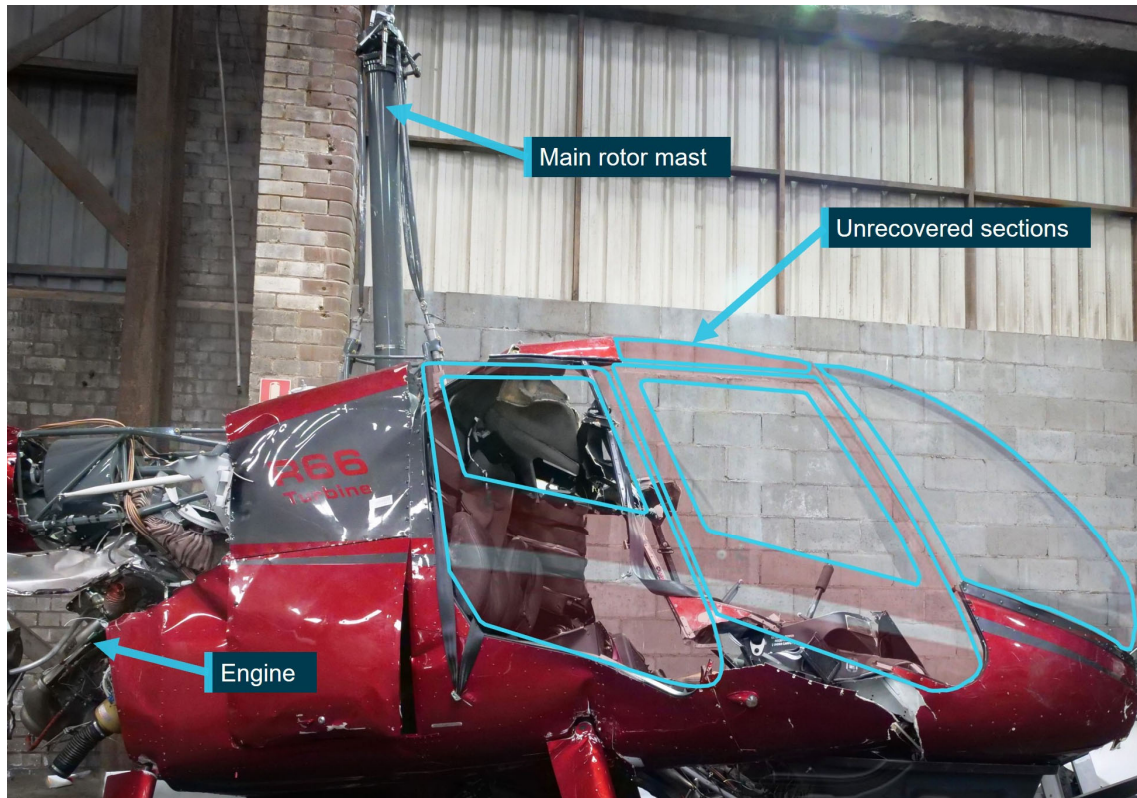
**Figure 6: Recovered fuselage**

windshield and forward cabin roof section, as well as the main rotor head and both main rotor blades, were not located during the sea search operation (Figure 6).

The ATSB's examination of the recovered helicopter structure indicated that a main rotor blade had likely impacted the right side of the cabin. Damage to the fuselage below the pilot's seat, evidence of main rotor blade paint transfer, and damage to the cyclic control column were all consistent with main rotor blade impact on the right side of the cabin.

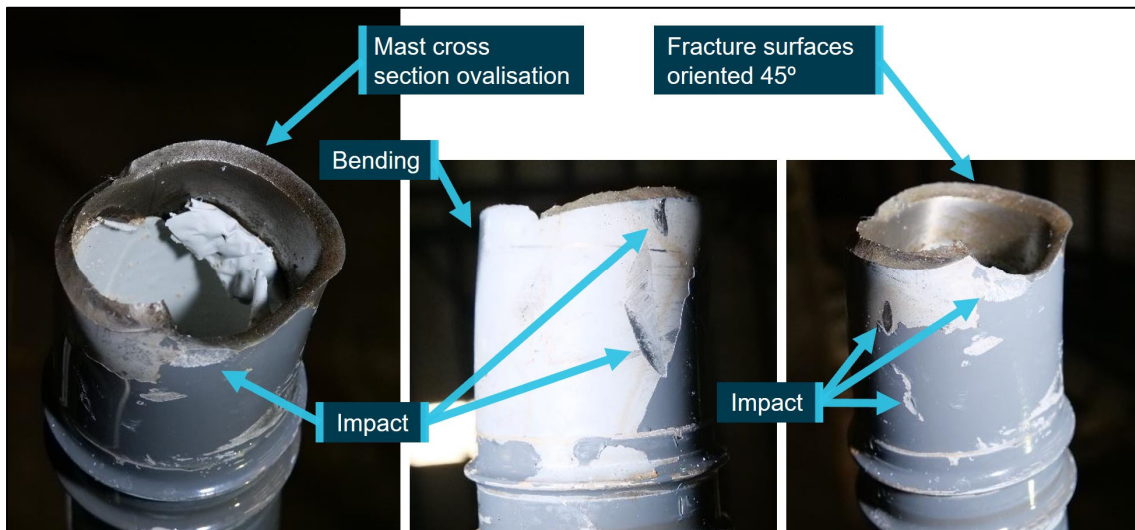
Figure 7: Main rotor mast fracture surface

Although the main rotor head and blades were not initially<sup>6</sup> recovered, mast bending, cross section ovalisation, impact marks below the fracture surface and fracture surface features (Figure 7), were all consistent with tensile overstress failure due to extreme teetering and mast bumping. No evidence of pre-existing defects, such as fatigue-related cracking, were evident on the fracture surfaces.

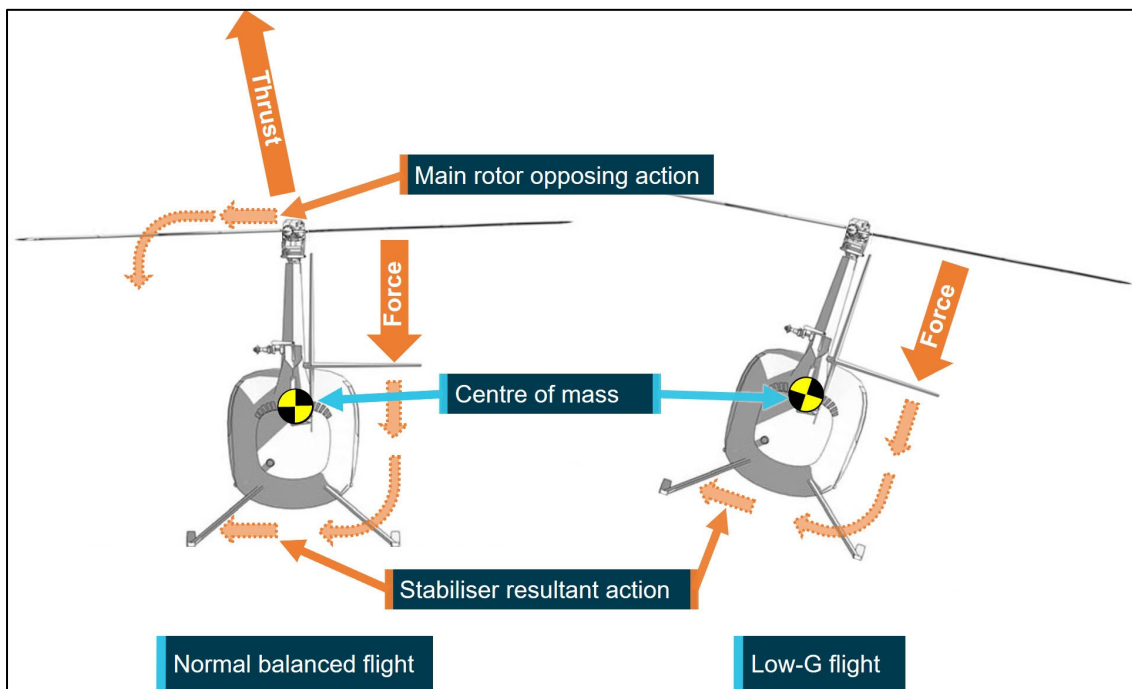
**Figure 9: Stabiliser force in flight and low-G**

Due to the asymmetric design of the stabiliser on Robinson helicopters, the downward force produced by the stabiliser is offset to the right of the aircraft centre of mass. This offset also creates a right rolling moment on the aircraft fuselage, which increases with airspeed. This tendency to roll right is countered by a left tilt of the main rotor disc that provides an opposing left roll moment on the fuselage to assist the maintenance of level flight (Figure 9).

The manufacturer reported that the tail rotor thrust contribution to the right roll is minor in comparison to the stabiliser force and therefore is not the primary cause of the uncommanded right roll during a low-G condition in Robinson helicopters with the asymmetric stabiliser fitted.

Robinson Helicopter Company (RHC) has developed a symmetrical stabiliser modification applicable to all Robinson models. The modification alleviates the low-G/right roll phenomenon associated with the stabiliser by repositioning the horizontal stabiliser aerodynamic downward force in line with the aircraft centre of mass. RHC has stated that, while an uncommanded roll will still develop in a low-G condition, its rate is greatly reduced, allowing pilots more time to recognise and respond appropriately.

At the time of writing, all models of Robinson Helicopters were being manufactured with the symmetrical stabiliser fitted. RHC has also advised that all asymmetrical stabilisers are being replaced with the symmetrical unit when they are returned to the factory for overhaul or repair. Symmetrical stabilisers were also available directly from RHC for retrofit outside of the factory.

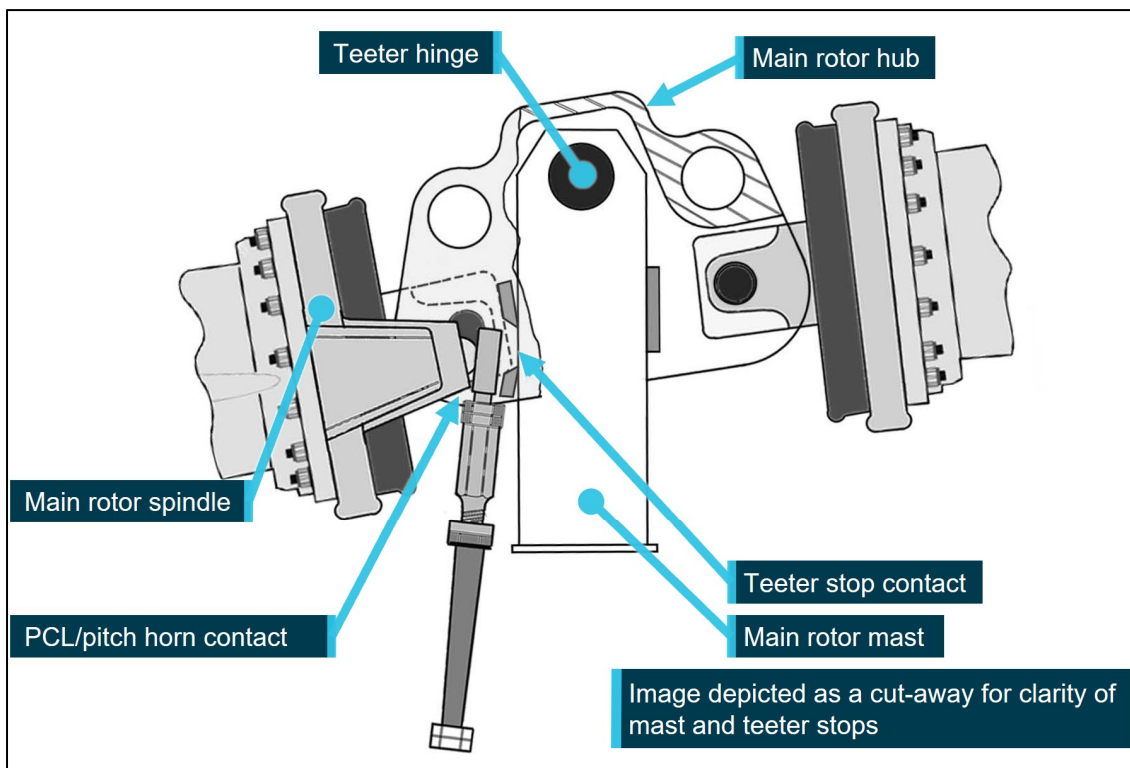
**Figure 10: Main rotor mast bump**

Mast bumping can generally be identified by extensive damage to the teeter stops and varying degrees of damage to the main rotor shaft. It can also result in failure of one or both pitch links, allowing uncontrolled pitching of the blade(s), allowing the blade(s) to deviate from their normal path of rotation and contact with the airframe. Severe mast

If the pilot responds to a low-G/right roll by applying left cyclic input before reloading the disc, the rotor disc will tilt (teeter) left without affecting the roll. The left main rotor tilt without the corresponding fuselage reaction reduces the clearance between the main rotor blade spindle and the main rotor mast. In extreme teetering cases the clearance reduces to zero and destroys the elastomeric teeter stops, resulting in the blade spindle bumping into the mast (Figure 10).

To reduce the risk of mast bumping, Robinson Helicopter Company specifies the correct response to a low-G induced right roll is to resist the instinctive response of left cyclic,

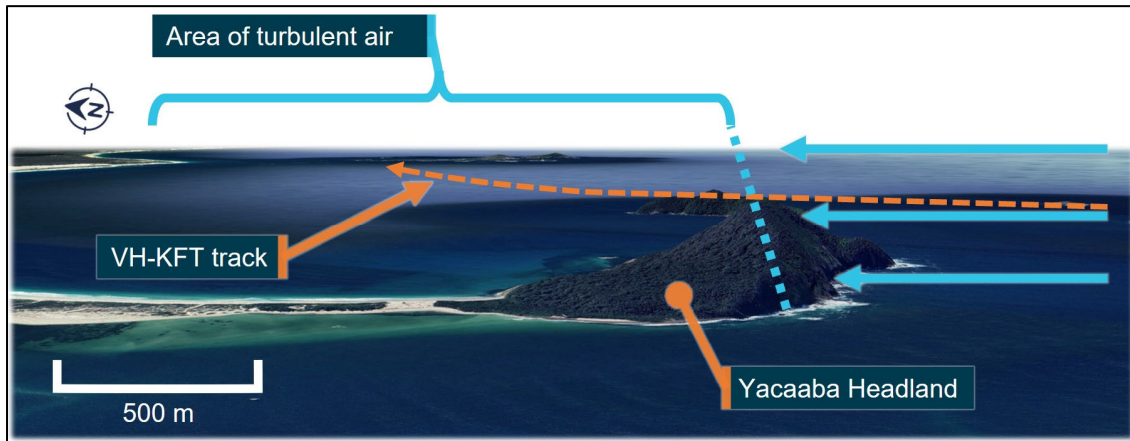
**Figure 14: Turbulent areas over Yacaaba Headland**

Yacaaba Headland is connected to the mainland by an isthmus, resulting in the headland peak being surrounded by sea, or low terrain in all directions. The headland measures about 1.8 km from east to west, and about 750 metres north to south. The headland rises steeply from the sea surface to the peak at 218 metres (715 ft), over about 200–250 metres south to north. The peak forms part of a ridge from east to west, reducing in altitude to about 80–100 metres (260–320 ft) at the point where the aircraft crossed, forming a steep scarp (about 45°) on the southern face of the headland (Figure 14 and Figure 15).

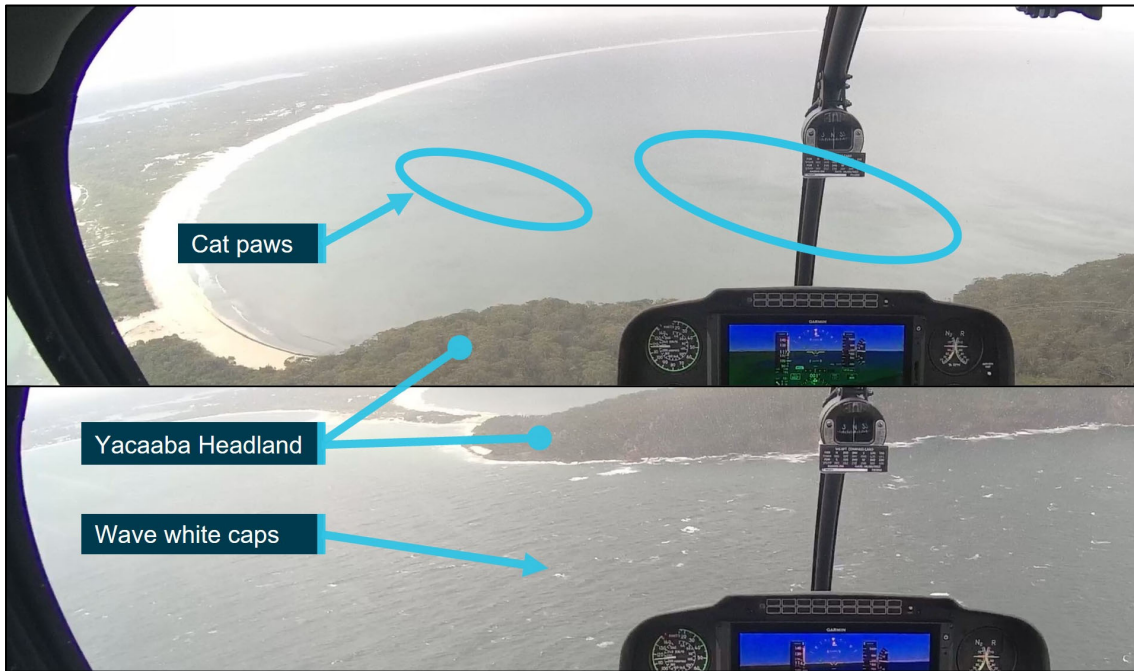
**Figure 16: Sea surface turbulence indicators**

Video footage recovered from the aircraft showed differences between the sea surface conditions on the north and south side of the headland, indicative of the presence of wind and turbulence (Figure 16):

- On the south side of the headland, the surface swell and wave white caps were indicators of south-easterly surface wind strengths of about 11–21 kt (Table 3).
- On the north side of the headland the sea surface was noticeably calmer, due to the shielding effect of the headland. However, dark patches on the sea surface, known as cat's paws, indicated the presence of localised gusts accompanied by turbulence. (Marin, 1996).

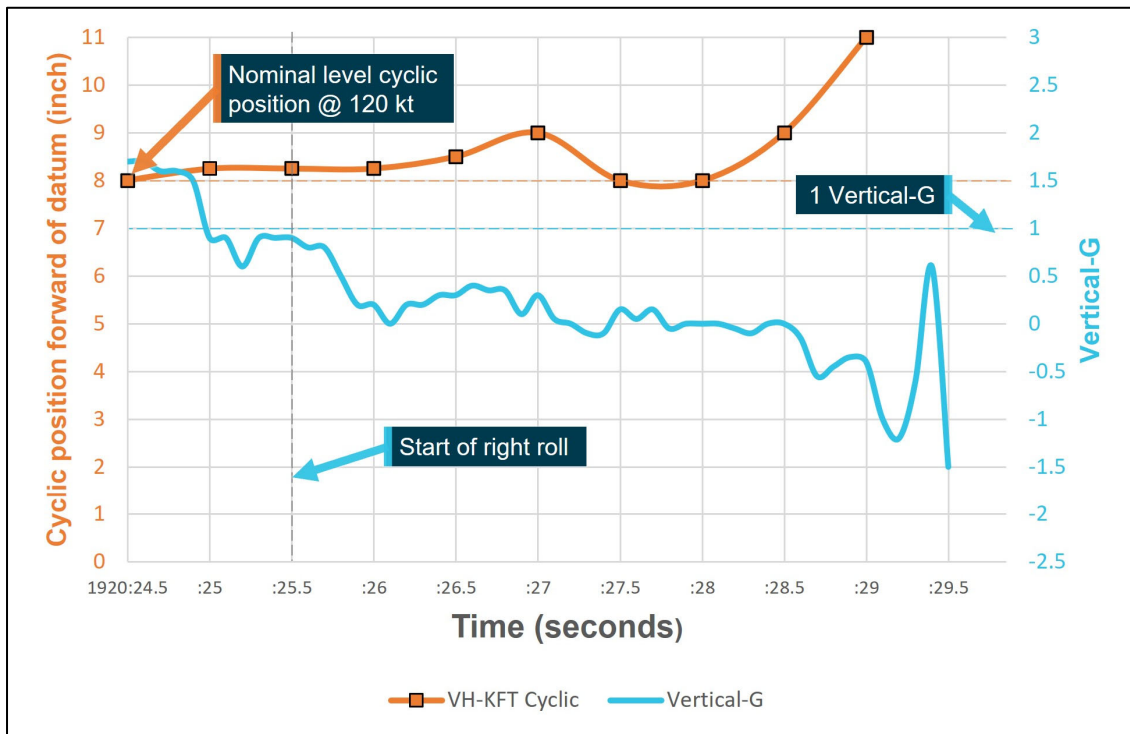
Figure 18: Vertical-G and cyclic fore/aft inputs

The measured fore-aft cyclic position was compared to instantaneous roll rate and accelerometer data (Figure 18) to assess the potential contribution of the cyclic movement to the recorded low-G. Lateral cyclic position was observed but not precisely measured.

Vertical accelerometer data showed significant and variable G loading throughout the final 12 seconds of flight. Between +2 and -0.6 G was recorded prior to the rapid right roll and final rapid reduction to zero G during the final 3.5 seconds (Figure 19). Roll angle data showed the aircraft was subject to roll acceleration throughout the entire final 12 seconds of flight, and the rapid right roll in the final 3.5 seconds coincided with the sharp decrease in vertical G.<sup>14</sup> In the 1 second leading up to the final right roll, vertical G loading decayed rapidly from about +1.6 G, holding briefly at about +0.9 G, before reducing rapidly again to around zero G after the initiation of the right roll.

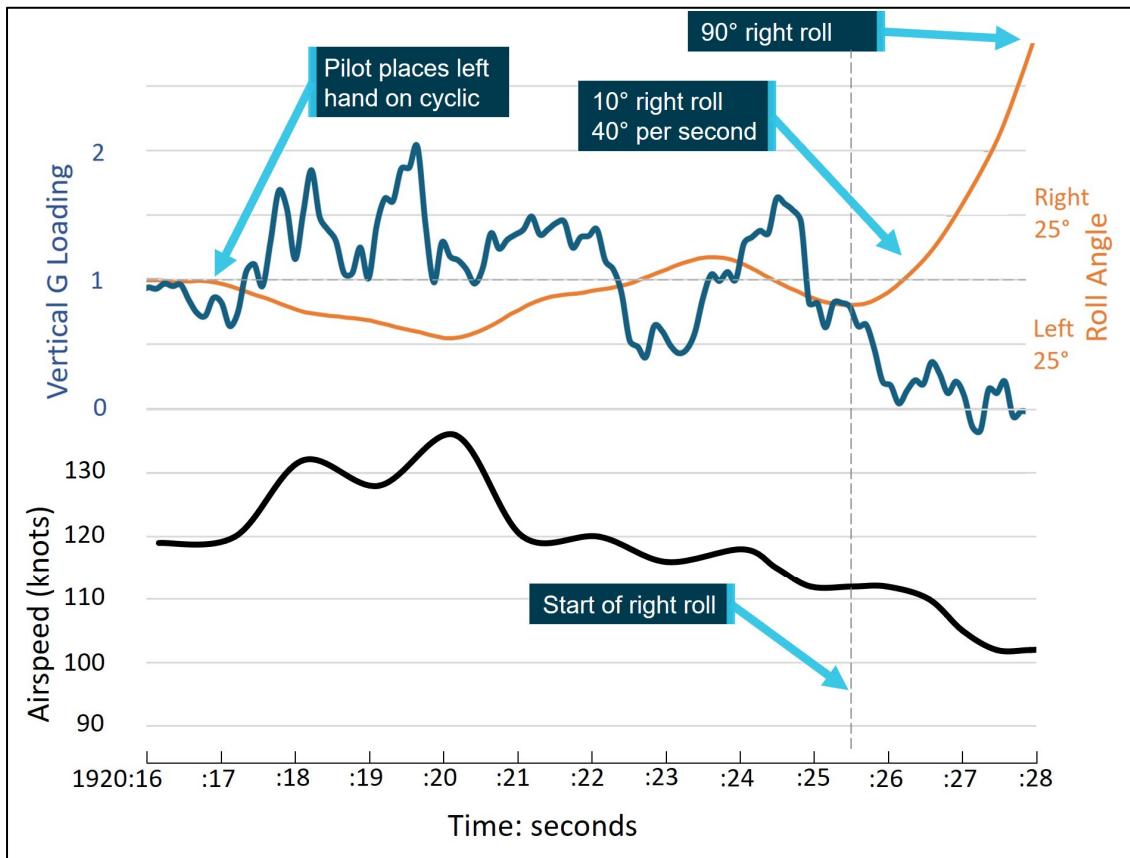
**Figure 19: Vertical-G, roll angle, and indicated airspeed**

Indicated airspeed was read directly from the airspeed gauge, visible in the accident flight video. Airspeed varied rapidly and significantly between 100 and 135 kt during the aircraft's encounter with turbulence (Figure 19). The rapid fluctuations presented on the airspeed gauge were possibly caused by the air pressure or direction fluctuations typical in turbulent air, and not necessarily indicative of ground speed changes. The pilot made no visible attempt to slow the aircraft using coordinated cyclic and collective control inputs during the turbulence encounter.

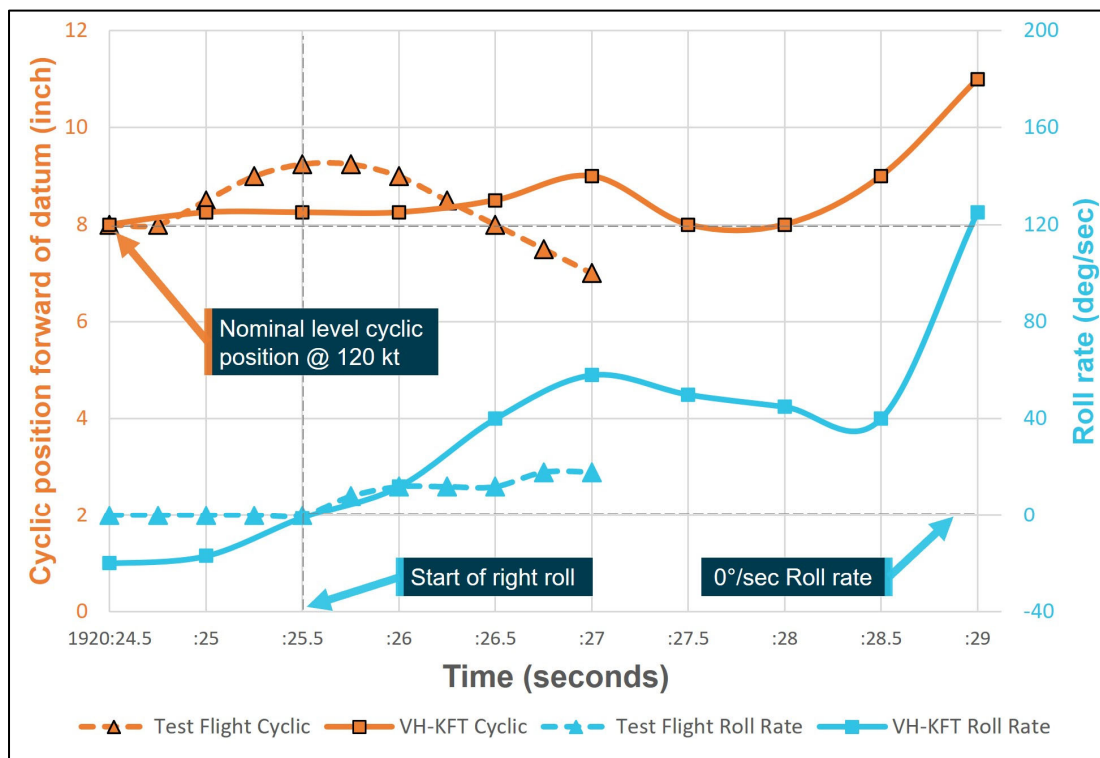
**Figure 20: Accident and test flight cyclic fore/aft inputs and roll response**

A similar aircraft reaction delay, of about 0.4 seconds, to aft cyclic movement was also evident in the data which, importantly, arrested the roll rate, but did not stop the roll for at least 1 second. Test flight data analysis was terminated 1.5 seconds after the roll initiation. Data derived from the test flight video was compared to the accident flight data, which showed a 0.5 inch per second forward cyclic movement to 0.25 inch, about 0.5 seconds prior to the initiation of the right roll (Figure 20). The right roll rate accelerated rapidly in the 0.5 seconds prior to the in-flight break-up, after it passed through about 90° right roll, peaking at about 125° per second immediately before the break-up.
