# **Pilot incapacitation, loss of control and collision with terrain involving Gulfstream 695A, VH-HPY**

55 km south-east of Cloncurry Airport, Queensland on 4 November 2023

## **ATSB Transport Safety Report**

AO-2023-053

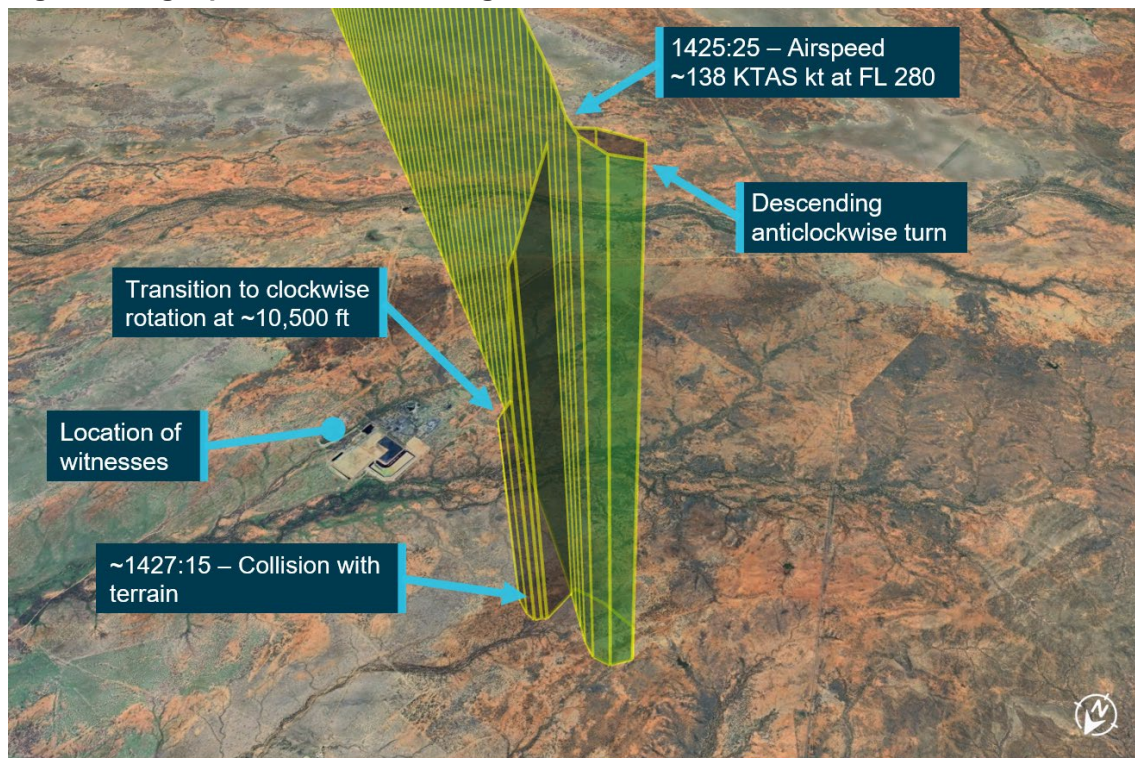
**Figure 4: Flight path of VH-HPY during the descent from FL280**

Recorded data indicated that, at 1423:20, the aircraft’s airspeed began to reduce from a cruise airspeed of about 236 KTAS.<sup>6</sup> At 1425:25, the airspeed had decreased to about 138 KTAS and the aircraft departed controlled flight (see *Flight performance analysis*). The aircraft initially entered a descending anticlockwise<sup>7</sup> turn with an increasing rate of descent. At an altitude of about 10,500 ft, the aircraft transitioned into a tight clockwise helical descent, likely an aerodynamic spin,<sup>8</sup> with a subsequent average rate of descent of about 13,500 ft/min (Figure 4).

Two witnesses at a nearby mining facility observed the aircraft descending in a nose-down, clockwise, corkscrew motion and described hearing a ‘whirring’ noise. The witnesses recalled that motion momentarily stopped part way down, before re-entering the nose-down corkscrew descent.

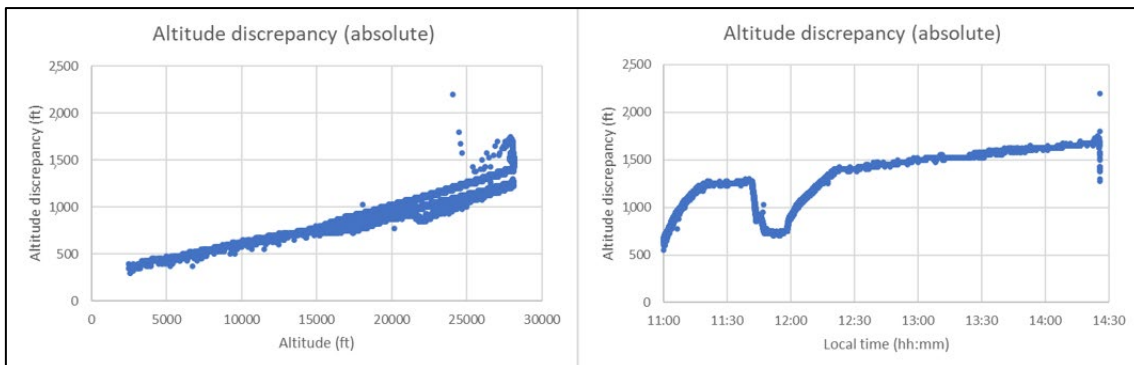
**Figure 9: Scatter plot of pressure and GPS altitude discrepancy with altitude (left) and over time (right)**

The ADS-B data that was broadcast from the aircraft during the accident flight contained a discrepancy between the pressure altitude and the GPS altitude (Figure 8).<sup>22</sup> At the start of the second cruise phase, the broadcast pressure altitude was 28,000 ft while the GPS altitude was 29,400 ft. At the end of the second cruise phase (approximately 2 hours later), the broadcast pressure altitude was 28,050 ft while the GPS altitude was 29,750 ft. The difference in pressure and GPS altitudes over the entire flight varied with altitude and flight time and is shown on a scatter plot below (Figure 9).

When the above data was corrected for local barometric pressure and GPS ellipsoid modelling, the difference in altitudes at the end of the second cruise phase of flight was about 1,400 ft. The GPS altitudes from ADS-B, OzRunways and TrackPlus, which had independent GPS sources and data processing, were broadly aligned over the entire flight, and it is therefore likely that the pressure altitude was reading low and the aircraft was likely flying at FL294 (i.e. the actual position of the aircraft was likely higher than indicated). The reason for the discrepancy could not be determined, although a static source leak inside the cabin could not be discounted.

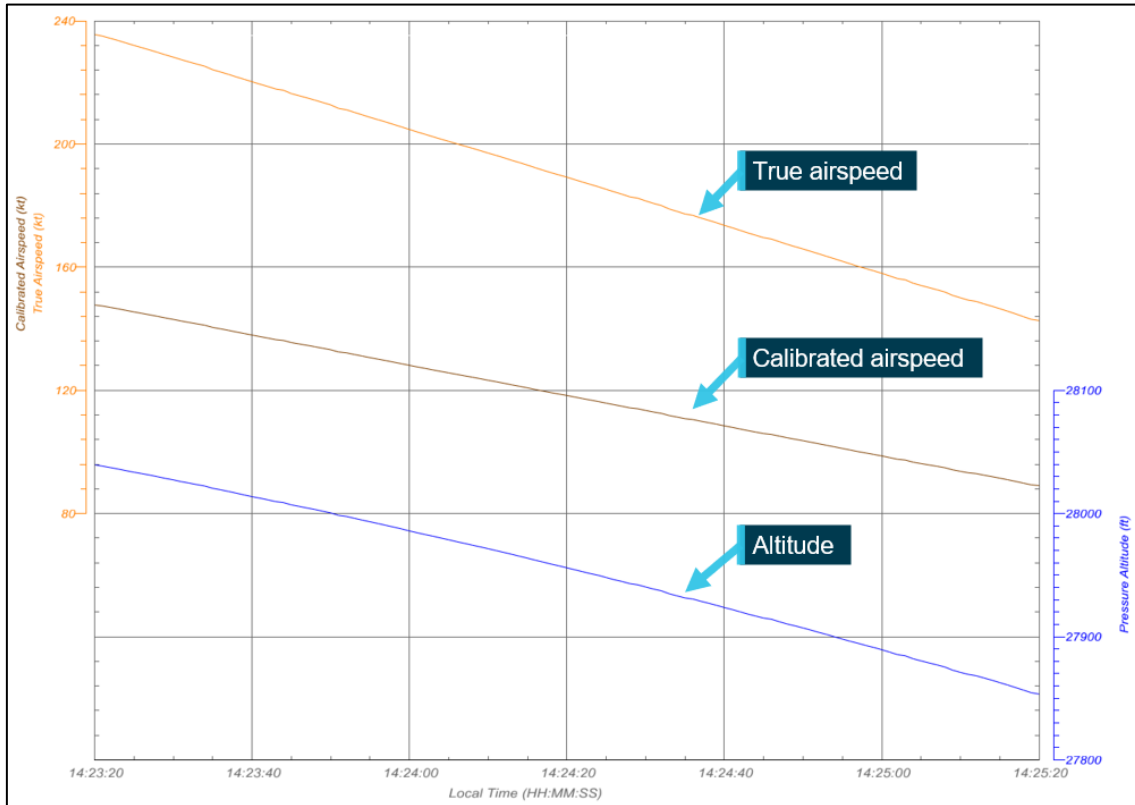
**Figure 10: Deceleration phase**

The aircraft stall speed at maximum weight was 78.6 KCAS. The corrected stall speed at the calculated operating weight of the aircraft was about 74 KCAS, 12 kt lower than the calibrated airspeed at the end of the assessed period. It was calculated that the aircraft had approximately 25% MCP applied at the end of the descent, which would slightly decrease the stall speed, giving further margin from the stall.

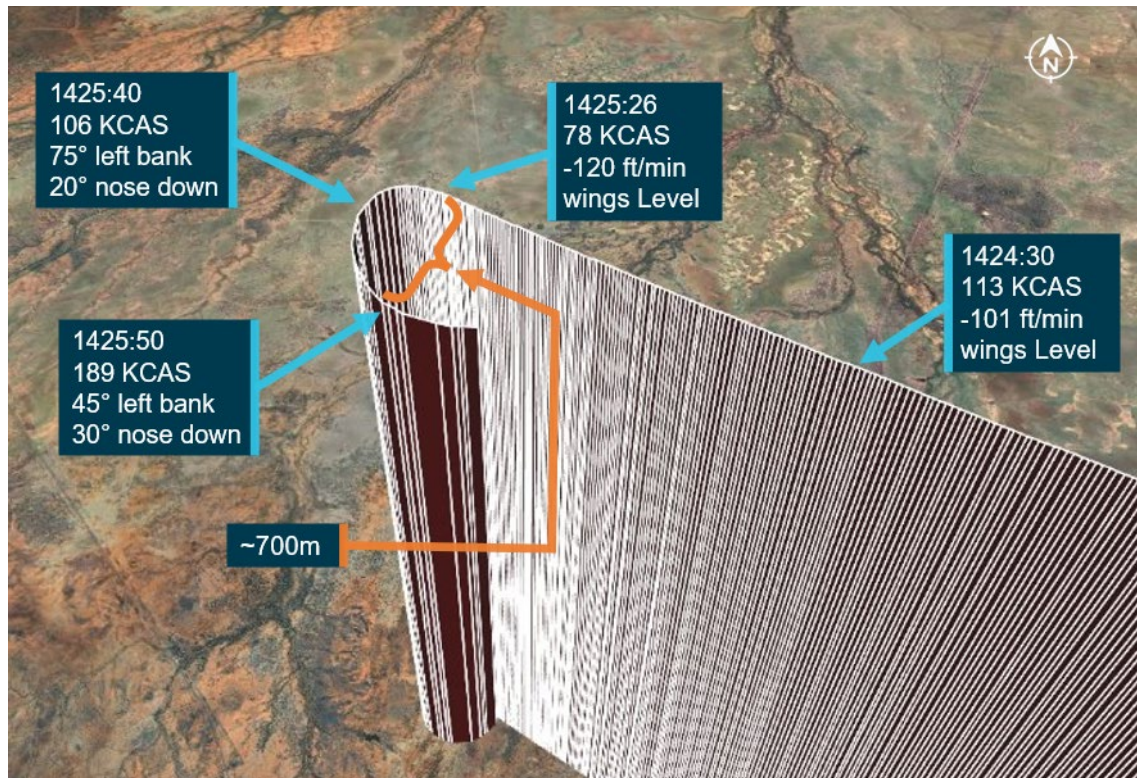
**Figure 11: Deceleration and loss of control**

At 1425:40, the aircraft's heading had turned through 85° and it had accelerated to about 106 KCAS. From this point, over the following 10 seconds, the angle of bank was estimated to reduce to around 45° and the nose-down pitch change slowed until it stabilised about 30° nose down all while the calculated AoA remained constant at around 8°. During this period, the aircraft's heading turned through a further 100° and the speed increased to about 189 KCAS. The diameter of the turn was approximately 700 m (Figure 11).

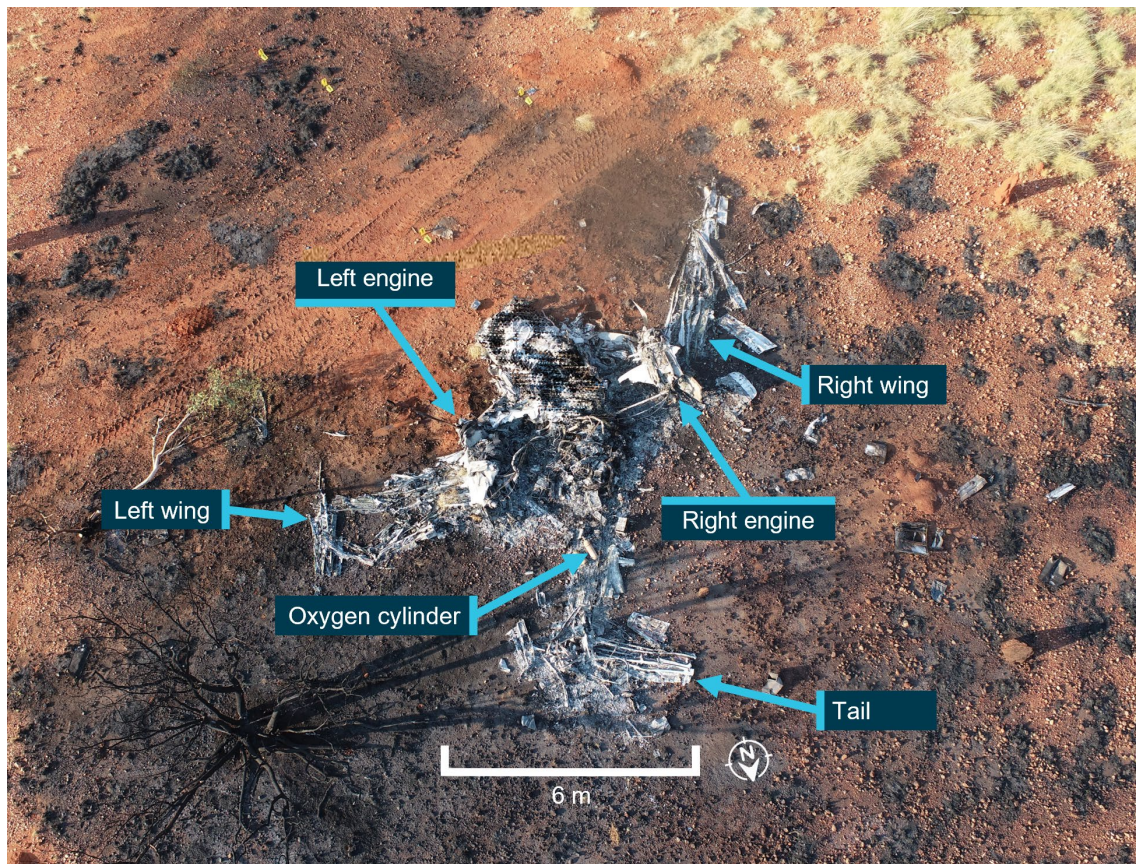
**Figure 12: Overview of the accident site**

The aircraft was destroyed by the impact with terrain and a subsequent fuel-fed post-impact fire (Figure 12). The ATSB conducted an onsite examination of the aircraft wreckage. The ground impact marks and wreckage position indicated that the aircraft impacted terrain upright with a shallow, nose-down attitude with little forward momentum. Immediately surrounding the wreckage, numerous landscape features (a tree and termite mounds) remained upright and had not been disturbed by the aircraft impact or its liberated debris (Figure 13). The compression and displacement of the aft fuselage relative to the engines, the displacement of the inboard wing section and the aircraft nose, showed that the aircraft was rotating clockwise on impact with the terrain, which was highly indicative of a spin.

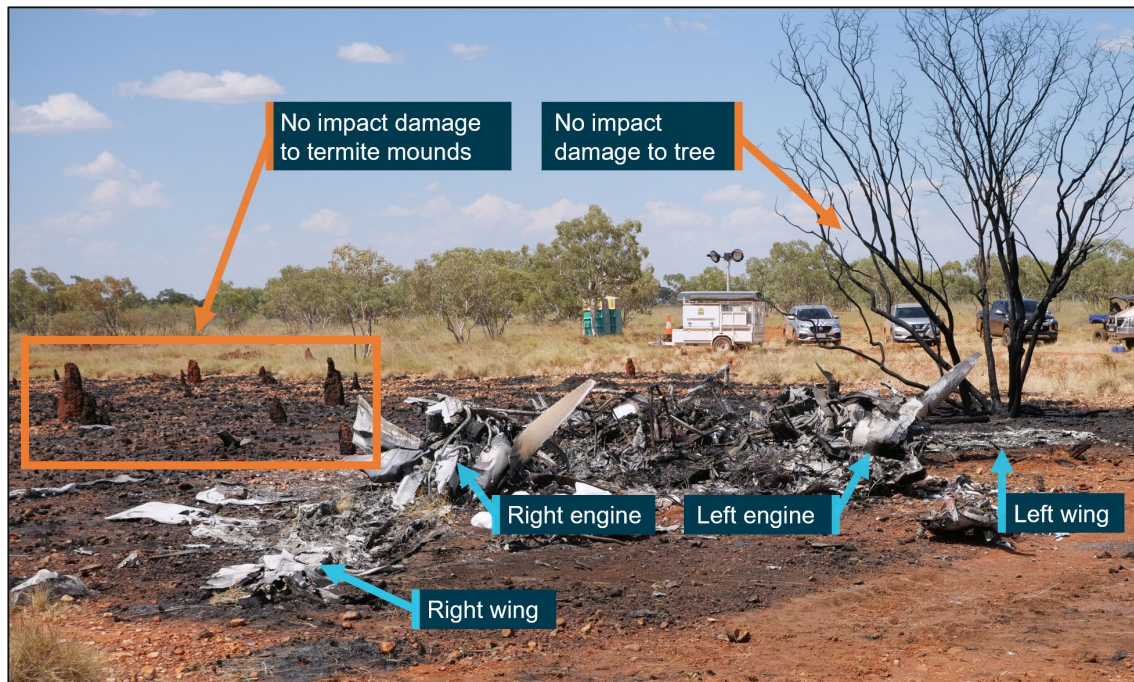
**Figure 13: Heavily disrupted and burnt remnants of the wreckage at the accident site**

*The surrounding landscape features (termite mounds and a tree) remained upright and were not disturbed from the impact.*  
Source: ATSB

All major aircraft components were accounted for at the accident site. The disruption to the airframe from the impact and the subsequent fire damage limited the extent to which the aircraft could be examined. The oxygen cylinder fitted to the aircraft was located in the wreckage and its associated components had been significantly fire damaged, precluding any assessment of the oxygen system's serviceability prior to the accident. Additionally, the components comprising the pressurisation system were unable to be assessed due to the extent of damage sustained.

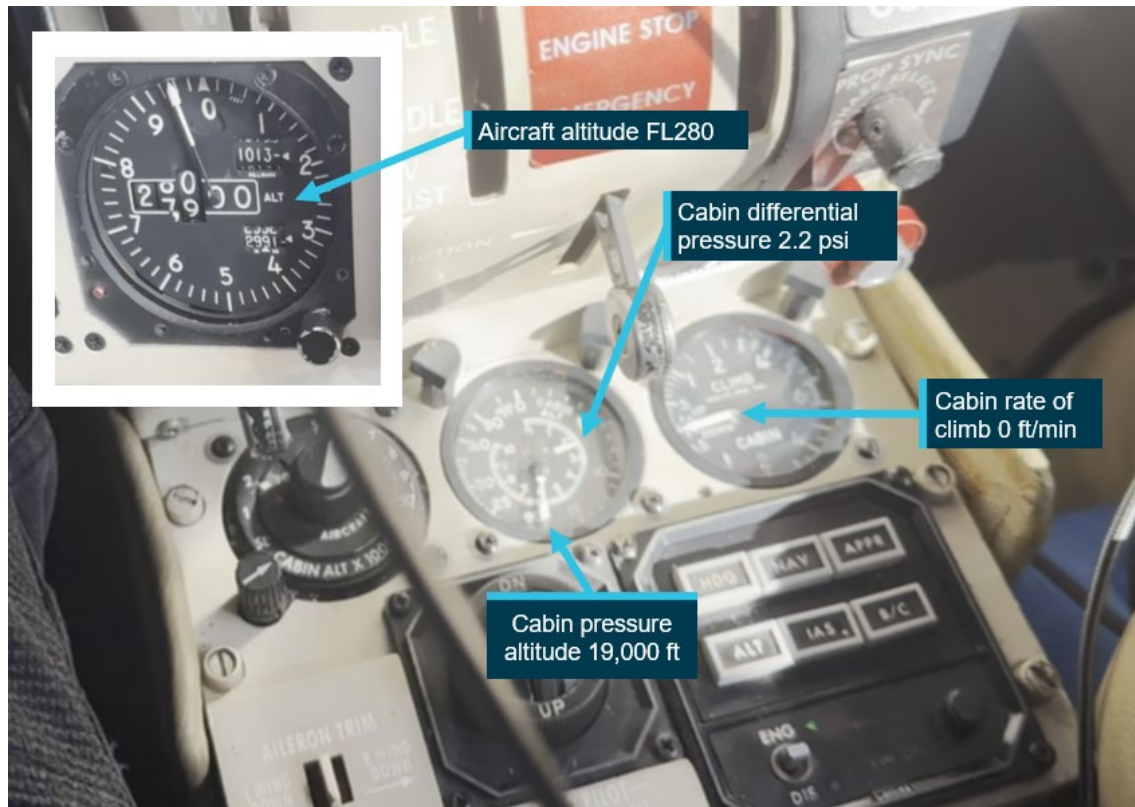
**Figure 15: Inflight cockpit indications captured on video footage 27 October 2023**

The most recent example occurred on 27 October 2023, 8 days prior to the accident, during a line scanning flight from Toowoomba with the COO, as pilot in command, and camera operator 2 on board. The COO used their phone to video the cockpit indications of the defect. The video captured the aircraft in cruise at FL280, with a cabin differential of 2.2 psi and a cabin altitude of about 19,000 ft (Figure 15). There was no audible cabin alarm on the video's audio.

The COO stated that, on that occasion, the pressurisation system defect had manifested during climb, but they elected to continue to their cruise altitude of FL280 as they hoped the system would rectify itself after a short time. They stated that they maintained FL280, while using the aircraft's emergency oxygen system as a supplemental oxygen supply, for a period of about 20 minutes before the pressurisation system 'probably' started working again. They also stated that they silenced the cabin altitude alerting system using the inhibit button located near the power levers. The defect was not entered in the aircraft's maintenance release, but the occurrence was communicated directly to the maintenance provider via text message with the accompanying video (see also *Recent maintenance*).
