# **Collision with terrain during go-around involving Cessna U206F, VH-TDQ**

39 km south-east of Moora, Western Australia, on 1 September 2024

## **ATSB Transport Safety Report**

AO-2024-049

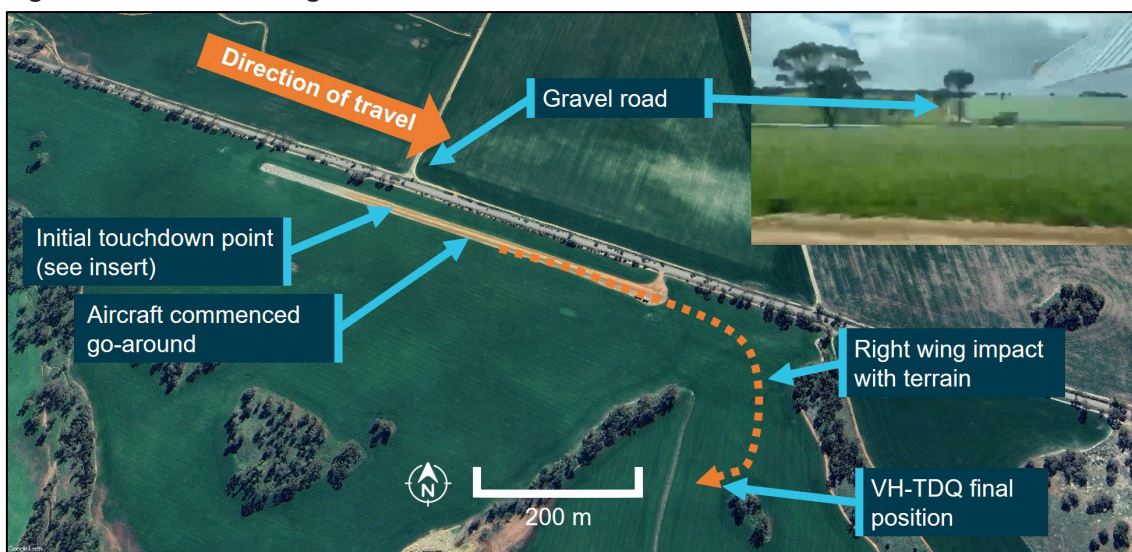
**Figure 2: Aircraft landing area**

The pilot landed the aircraft about 80 m (Figure 2) past the end of the easterly runway and bounced twice before they applied full power and commenced a go-around. The pilot was unable to recall their airspeed at the time of the flap reduction, however reported that the aircraft had probably dissipated a considerable amount of speed during the bounces prior to initiating a go-around. As the aircraft began the initial climb the pilot reduced the flap setting, unknowingly mis-selecting the 10° setting.
