# Safety advisory notice

To operators of all Cessna 206 variants

Number: AO-2024-049-SAN-002  
Released June 2025

## Cessna 206 cargo door emergency exit

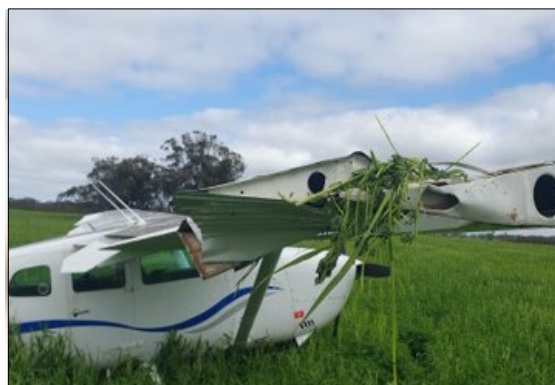
Source: Operator

The rear seat passengers, an older person and a child, were unable to egress the aircraft via their closest emergency exit (the cargo doors). The pilot tried assisting them but found that the forward cargo door was blocked due to the flap extension and was unaware how to open the rear cargo door with the forward cargo door blocked by the flap. The pilot attempted to retract the flaps so the door could be opened, but they would not retract. The pilot then instructed the passengers in the rear seats to climb over the middle row of seats so they could exit through the left forward cabin door. This ultimately increased the time taken to evacuate the aircraft and further increased the risk of passenger injury and post-impact survivability, such as if fire or ditching had been a factor.

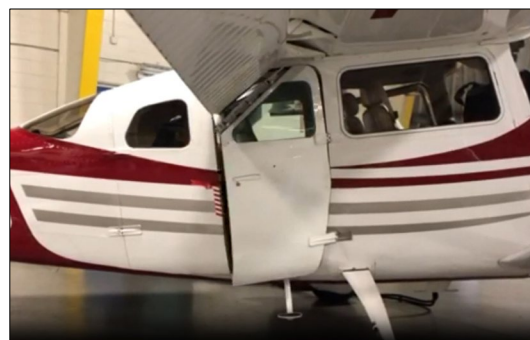
In 2020, [STC SA20-34](#) was approved as an alternative means of compliance, which allowed the forward cargo door corner to be hinged so the door corner can fold and the door fully open with flap extended in any position and without any restriction to the rear cargo door.

Hinged forward cargo door.  
Source: Coast Dog Aviation

**AO-2024-049-SAN-002:** The Australian Transport Safety Bureau strongly encourages operators and owners to review Transport Canada [Airworthiness Directive CF-2020-10](#), and consider either the removal of a middle row seat to improve rear seat occupants' access to the pilot's forward left cabin door or the fitment of approved Cessna 206 emergency exit modifications to reduce the risk created by the extended flap preventing the immediate and unobstructed use of the rear cargo doors during an emergency exit.
