Safety advisory notice

To operators of all Cessna 206 variants

Number: AO-2024-049-SAN-001
Released: June 2025

Cessna 206 cargo door passenger pre-flight briefing

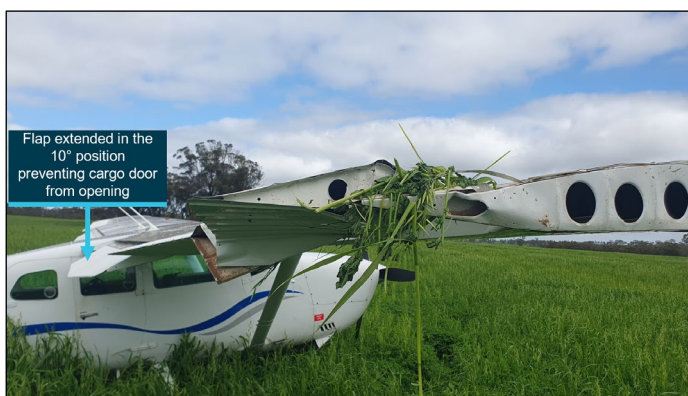
On the morning of 1 September 2024, the pilot of a Cessna U206F took off from a private aircraft landing area, 40 km south-east of Moora, Western Australia, to conduct a local scenic flight with 5 passengers on board. On return to the landing area, after bouncing twice on landing, the pilot then attempted to conduct a go-around. However, an incorrect flap setting resulted in the aircraft not climbing, impacting the right wing with terrain before coming to a stop in an adjacent field.

The rear seat passengers, an older person and a child, were unable to egress the aircraft via their closest emergency exit (the cargo doors). The pilot tried assisting them but found that the forward cargo door was blocked due to the flap extension and was unaware how to open the rear cargo door with the forward cargo door blocked by the flap. The pilot attempted to retract the flaps so the door could be opened, but they would not retract. The pilot then instructed the passengers in the rear seats to climb over the middle row of seats so they could exit through the left forward cabin door. This ultimately increased the time taken to evacuate the aircraft and further increased the risk of passenger injury and post-impact survivability, such as if fire or ditching had been a factor.

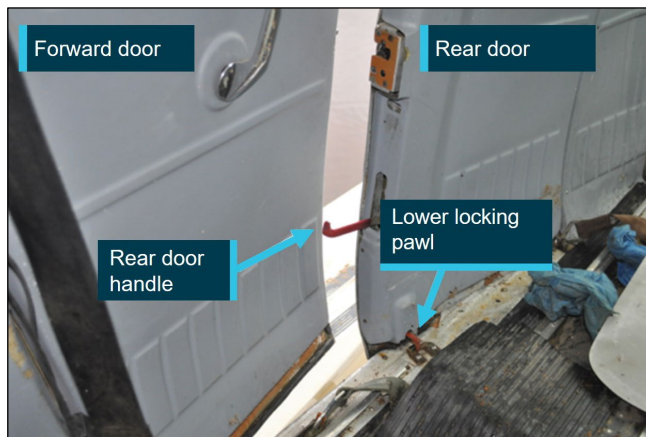
The Cessna 206 is a 6-seat, high wing aircraft with a forward cabin door on the pilot's side and a double cargo 'clam-shell' style door on the rear right hand side of the aircraft. When the aircraft flaps are extended 10° or more, this prevented the forward, overlapping part of the cargo door from opening, requiring a multi-step process to open the rear part of the door to exit the aircraft.

During landing and take-off, it is likely there will be flap extension and therefore also likely that the flaps would remain extended after a forced landing, ditching or accident, making the egress via the rear cargo doors more difficult for passengers.

The newer Cessna 206H model incorporates the improvements that were made with the 1991 Cessna service bulletin SEB 91-4 *Cargo door latch improvement* applicable to all models prior to the Cessna 206H. The service bulletin recommended modifying the rear door handle to include a spring to ensure that the handle would return to the stowed position after opening, this improved the ease of opening the rear cargo door when the flaps remained extended. The service bulletin was not a mandatory modification.

Pilots and operators are encouraged to ensure passengers of Cessna 206 aircraft with the standard double cargo doors are provided a pre-flight safety briefing that demonstrates the emergency egress process required to use the cargo doors when the flaps are in the extended position. Operators are encouraged to develop safety briefing cards with imagery clearly depicting the process as well as incorporating into the passengers' pre-flight briefing. The incident also highlights the responsibilities of pilots to ensure passengers have a thorough understanding of the use of emergency exits.
