Entry to a closed taxiway involving Pilatus PC-12, VH-FXJ

Adelaide Airport, South Australia on 4 November 2024

ATSB Transport Safety Report

AO-2024-061

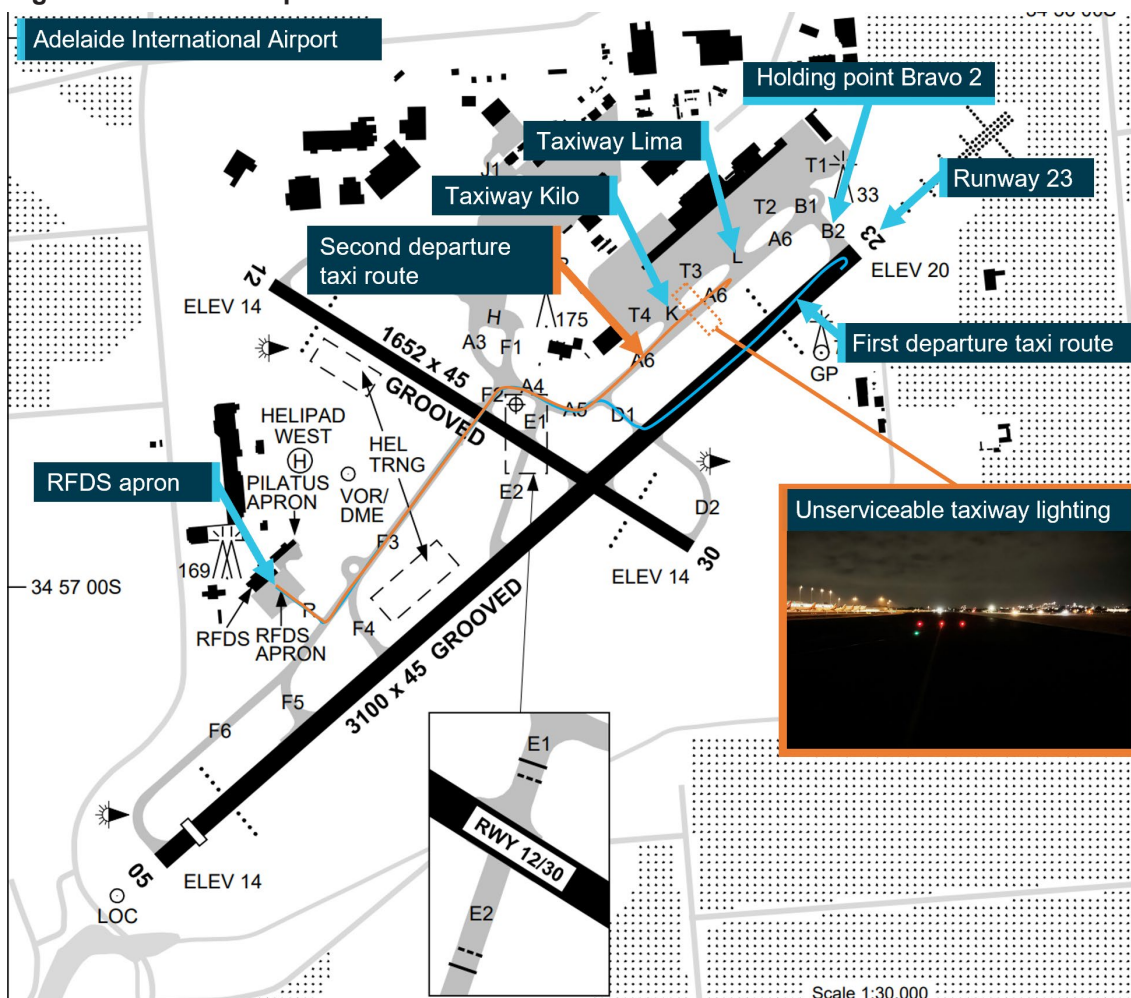
Figure 1: Adelaide Airport

The image shows both taxi routes taken by Flydoc 543 and the position of the unserviceable taxiway lights. The blue line is the taxi route for the first flight, the orange line is the taxi route for the incident flight. The view of the unserviceable taxiway lights was taken on 14 November 2024. It is an exemplar image of the lights on the night the incident took place. Source: Airservices Australia, Adelaide Airport, and Flightradar24; annotated by the ATSB

This clearance required the aircraft to taxi through the unserviceable area. The pilot did not question the clearance, assuming that the works had ended early.

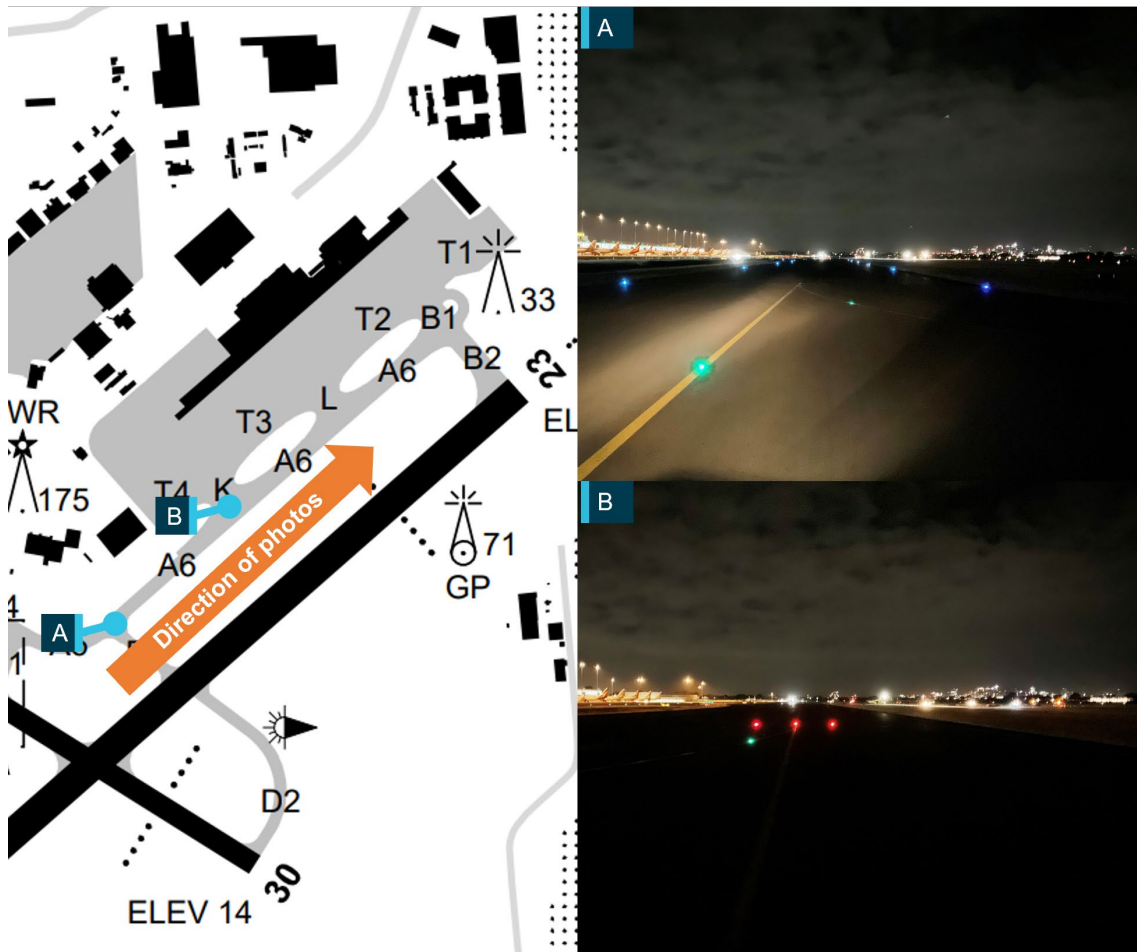
Figure 3: Approaching unserviceability lights

Several days after the incident, Adelaide Airport provided photographs of the unserviceability lights on taxiway A6, taken in similar conditions to those at the time of the incident. The images identified that the red unserviceability lights were difficult to see while on the southern end of taxiway A6 due to bright works lights beyond the unserviceable area (Figure 3). However they became more noticeable as the aircraft approached the closed area.

Image shown is an exemplar of the lighting on the night of the incident. The photo shown was taken several days after the incident occurred.

Increasing the span of unserviceability lights, in circumstances where there is significant obscuring background lighting, would make a closed area much more distinguishable. As done for the markers, a recommendation would encourage operators to consider their circumstances to assess the number of lights required to clearly identify the area.

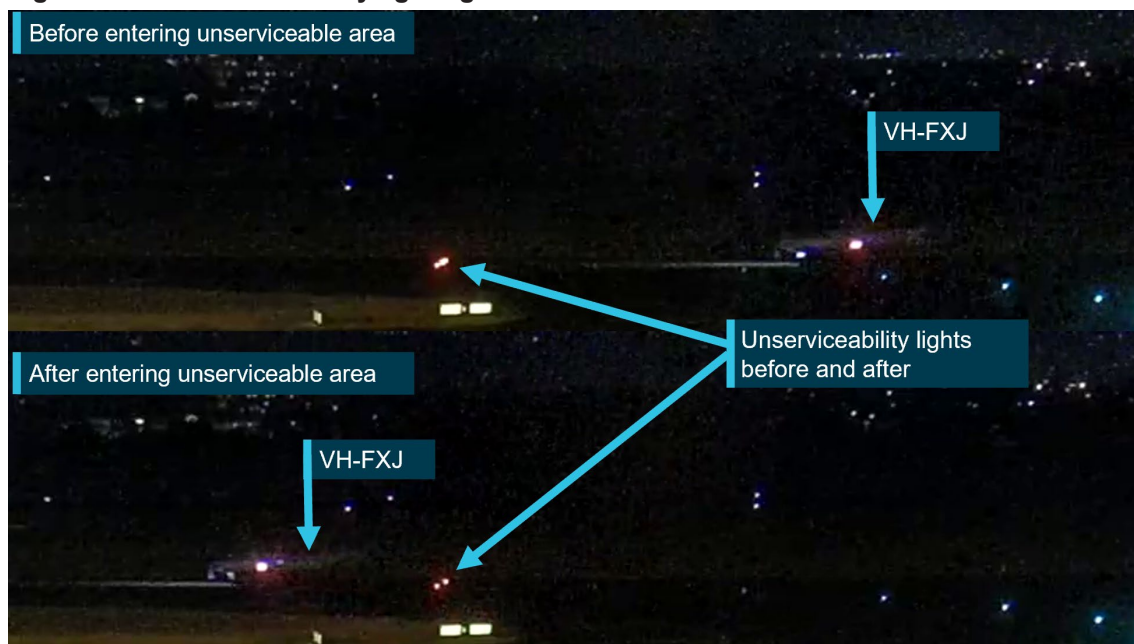
Figure 4: A6 unserviceability lighting before and after the occurrence

Adelaide Airport also provided the ATSB with video footage of the incident. This showed the unserviceability lighting before and after the aircraft entered the area (Figure 4). It also showed that after completing a 180° turn and coming to a stop facing the 2 remaining red unserviceability lights, the aircraft remained stationary for approximately 4 minutes while ground personnel cleared the remaining lights and debris.
