Collision between a truck and V/Line train 7727

Barwon Terrace level crossing, South Geelong, Victoria on 3 April 2023

ATSB Transport Safety Report

RO-2023-003

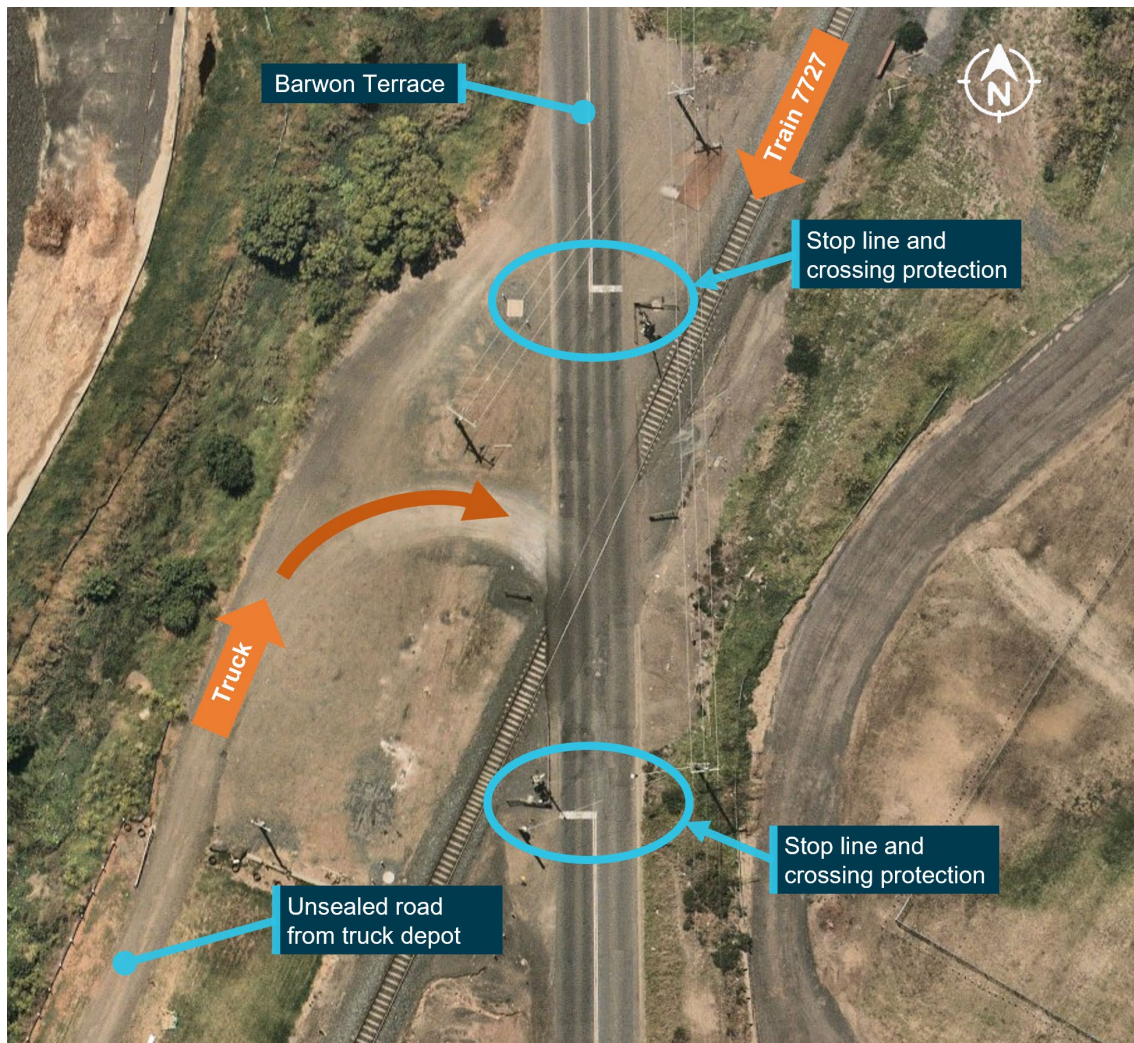
Figure 2: Direction of travel of train and route of truck onto the level crossing

At about 0635, the truck left the depot and travelled north along the unsealed road towards Barwon Terrace. It was dawn (shortly before sunrise), overcast and dry. As the truck approached the northern end of the unsealed road, the truck turned to the right and drove slowly onto the level crossing (Figure 2). This positioned the truck between the protection equipment located on each side of the crossing. The level crossing flashing lights and bells were operating, and booms had descended. At the same time, train 7727 approached the level crossing from the north.

The truck entered the level crossing between the level crossing protection equipment on either side of the track and stopped on the track. The driver probably realised a train was approaching and reversed the truck but was unable to clear the track in time.

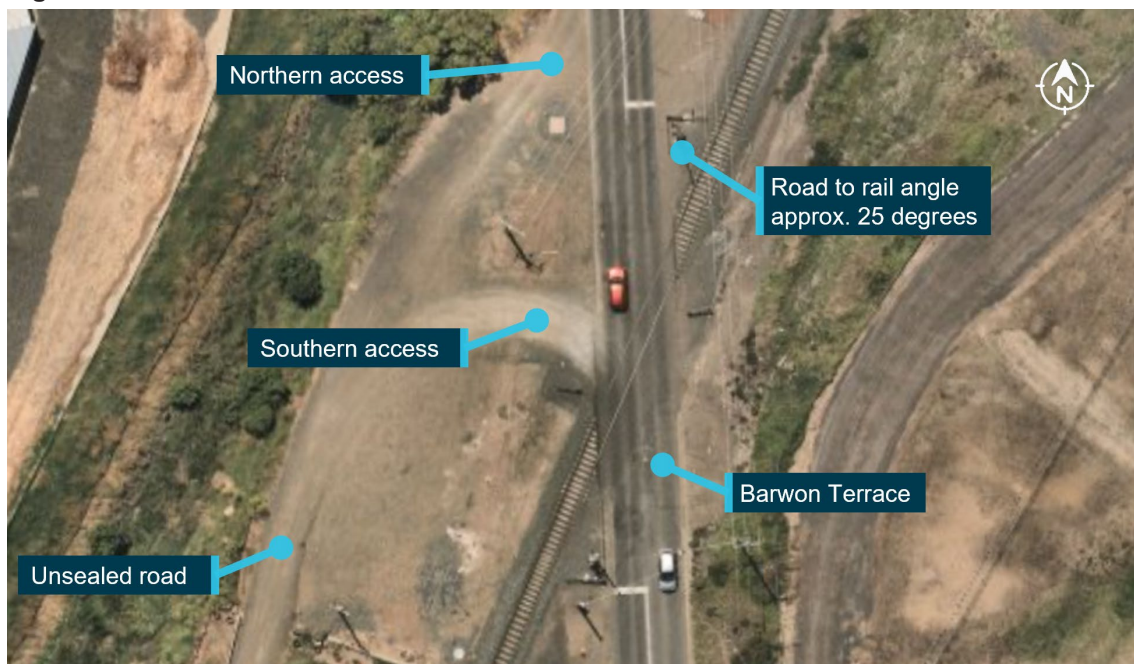
Figure 3: Barwon Terrace interface with rail line

Barwon Terrace was a sealed bi-directional dual lane motor vehicle carriageway managed by the City of Greater Geelong (COGG). At its intersection with the rail line, Barwon Terrace ran in a north / south direction. Travelling south away from Geelong, Barwon Terrace intersected the rail track at the level crossing at an angle of about 25 degrees to the road user's left (Figure 3). The maximum speed permitted on Barwon Terrace was 60km/h.

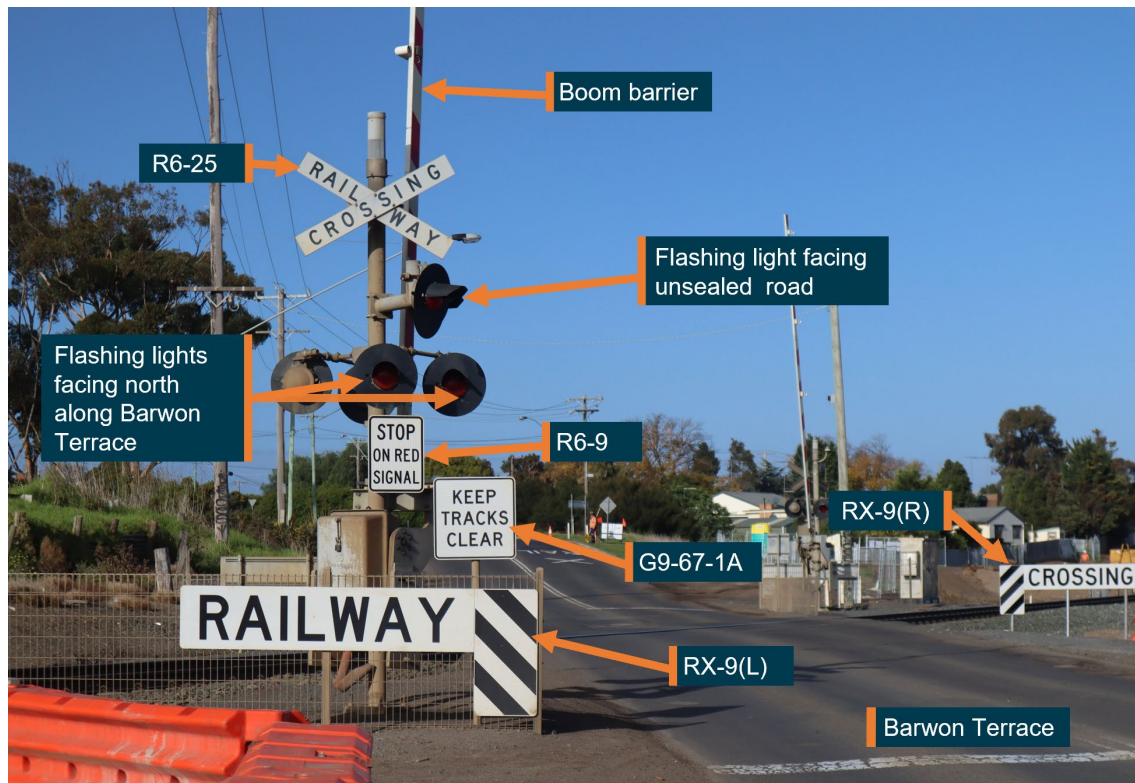
Figure 4: Level crossing protection for southbound traffic

For road traffic approaching from the north, railway crossing warning signage included an RX-5 railway crossing flashing signal assembly,⁶ a Keep Tracks Clear Sign (G9-67-1A) and a Railway Crossing with marker assembly sign (RX-9) (Figure 4).⁷ There was a pair of standard flashing lights for southbound Barwon Terrace traffic and an additional flashing light directed towards the exit of the unsealed road. This single flashing light was directed to the northern access of the unsealed road and could not be clearly seen from the southern exit nearer the track crossing and used by the truck.

The protection equipment at the crossing was working at the time of the incident. This was confirmed by CCTV, download data taken from the crossing equipment following the incident and eyewitnesses accounts.

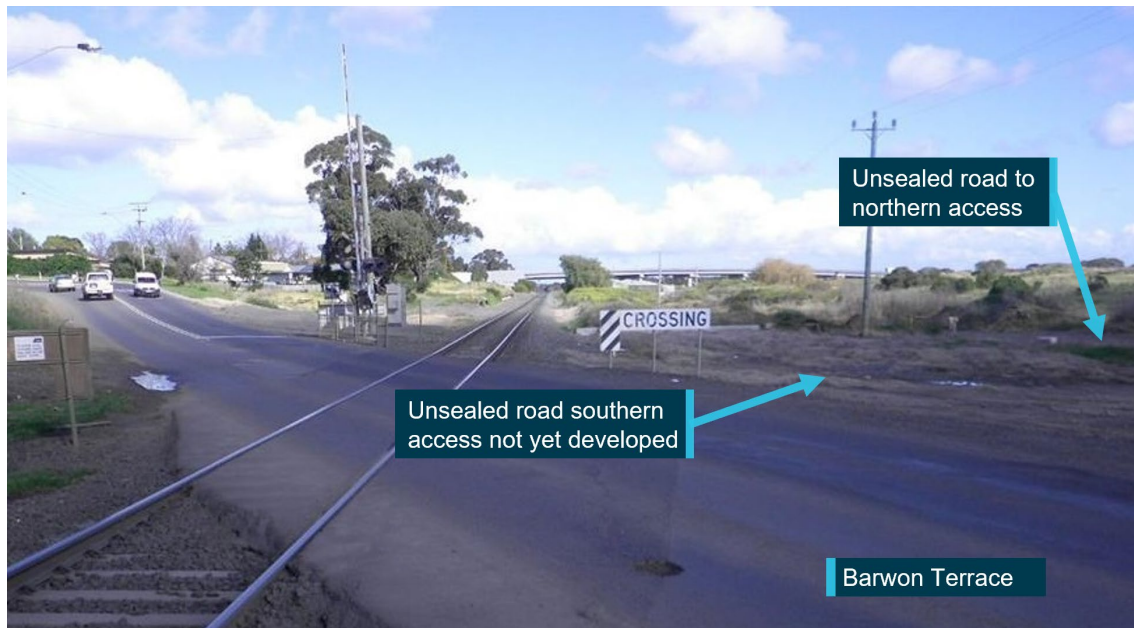
Figure 5: Junction between the access road and Barwon Terrace in 2017

The most recent (prior to the collision) full ALCAM survey at the Barwon Terrace level crossing was conducted in July 2017 and reviewed in 2018. The assessment and review noted that flashing lights, bells and audible warning devices and the relevant level crossing signage were deployed at the crossing. The survey drawing prepared from the survey in 2017 and associated photographs at that time indicated that the used route to and from the unsealed road was on its northern interface, and not the southern access later used nearer to the track (Figure 5).

In 2017, the unsealed road joined Barwon Terrace north of the level crossing. The access pathway used by the truck on the day of the incident had not yet developed.

- The unsealed road access route close to the level crossing probably developed after the 2017 survey of the Barwon Terrace level crossing using the Australian Level Crossing Assessment Model (ALCAM), and the ALCAM survey report did not identify the route.
- There was a missed opportunity for identified hazards associated with the level crossing configuration to be brought to the attention of the appropriate operational area within V/Line.

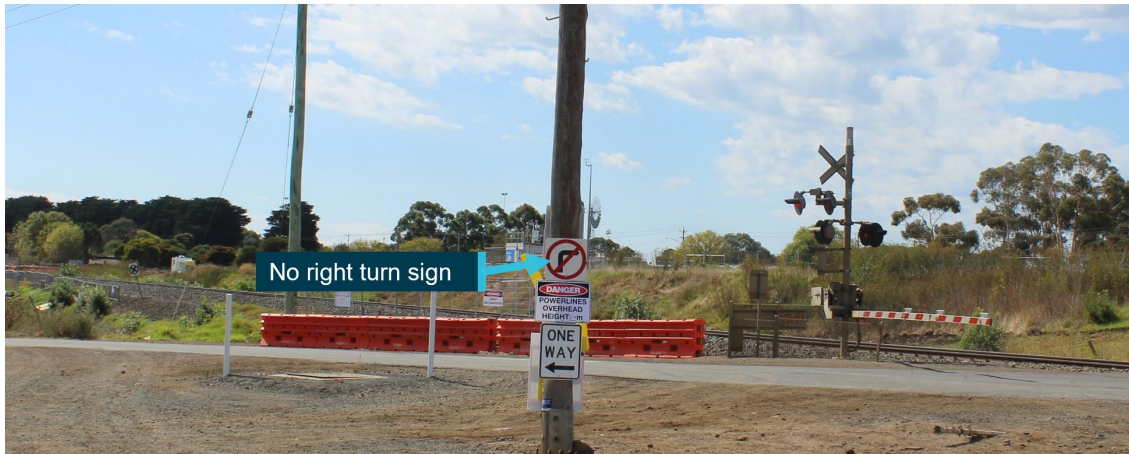
Figure 7: No right turn sign on the power pole

On 9 March 2023, prior to the collision and after an Alliance safety officer observed an Alliance vehicle turning right onto Barwon Terrace into the middle of the level crossing, a no right turn sign¹³ was affixed to the power pole (Figure 7). The sign faced south towards traffic approaching from along the unsealed road. During 'Pre-start' and 'Safe Talks' at team meetings, Alliance personnel were also advised that they were not to turn right when exiting the unsealed road onto Barwon Terrace. V/Line personnel were present at some safety meetings.

Photograph showing the no right turn sign on the power pole.
Source: The Office of the Chief Investigator

In addition to briefing rail project workers about the hazard, additional signage prohibiting a right turn from the unsealed road onto Barwon Terrace was erected as a risk control. However, there was a missed opportunity for the safety concerns to be raised with the appropriate operational area of V/Line, either by the rail project directly or V/Line representatives onsite.

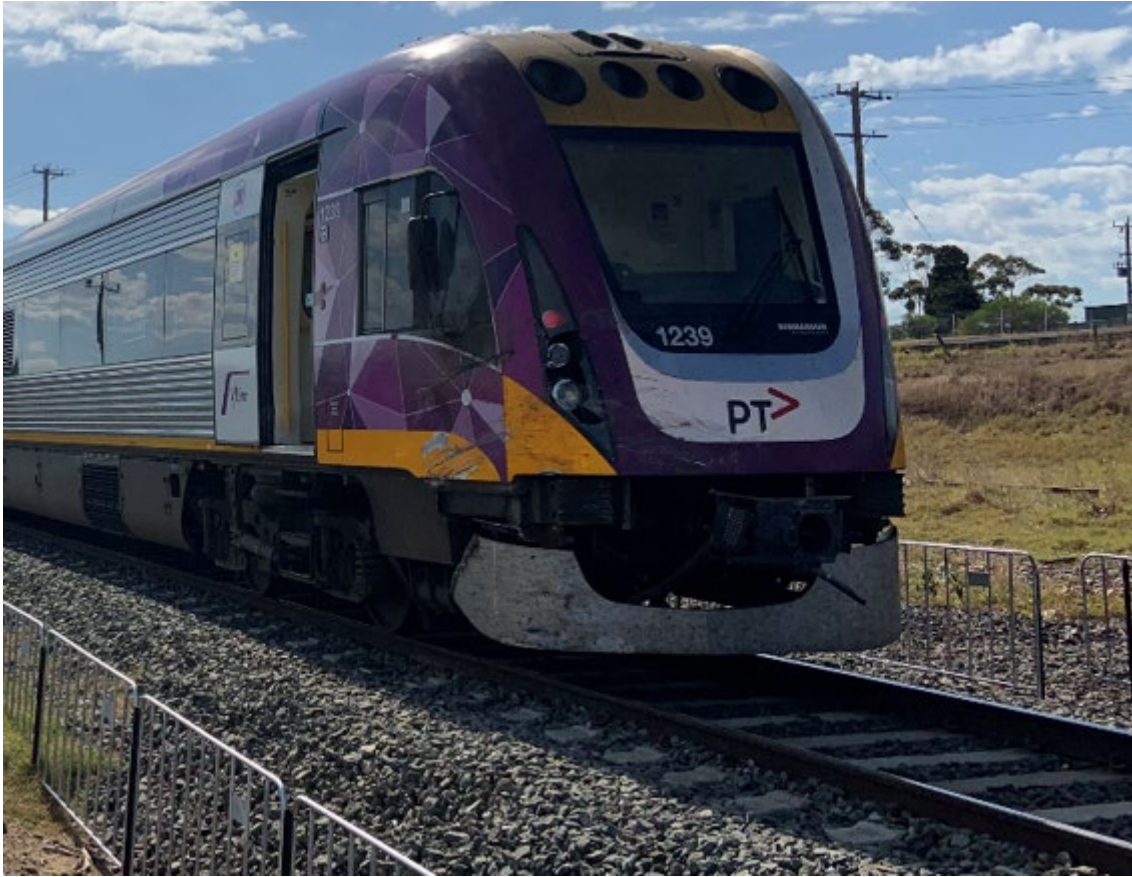
Figure 9: Damage to the front of train 7727

The train driver was qualified, assessed as competent and medically fit at the time of the collision. The train sustained minor damage to its front, did not derail and was able to be driven to the Waurin Ponds stabling yard.

The damage to the front of V/Line train 7727 following the incident.
Source: The Office of the Chief Investigator
