# Safeworking incident involving MTM trains 3148 and 7255

Ferntree Gully, Victoria, on 25 February 2024

## ATSB Transport Safety Report

RO-2024-001

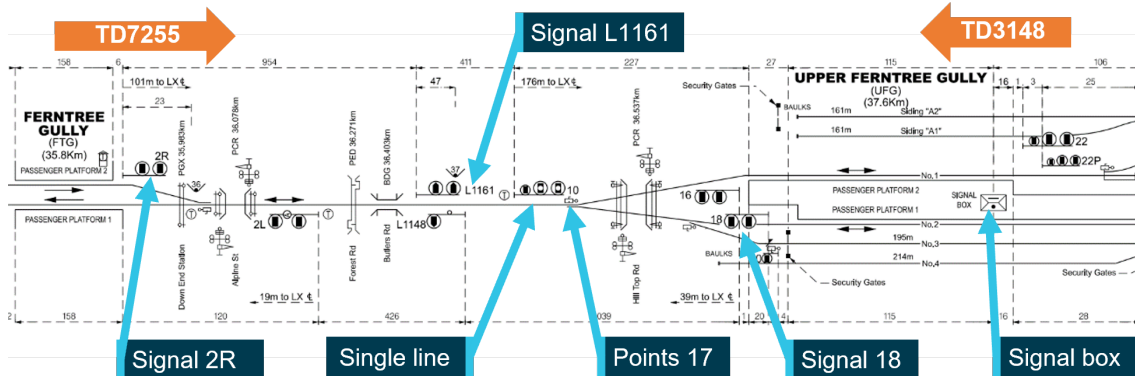
**Figure 2: Signalling arrangement between Bayswater and UFG**

Train 7255 passed through Boronia station at about 0942 and then through FTG station and departure home signal<sup>1</sup> 2R at about 0945 (Figure 2). Signal 2R displayed a medium speed warning which indicated that the line ahead was clear, but that the next signal was at stop. Medium speed at this location was 40 km/h.

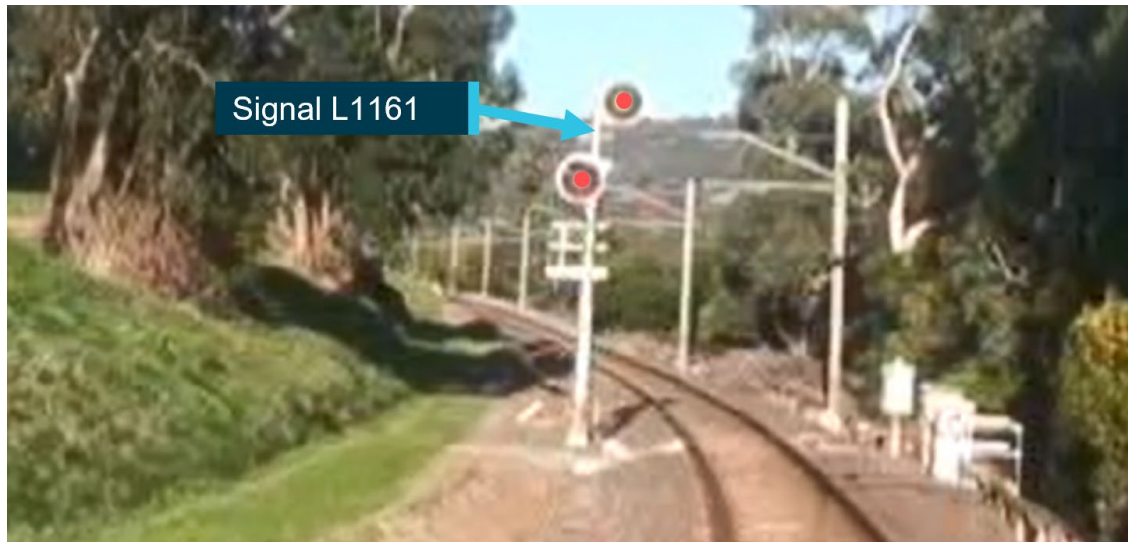
**Figure 3: Signal L1161 on the approach from FTG, annotated to show at stop**

Train 7255 then entered the single line section between FTG and UFG. At about 0947 the train stopped on the single line at signal L1161 which displayed a stop indication (Figure 3). Under network rules and procedures, the signal could have been passed and the train continue under caution. However, the driver advised that they decided to wait because they were aware that train 3109 was ahead and had probably not yet exited UFG.

Signal L1161 has been annotated to show the signal aspect when at stop.

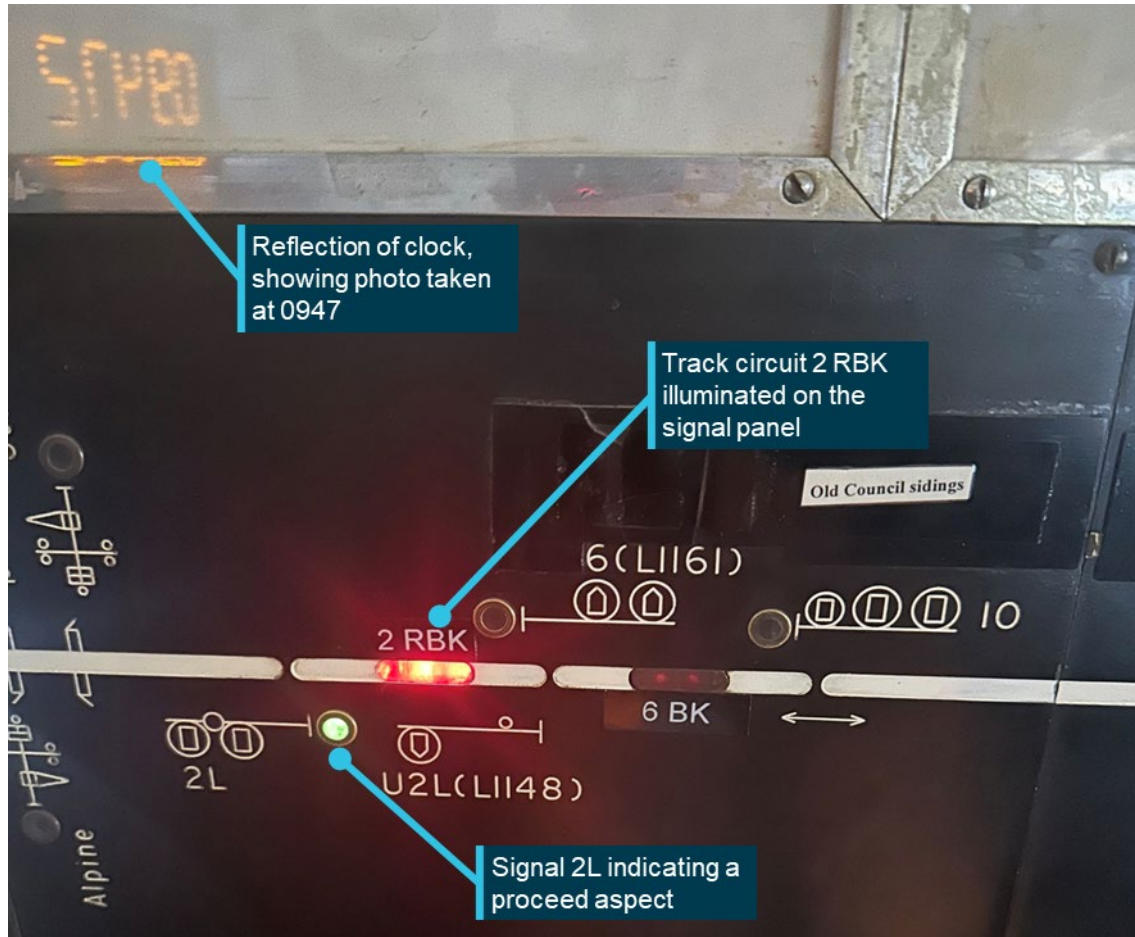
**Figure 4: Photograph of signal panel taken by station officer at 0947**

At around the same time, the station officer<sup>2</sup> at UFG returned to the signal panel after preparing a meal in the nearby office kitchen and observed the red illumination at track circuit 2RBK (Figure 4).

*Note 1: The distance between signals L1161 and 2L was approximately 830 track-m. Train 7255 was about 72 m long and therefore able to stand at signal L1161 without encroaching on the track circuit in advance of signal 2L. Hence, 2L was able to show a proceed aspect.*  
*Note 2: The signal panel was not capable of displaying an indication for signal 6 (L1161) when the trackside signal showed a stop aspect.*  
 Source: MTM, annotated by the OCl

Unaware that the red illumination was caused by the presence of train 7255 which was now stationary at signal L1161, the station officer, using switches on the panel, made an unsuccessful attempt to change the UFG departure signal (signal 18) to proceed in preparation for train 3148 (which was approaching from Upwey) to travel to FTG.

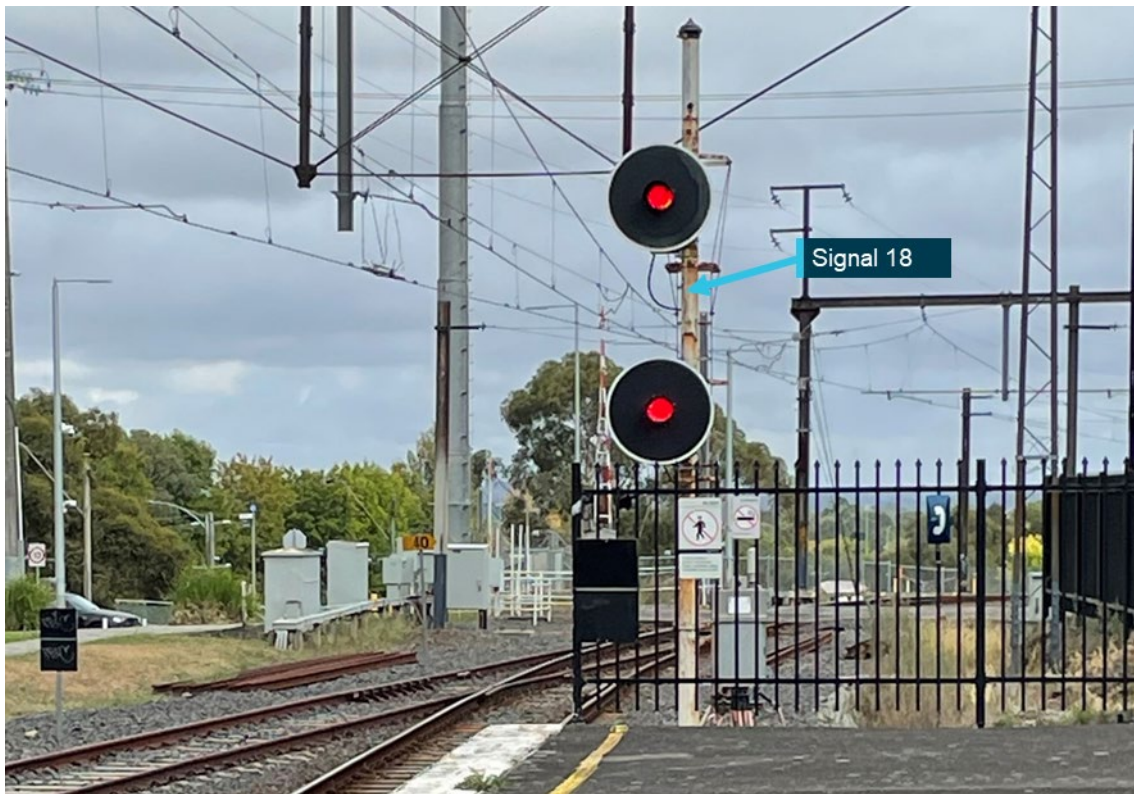
**Figure 5: Home departure signal 18 at UFG platform 2 shown at stop**

At 0950, train 3148 arrived into platform 1 at UFG. At 0951 train 3109 departed the station platform 2 towards Belgrave.<sup>3</sup> Train 3148 was then to depart UFG towards FTG but was held at platform 1 by departure signal 18 which continued to display a stop indication (Figure 5).

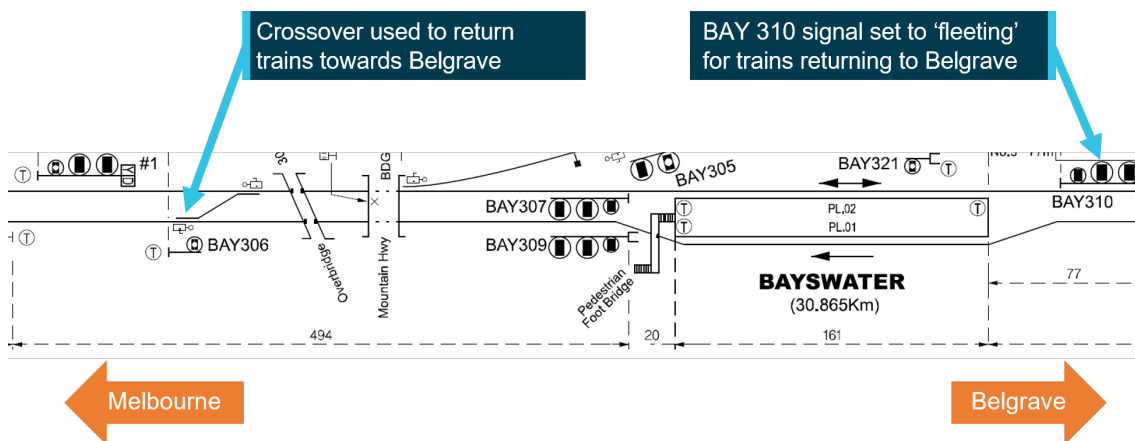
**Figure 7: Track and signalling layout at Bayswater**

The platform 2 departure signal BAY310 was set to 'fleeting mode'. This feature allowed the signal to provide a proceed indication as soon as the track ahead was clear of rail traffic. This also meant that trains could be provided a proceed indication in advance of their timetabled departure times. On the day of the incident, signal BAY310 displayed a proceed aspect when train 7255 approached the signal. This allowed the driver to pass the signal without stopping at platform 2 at Bayswater station and in advance of its scheduled departure time and proceed towards FTG.

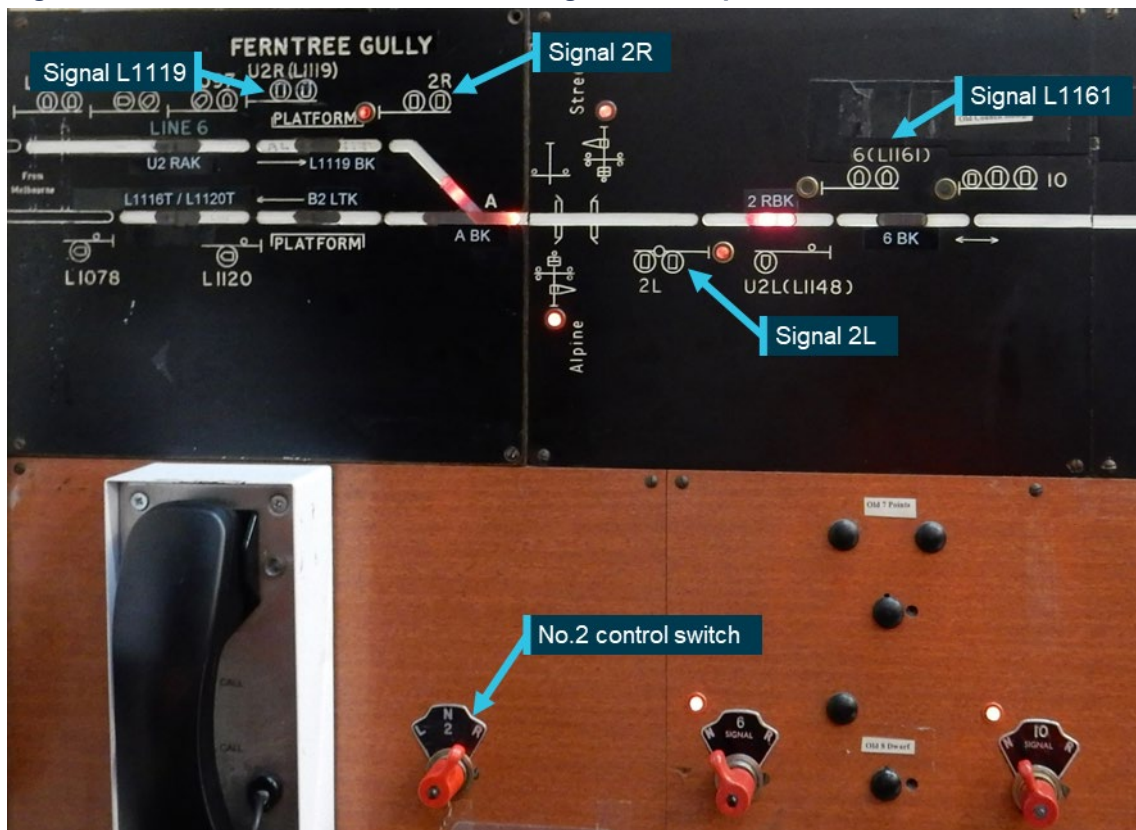
**Figure 9: No. 2 control switch on the UFG signal control panel**

Signal 2R could be set to fleeting for train movements towards Belgrave by setting the control switch on the signalling panel to the 'R' position. The switch was in this position and set for fleeting when train 7255 approached platform 2 at FTG. Once train 3109 had cleared the single line section and arrived at the platform at UFG station, signal 2R provided a proceed indication which allowed train 7255 to enter the section at about 0945.

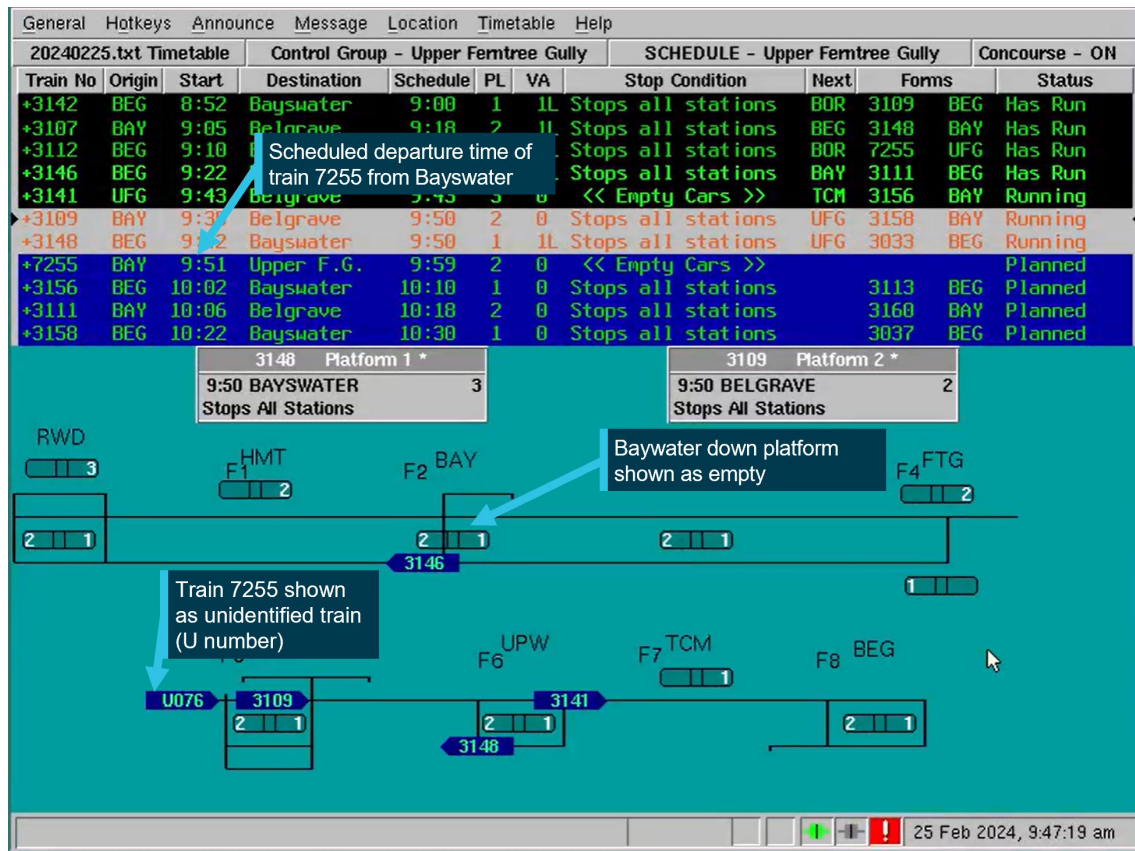
**Figure 11: Screenshot of a recording of the PRIDE system at 0947, 25 February**

Because the TLP could not identify train 7255 when it left Bayswater to travel to UFG, the train was allocated a 'U' number (U076) within the PRIDE system. The train was shown located in the single line section between FTG and UFG (Figure 11). The PRIDE system also displayed scheduled departures for trains leaving Bayswater. At 0947 it indicated that train 7255 was scheduled to depart at 0951.
