Level crossing collision between a track machine consist and a road vehicle

Nicholson Street, Dalby, Queensland, on 18 February 2025

ATSB Transport Safety Investigation Discontinuation Notice

RO-2025-001

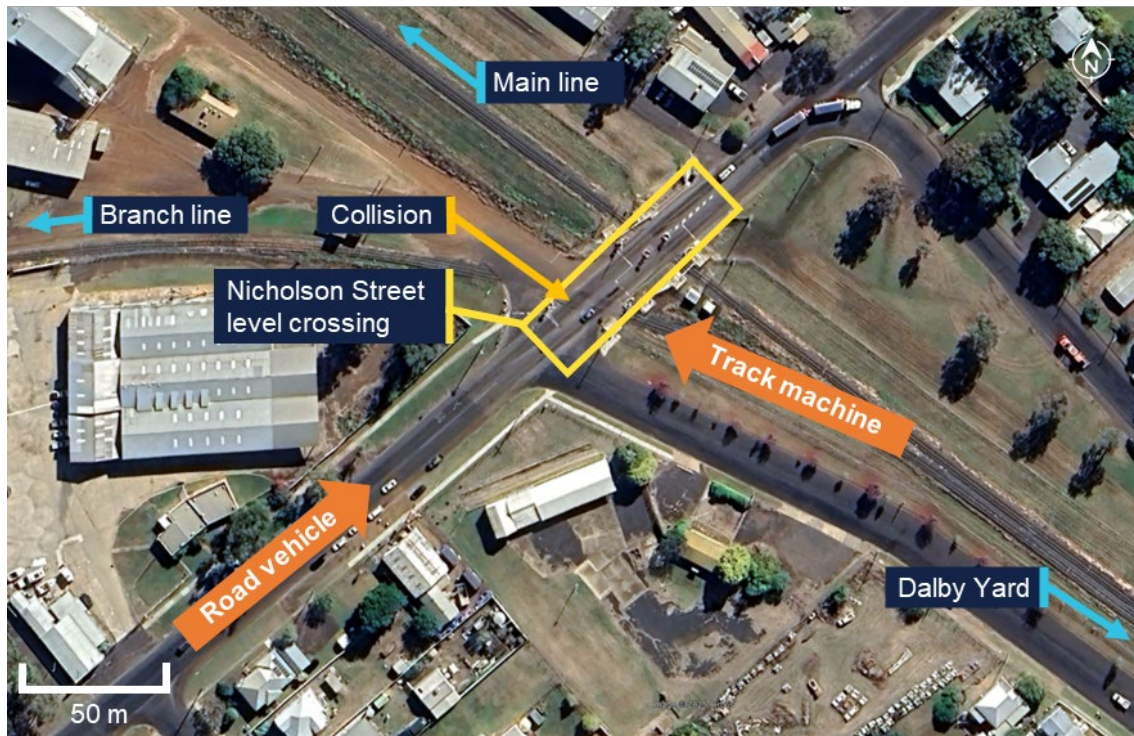
Figure 1: Layout of the Nicholson Street level crossing

The track machine consist then travelled north-west through a dual-track active level crossing with Cunningham Street, and a single-track active level crossing with the Bunya Highway. A third active level crossing with Nicholson Street was located around 450 m further along the line. The Nicholson Street level crossing had a different layout to nearby level crossings, as it consisted of dual single-track active level crossings 30 m apart in the same crossing square (Figure 1).

The split level crossings at Nicholson Street were a consequence of the track layout. A branch line to Glenmorgan deviated from the mainline around halfway between the Bunya Highway and Nicholson Street level crossings, and both tracks then crossed Nicholson Street separately.

The mainline crossing on Nicholson Street had flashing warning lights and half-boom barriers as active protection, whereas the branch line crossing only had flashing warning lights and did not have booms.

As a result, only one of the 2 level crossings would activate with the presence of a train, and the other crossing would remain open for road traffic.
