Collision with terrain involving Cessna U206G, VH-JVR

124 km west of Norseman, Western Australia, on 3 March 2022

Aviation Occurrence Investigation (Systemic)

AO-2022-011

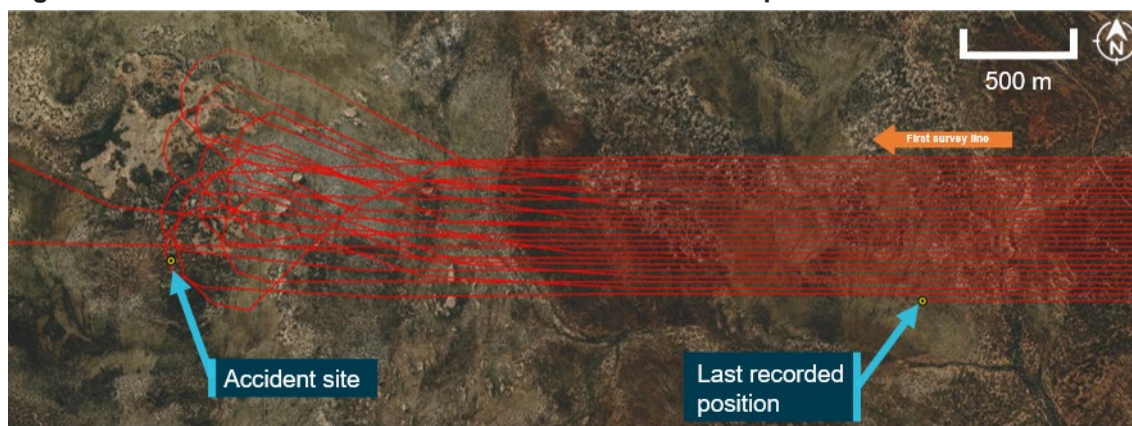
Figure 2: VH-JVR's accident site location and last recorded position

The JRCC initiated a search and rescue operation at 1739. The aircraft wreckage was located at 1852, approximately 3.2 km west of its last recorded position (Figure 2). The search aircraft's crew were unable to establish communications with the pilot of VH-JVR. The JRCC also deployed a rescue helicopter to the site, and at 0042, they found the pilot, fatally injured a short distance from the wreckage.

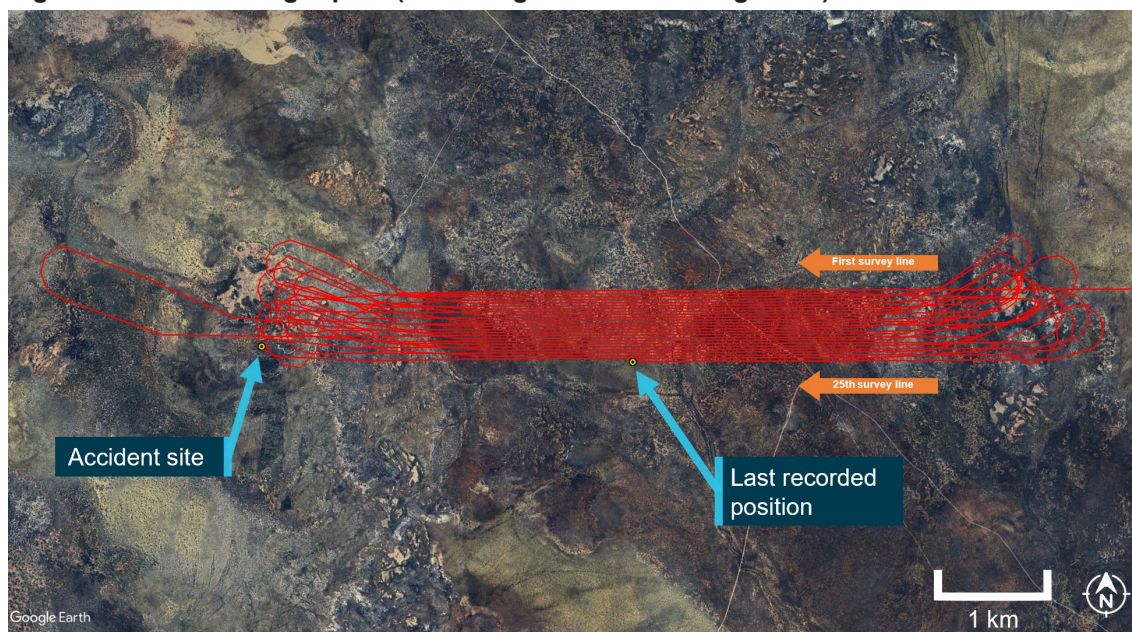
Figure 3: Recorded flight path (excluding transit from Kalgoorlie)

The recovered data showed that the pilot had conducted procedure turns (refer to section titled *Survey pattern*) at the end of each of the completed 24 survey lines, over a period of about 50 minutes. Although all turns were observed to be conducted in a similar manner, one particular turn commenced at a greater distance away from the survey area. During interview, the CP suggested that the pilot may have done so in order to have a drink or attend to a flight-related task. The ATSB noted no evidence to suggest any concern with this particular turn. The aircraft was on the 25th survey line when the data stopped, and the accident site was in the vicinity of the expected 25th procedure turn (Figure 3).

The recorded data showed the survey lines were being conducted in an east-west orientation, with left turns conducted to the west and right turns to the east. The average survey line speed was 114 kt at an average height of about 78 ft above ground level (AGL).

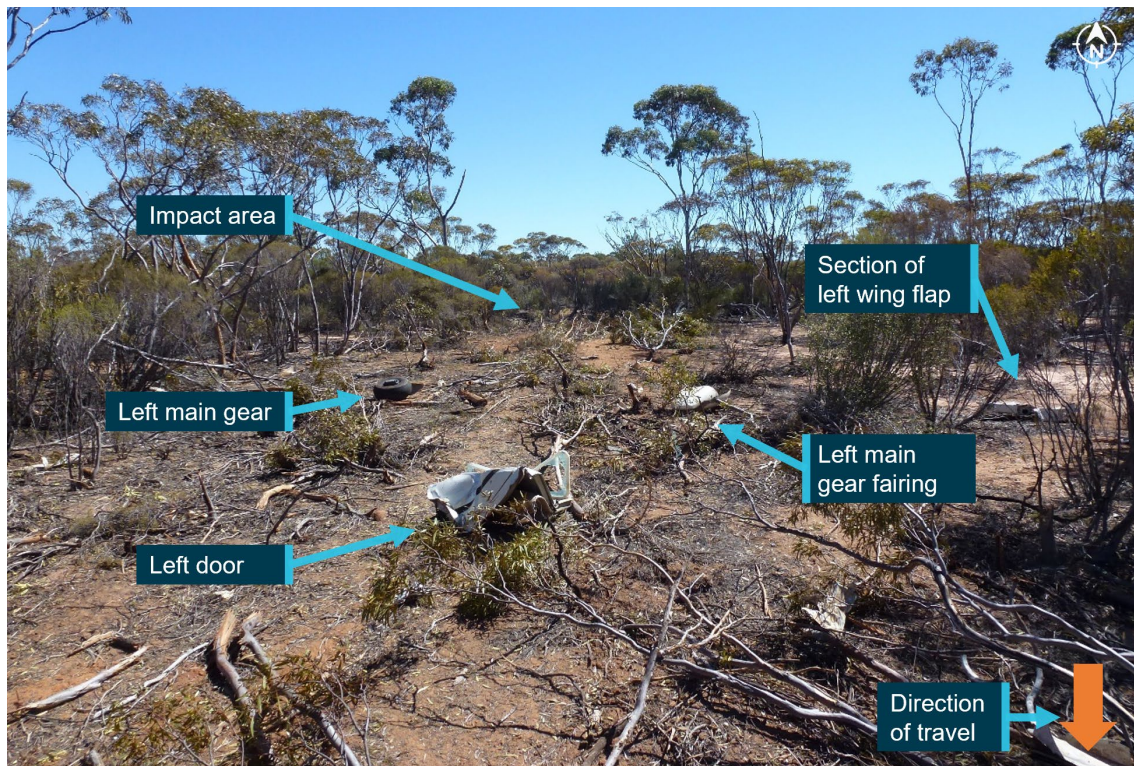
Figure 4: Wreckage trail looking north towards the impact area

The wreckage trail consisted of a number of felled trees and aircraft components, including the nose gear assembly, left main gear and fairing, left door, section of the left wing flap, windscreen and sections of the lower engine cowl and lower engine components. There was no indication of fire in the wreckage trail or detached aircraft components (Figure 4).

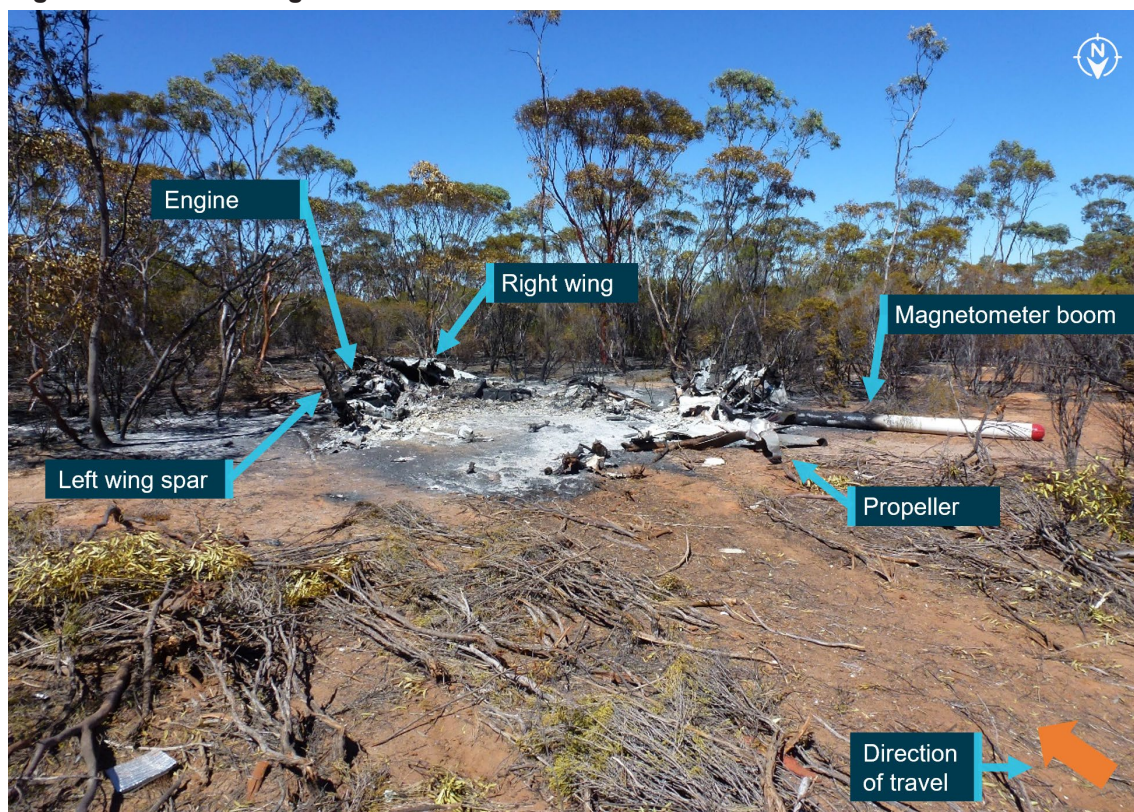
Figure 5: Main wreckage

The propeller had separated from the engine and was located towards the rear of the wreckage and the engine was upside down and detached from its mounts. Although the left wing was significantly affected by fire, the wing spar was still distinguishable. The right wing was relatively intact as was the magnetometer boom, albeit damaged by fire (Figure 5).

Although post-impact fire damage precluded examination of a significant proportion of the aircraft, inspection of the site and wreckage found:

- no evidence of any pre-existing structural, mechanical or flight control defects that would have prevented normal operation
- the wing flaps were in the fully up (retracted) position
- a small, yet intense fire zone indicative of a significant amount of fuel, with ignition occurring from the left-wing integral fuel tank rupturing during the accident sequence
- the fuel selector was in the 'BOTH' orientation
- damage to the propeller indicated that the engine was producing power at the time of the impact.
