# **Collision with terrain involving Cessna U206G, VH-JVR**

124 km west of Norseman, Western Australia, on 3 March 2022

## **ATSB Transport Safety Report**

AO-2022-011

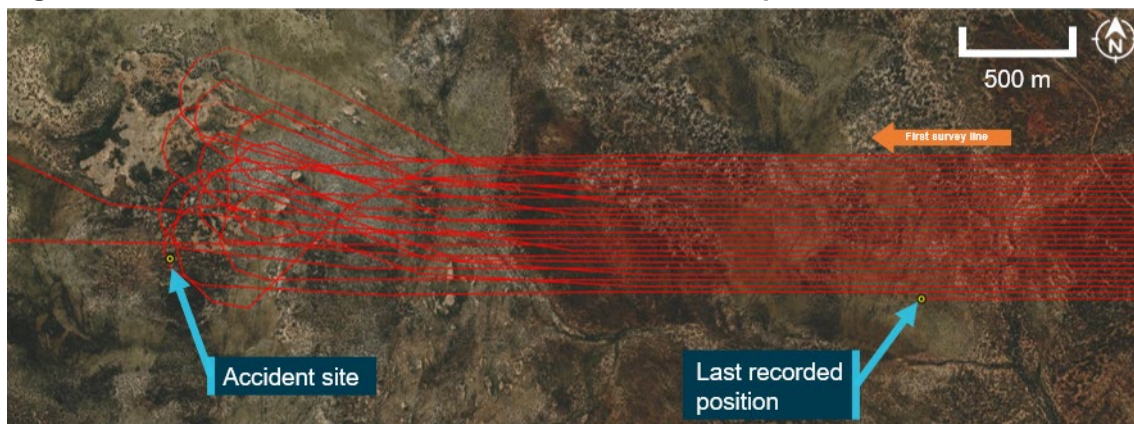
**Figure 2: VH-JVR's accident site location and last recorded position**

The JRCC initiated a search and rescue operation at 1739. The aircraft wreckage was located at 1852, approximately 3.2 km west of its last recorded position (Figure 2). The search aircraft's crew were unable to establish communications with the pilot of VH-JVR. The JRCC also deployed a rescue helicopter to the site, and at 0042, they found the pilot, fatally injured a short distance from the wreckage.
