# In-flight fire and cabin smoke involving Saab 340A, VH-KDK

114 km east-north-east of Cobar, New South Wales, on 23 April 2023

## **ATSB Transport Safety Report**

AO-2023-020

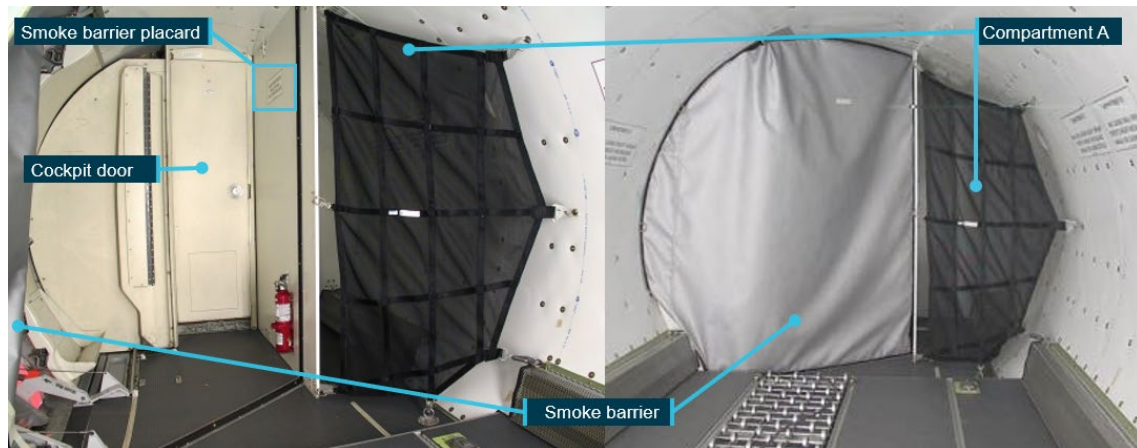
**Figure 3: Smoke barrier curtain location in exemplar aircraft**

During interview, the flight crew stated that they were not aware of the use of the smoke barrier, and that it had been located after the incident in compartment A of the cargo area, and that it was not in place on the left of the cabin. The ATSB did not determine why the engineers who loaded the engine into VH-KDK had not secured the smoke curtain.

Saab has revised their preparatory and walk-around pre-flight checklists to include the fitting of the smoke barrier curtain when carrying cargo in the cargo-configured aircraft.

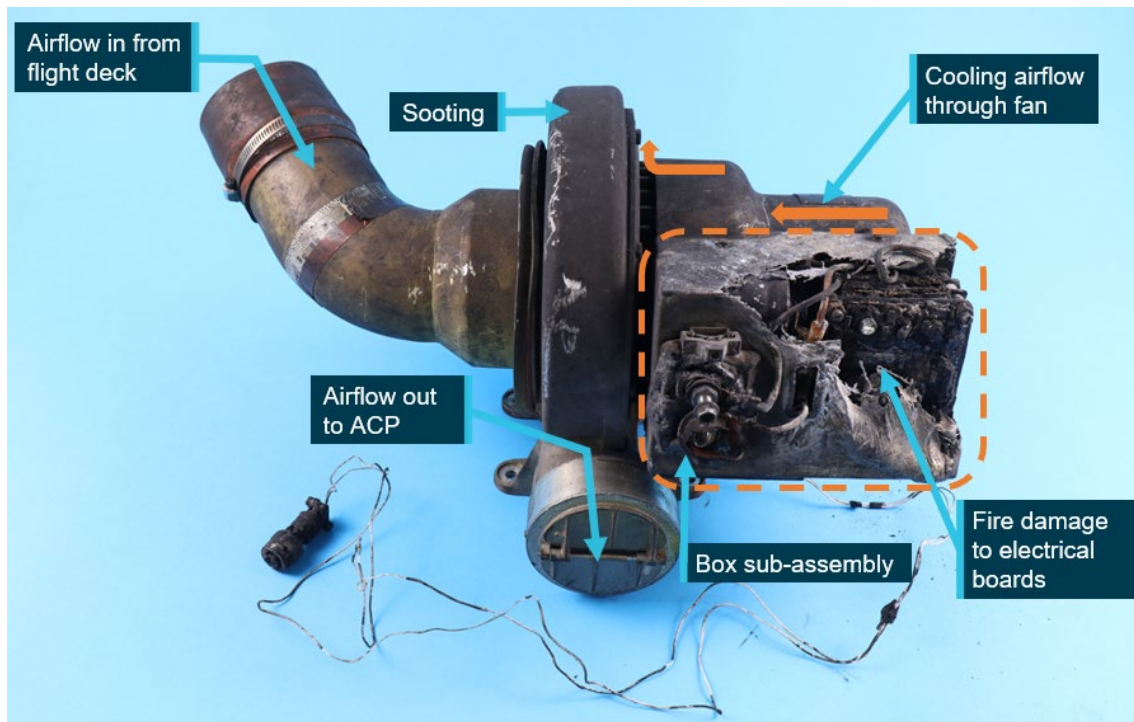
**Figure 5: Damaged recirculating fan**

Fire damage was found in the area around the right recirculating fan and on the fan itself (Figure 5). There were no other components in the vicinity of the fan with significant fire damage. As such, it is likely the right recirculating fan was the source of the fire.

An examination of the recirculating fan was conducted at the ATSB's technical facilities in Canberra. The examination found that the fire damage was most significant at the external box sub-assembly which housed the EMI filter, the resistor support plates and electronic card sub-assembly. The aluminium cover of the box sub-assembly had melted, the electrical wiring was damaged, and some terminals had disconnected as a result of the fire damage. There was heavy soot and melting of solder in the cooler assembly.

The electronic card sub-assembly was made up 3 circuit boards, mounted to the resistor support plate. The function of the circuit boards was for motor speed detection, timer control, and a logic card. The damage exhibited on the circuit boards showed significant burning, consistent with the other components within the aluminium cover.

The electromagnetic interference (EMI) filter sub-assembly had considerable damage to the filter itself and to the mounting plate with signs of melting and heat tinting of the steel plate structure, indicating a significant heat source. The heat tint was indicative of temperatures of approximately 310° to 330°C.

Of note, the fire did not appear to be associated with the motor and there was no indication of damage to the internal components of the fan and was able to rotate freely. There was carbon and soot observed on the external surface on the motor. The crew stated that there had been no circuit breakers tripped that would be associated with the failure of the electronic card sub-assembly.

The ATSB examination of the recirculating fan could not determine the cause of the failure of the electronic components attached to the assembly.

The source of the in-flight fire was traced to the right recirculating fan assembly. Although the fan was not damaged internally, the fire damage was most significant at the box sub-assembly, which was mounted external to the fan and housed the electrical control circuit boards. It is likely that an electrical component or components within the box sub-assembly failed, resulting in the underfloor fire. The fire damaged underfloor insulation and plastic air conditioning ducting components, which led to thick smoke filling the cabin and cockpit and aircraft structural damage.

Rex advised that it is implementing a fleet-wide inspection of the flight deck and passenger compartment recirculation fans at the next aircraft heavy maintenance visit. The inspection will be focused on the electronic sub-assembly module of the recirculation fan due to this component being identified to have the most significant fire damage on the fan assembly removed from VH-KDK.

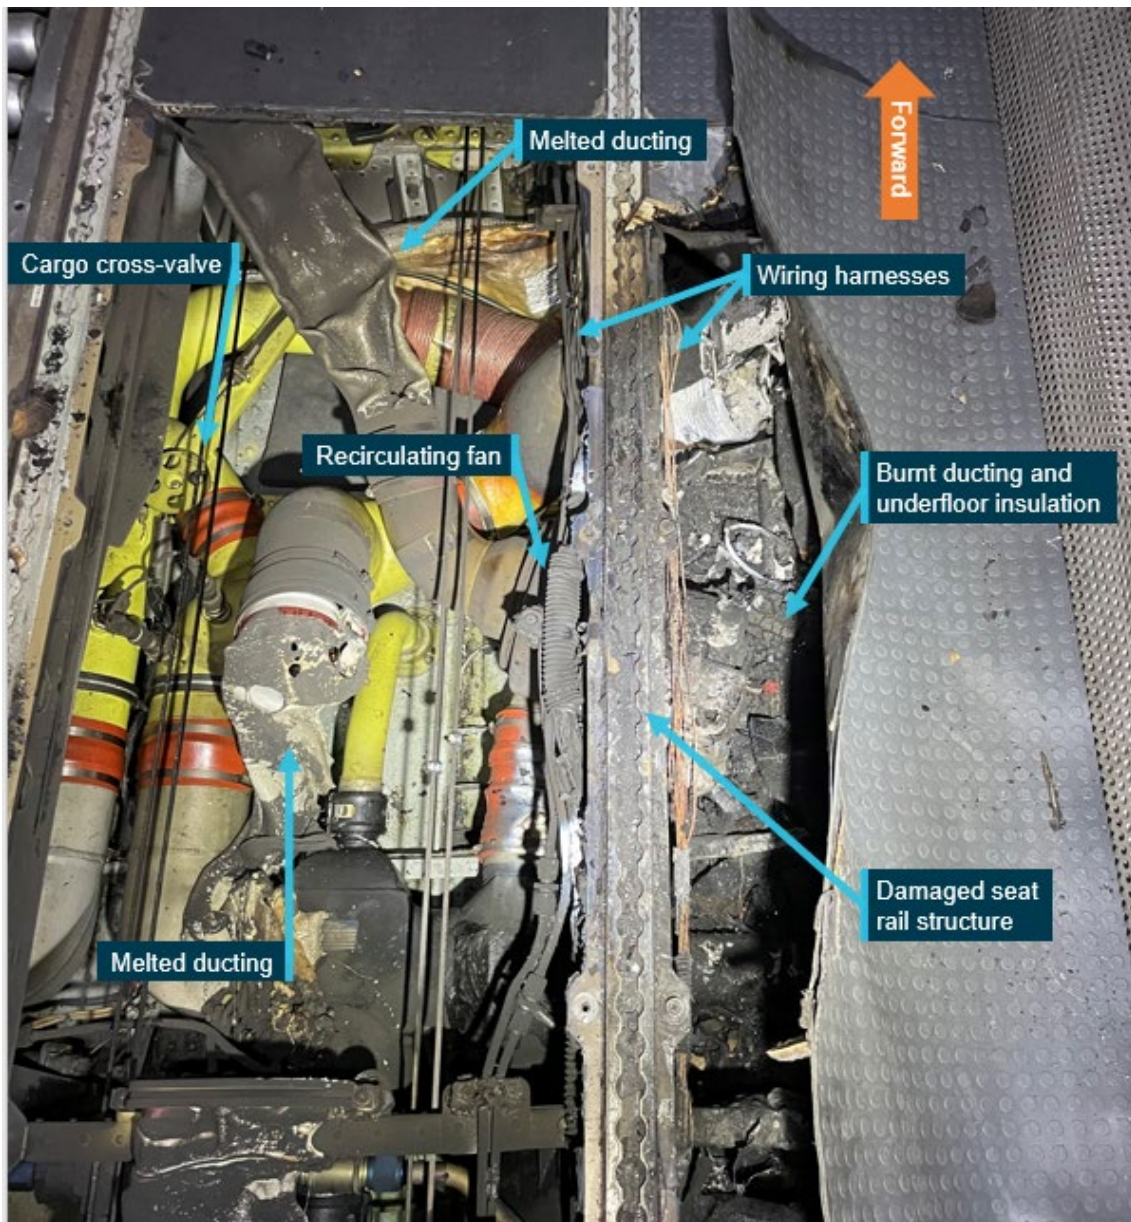
**Figure 8: Underfloor fire damage**

The damage caused by the underfloor fire was substantial. The fire had damaged underfloor air conditioning ducting and electrical wiring (Figure 8).

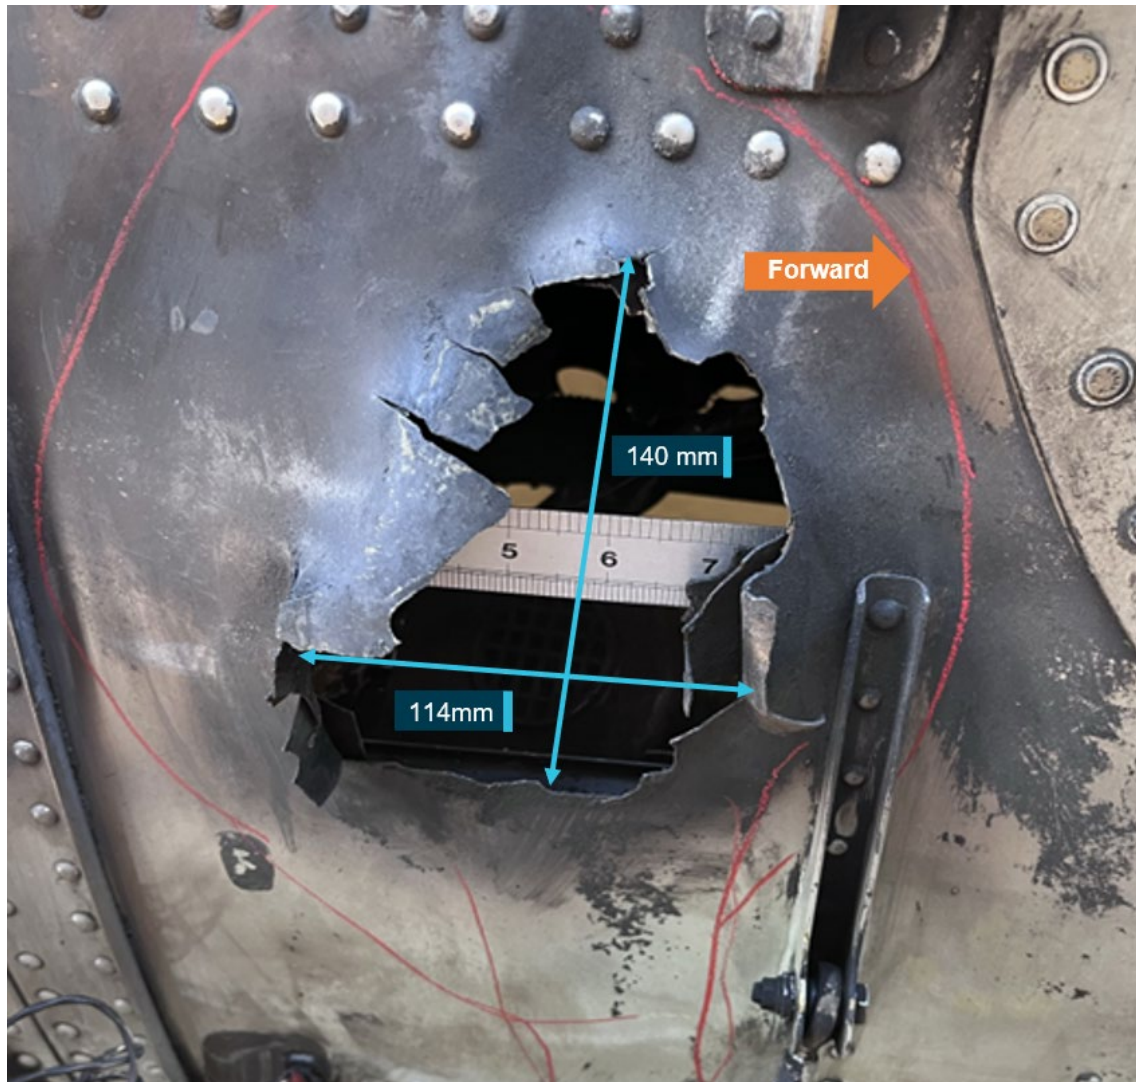
**Figure 9: Fuselage skin breach**

Structural components in the surrounding area had been distorted by the extreme heat, including the floor panels, which had collapsed when fire crews entered the aircraft and inadvertently walked over the affected area. The seat track support structure had distorted, and the fuselage

was weakened by the fire which breached the outer skin, preventing the aircraft from remaining pressurised (Figure 9).

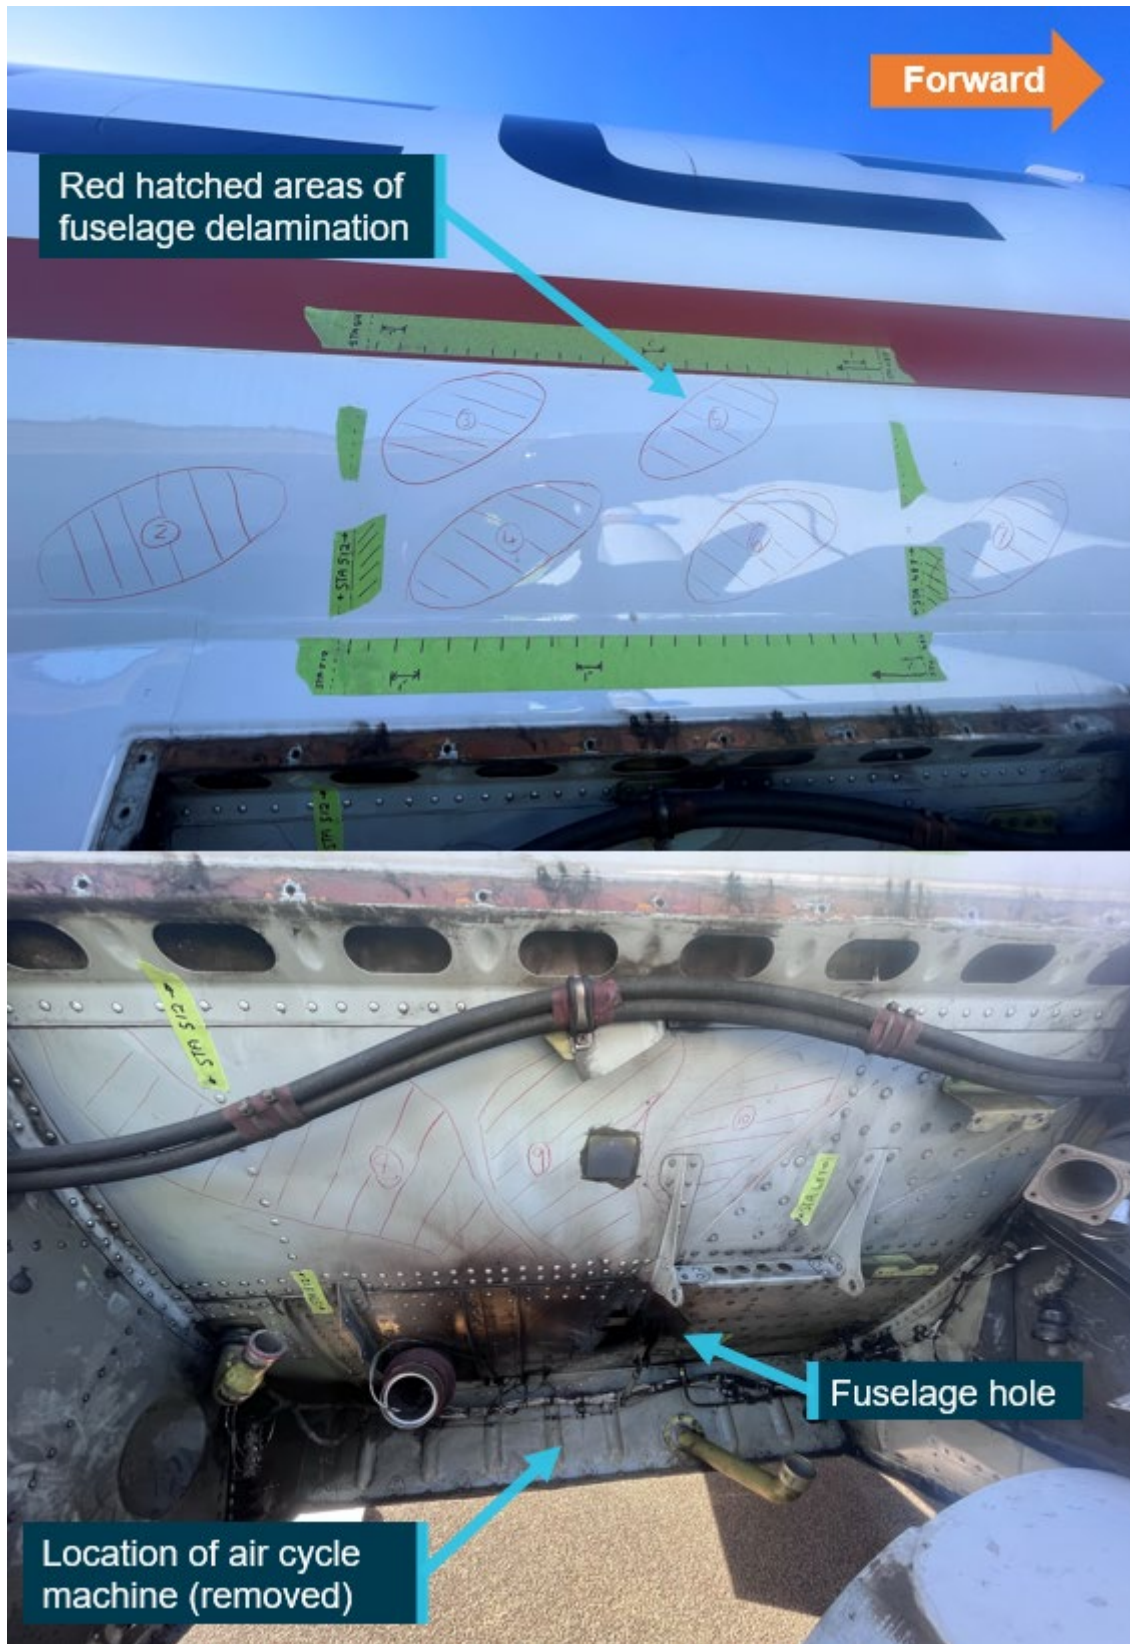
Figure 10: Right side delamination on fuselage

The fuselage in the immediate area above and below the cabin floor was buckled and delaminated. The heat from the fire most likely travelled between the interior panels and freight lining, leading to the damage observed (Figure 10). Following an engineering inspection of the fire damage, the aircraft was withdrawn from service and not repaired.
