Control issues and ditching involving RPA swarm of 500 Damoda Newton 2.2 RPA

Victoria Harbour, Docklands, Victoria on 14 July 2023

ATSB Transport Safety Report
Aviation Occurrence Investigation (Defined)
AO-2023-033
Final – 15 July 2025

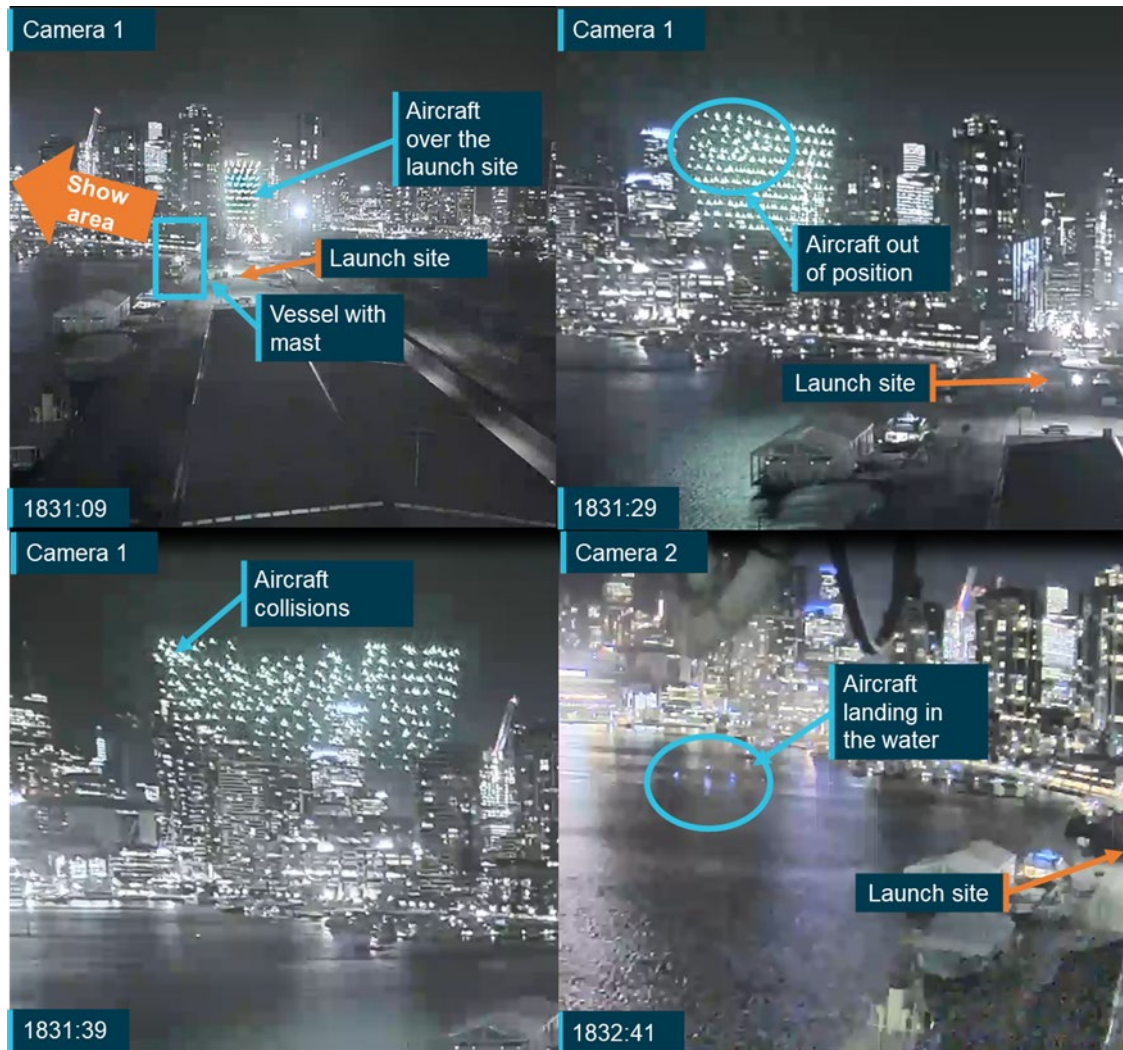
Figure 2: CCTV footage of show

At approximately the same time as the second loiter command was issued, multiple aircraft presented with critical errors indicating an autopilot failure. This was shortly followed at 1831:55 by the RPIC identifying that there was a 'fly-away'. Further errors of varying severity levels continued to present on the GCS. After confirming that the copilot had the fly-away aircraft under their control, the RPIC directed the copilot to disarm³ that aircraft.

Camera 1 captured the location of the boat mast that the RPIC had identified as presenting an obstacle to the swarm (Figure 2). Camera 4 captured multiple flags showing full extension at the time that the show was launching in the background. Noting that wind conditions varied with height, this camera was used to gain a general understanding of the conditions around the show site in the lead-up to, and at the time of, the show.

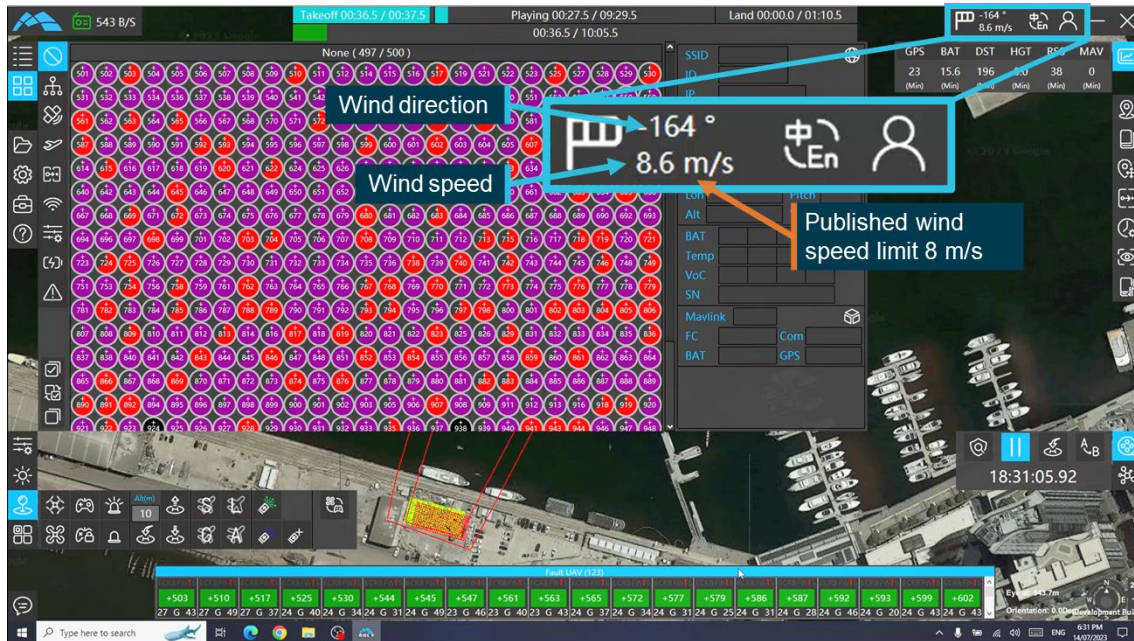
Figure 5: GCS software display with wind speed readout highlighted

When the wind speed limit was exceeded, there was no audible, visual or tactile alert presented to the pilot. As such, the flight crew needed to actively monitor the parameter to be aware of an exceedance of the wind speed limit. Figure 6 shows the wind speed indicator at 3 moments during the show with the wind speed below, just above and significantly exceeding the 8 m/s published wind speed limit of the aircraft.

The flight crew were both unaware that the ground control station had a wind speed monitoring function. The remote pilot in command did not use it to monitor the wind conditions after take-off. As a result, they did not identify that the wind exceeded the aircrafts' limits and continued with the transition to the show area.

The manufacturer advised that updating the ground control station software to include an active alert for wind speed exceedances was technically possible and that this feature was being considered for future software releases. The ATSB issued a safety recommendation to the manufacturer that such alerting be implemented.

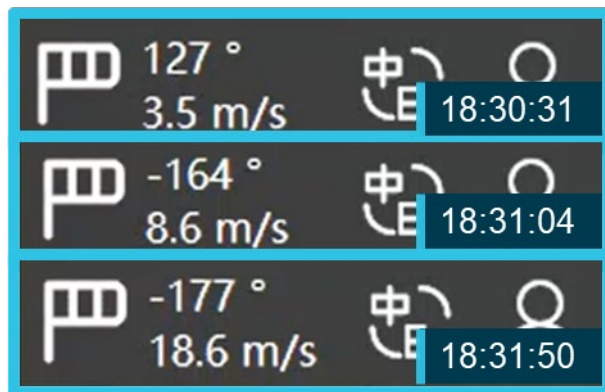
Figure 6: Wind speed display below, just above and significantly exceeding the wind speed limit

The flight crew advised that at the time of the show they were not aware that this functionality was available to them. The RPIC reported that they only became aware of it when they were reviewing the incident with another one of the operator's pilots who identified the indicator to them. The RPIC stated that if they had identified this information at the time of the show then they would have likely terminated the show when the wind speed limit was reached.

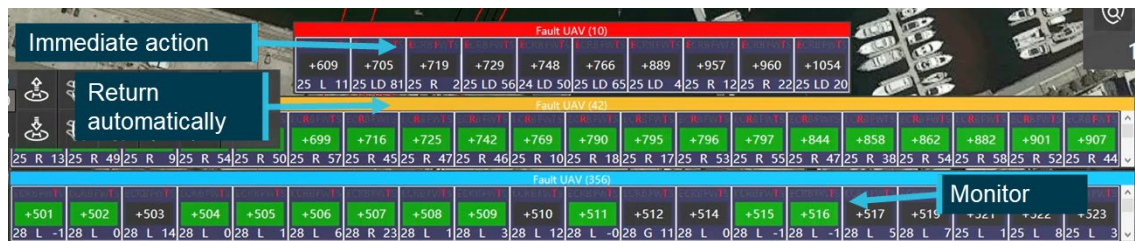
Figure 8: GCS recording showing the 3 error categories as they appeared on the night of the show

Where an aircraft showed errors from multiple different categories the aircraft was placed in the highest category of urgency encountered. Figure 8 shows all 3 of the categories appearing on the GCS for this occurrence, shortly after the aircraft transitioned towards the show area.

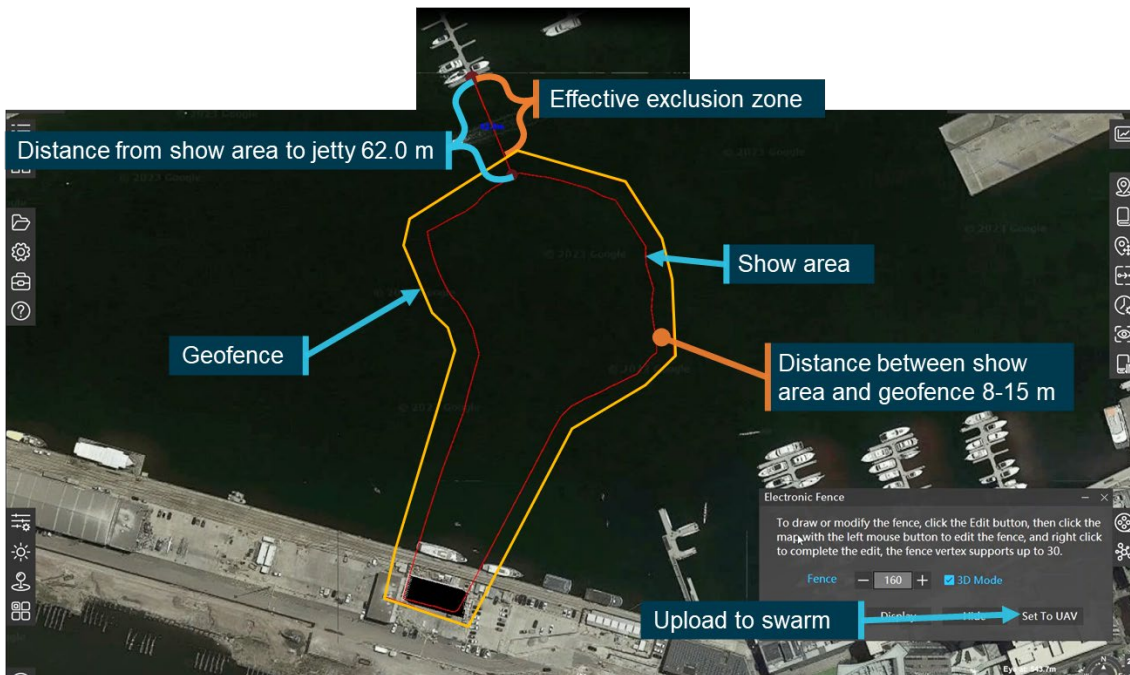
Figure 14: Exclusion zone positioning

Prior to setting the geofence, the pilot measured the distance between the edge of the show area and a publicly-accessible jetty on the opposite side of the harbour to be 62 m. The RPIC then set the geofence around the show area manually using a buffer of 8–15 m, resulting in an effective exclusion zone between 47–54 m (Figure 14).

Based on the operator's exclusion zone calculation process, the ATSB assessed the size of zone required to contain aircraft operating at maximum show speed and subject to a tailwind of twice the approved limit of the aircraft (16 m/s) at a height of 126 m (the maximum planned height of the show). In that scenario, an exclusion zone of more than 100 m would have been required.

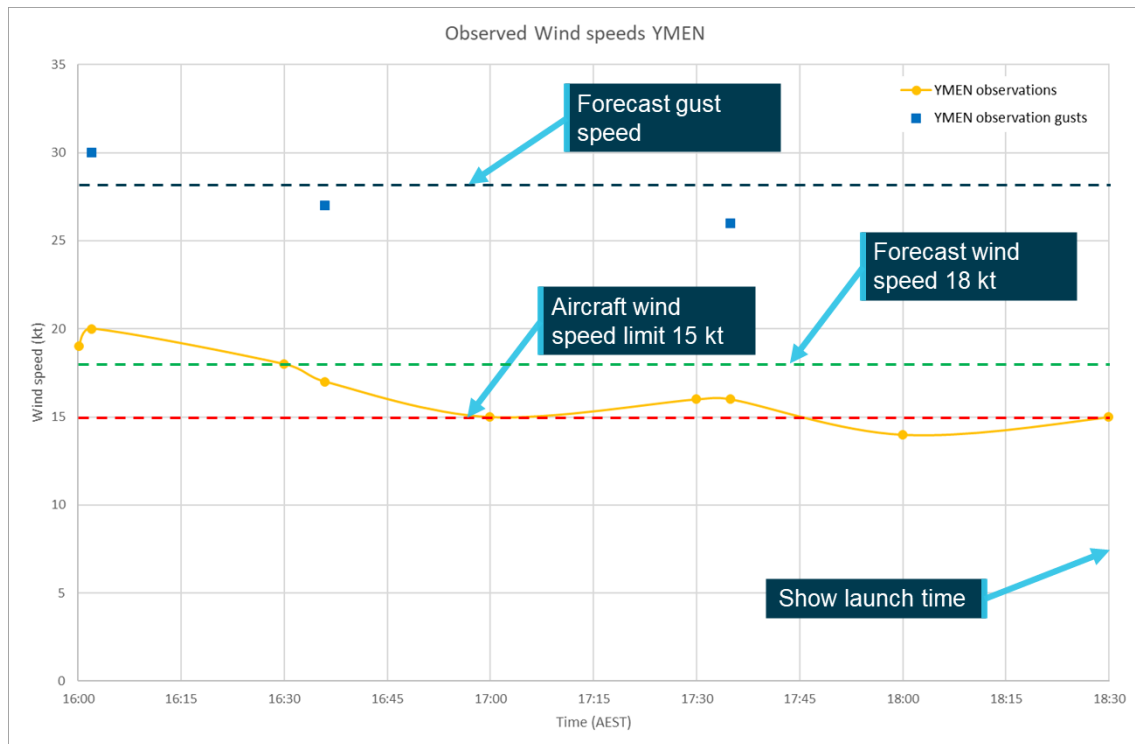
Figure 15: YMEN wind speed observations

conditions. The wind direction was consistently from the north and wind speeds varied around the aircrafts' limit, with gusts between 25–30 kt (Figure 15).

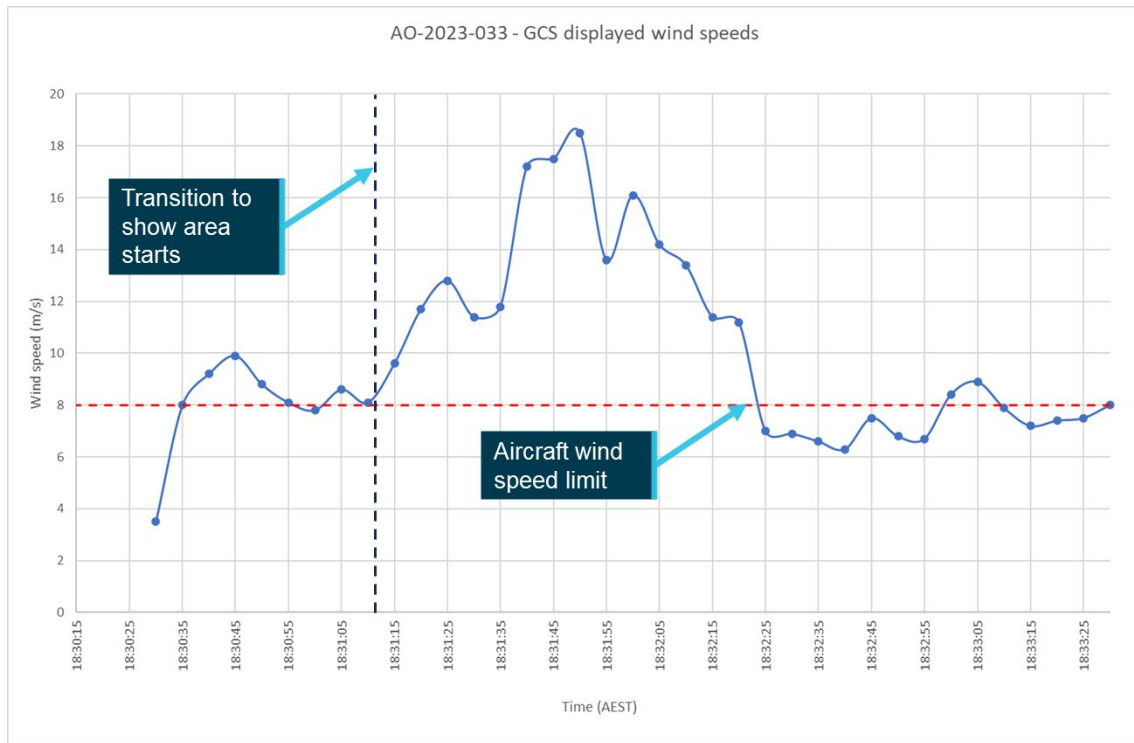
Figure 16: Wind speeds displayed on the GCS

Over the following 35 seconds the wind speed decreased and remained at or close to the limit until 1833:30, approximately 2 minutes after the show was launched. At the time the wind speed decreased most of the aircraft had activated their failsafe mode and were attempting to land in the water. Notwithstanding the potential effect of wind gusts, at these lower heights the wind speeds were likely closer to the speeds recorded on the ground before launch.

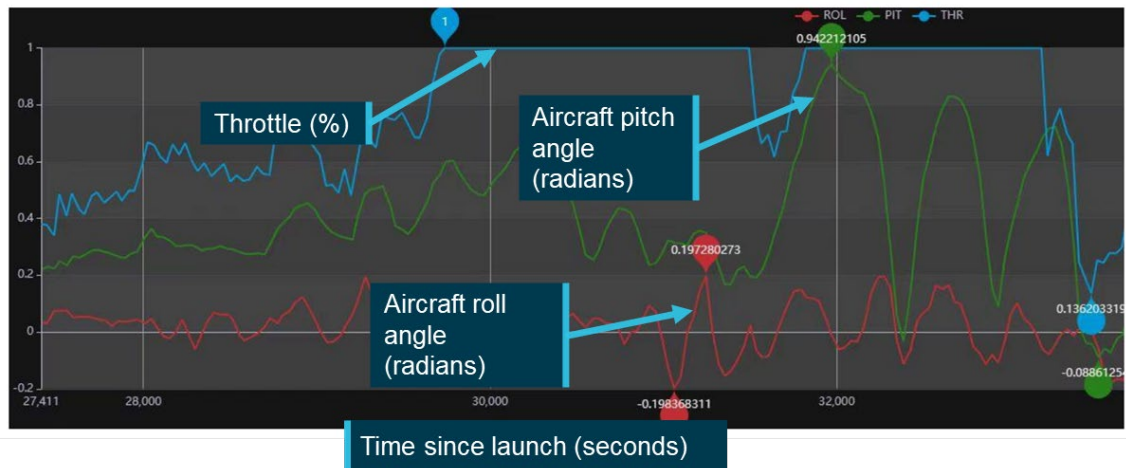
Figure 17: Aircraft pitch, roll and throttle parameters

The manufacturer concluded that the aircraft had encountered wind conditions exceeding their capability.

Specifically, while most of the aircraft were showing the commanded loiter mode, the manufacturer identified that:
