Incorrect configuration involving Embraer E190, VH-UYI

Near Honiara International Airport, Solomon Islands on 23 February 2024

ATSB Transport Safety Report

AO-2024-007

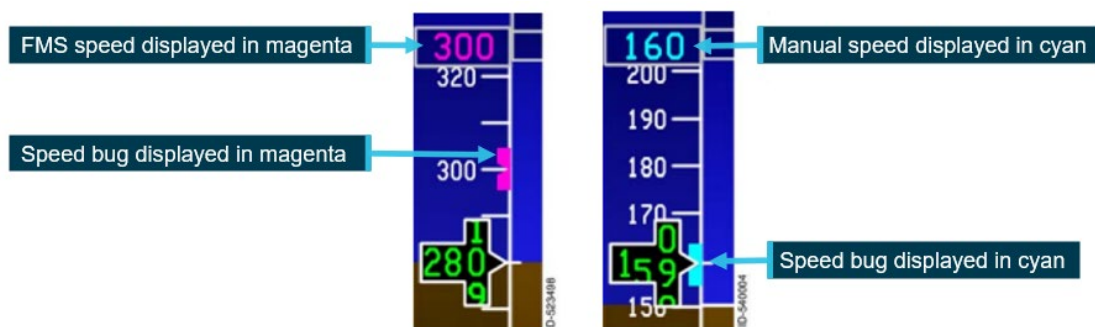
Figure 2: FMS and manual speed displays

In FMS mode, the airspeed selection was managed by the FMS. The airspeed was displayed on the PFD in magenta (Figure 2).

In manual mode, flight crew retained responsibility for airspeed control, by selecting the airspeed using the SPEED selector knob, which then displayed the selected airspeed on the PFD (Figure 2). This target speed was used by both the autothrottle and the autopilot. A manual selected airspeed was displayed on the PFD in cyan.

Example of speed tape showing the different speed modes. FMS mode on the left and manual mode on the right.
Source: Honeywell, annotated by the ATSB

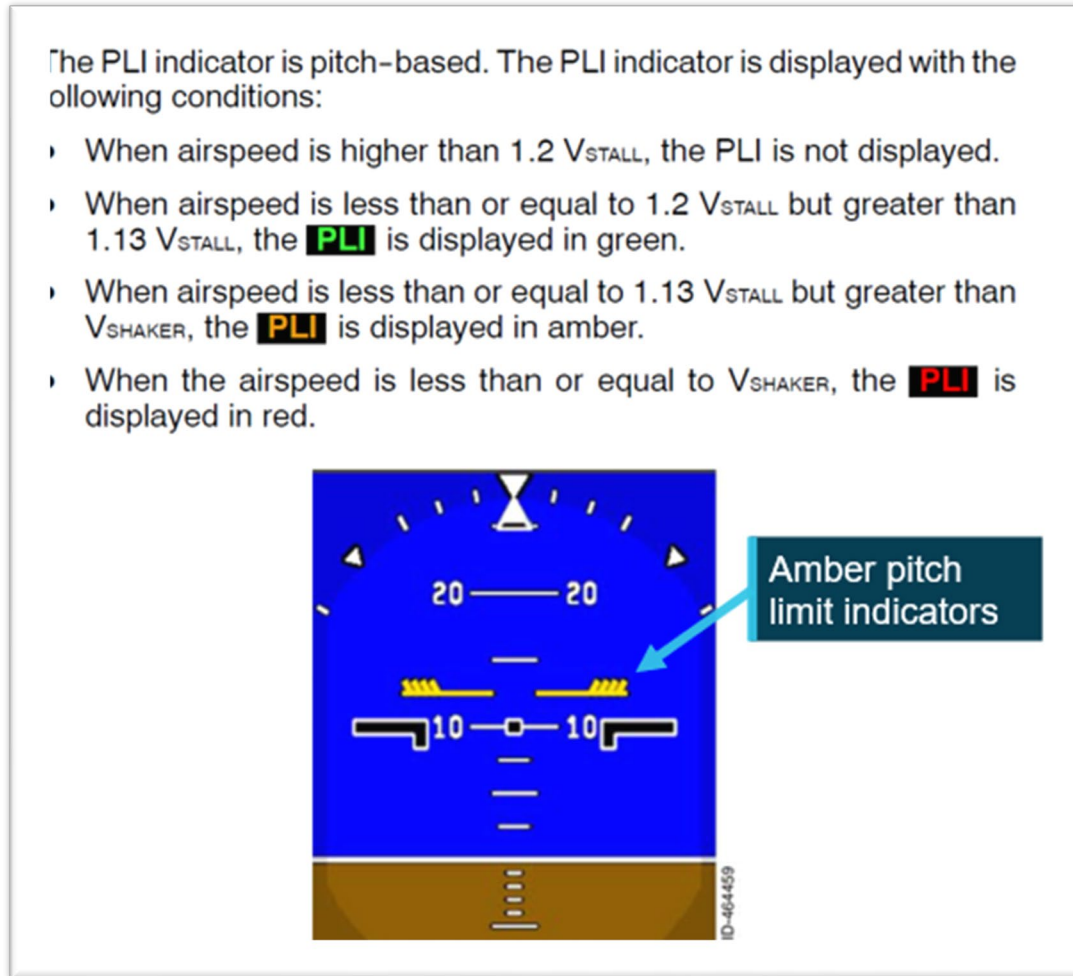
Figure 4: Pitch limit indicators

The aircraft's SWPS computed a pitch limit indicator (PLI). This was a 'pitch-based indication of the margin (in degrees) between the stick shaker speed and the current airspeed' (Figure 4). The PLI margin was calculated continuously and displayed on the PFD when the airspeed was less than 1.2 the stall speed.
