Turbulence event and cabin crew injury involving Boeing 737, VH-VYK

36 km south-east of Brisbane Airport, Queensland, on 4 May 2024

ATSB Transport Safety Report

AO-2024-032

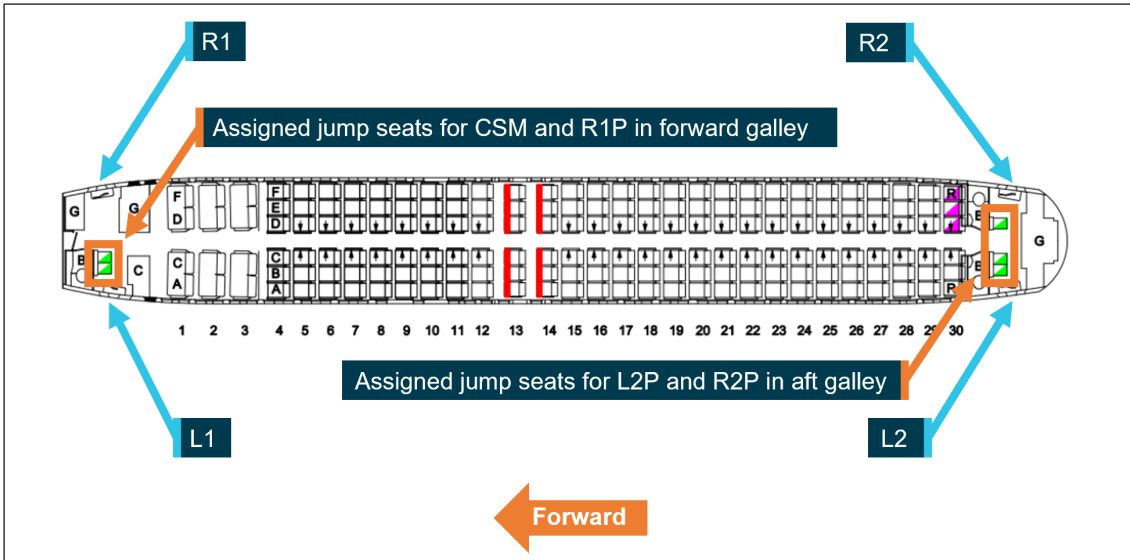
Figure 1: 737 Cabin layout, doors and assigned jump seats for cabin crew

The cabin crew on board was comprised of a complement of 4 members, with their assigned jump seats located in the forward and aft galleys. Each cabin crew member was responsible for one of the 4 main cabin doors (Table 1) during critical phases of flight, with their assigned jump seat (Figure 1) located immediately next to their assigned door. The cabin crew were under the supervision of the customer service manager (CSM) who was responsible to the captain for administration of in-cabin service and liaison with the crew for all service and safety related matters.

Cabin Door	Cabin crew assignment
Left one (L1)	Customer service manager (CSM)
Right one (R1)	Right one primary (R1P)
Left two (L2)	Left two primary (L2P)
Right two (R2)	Right two primary (R2P)

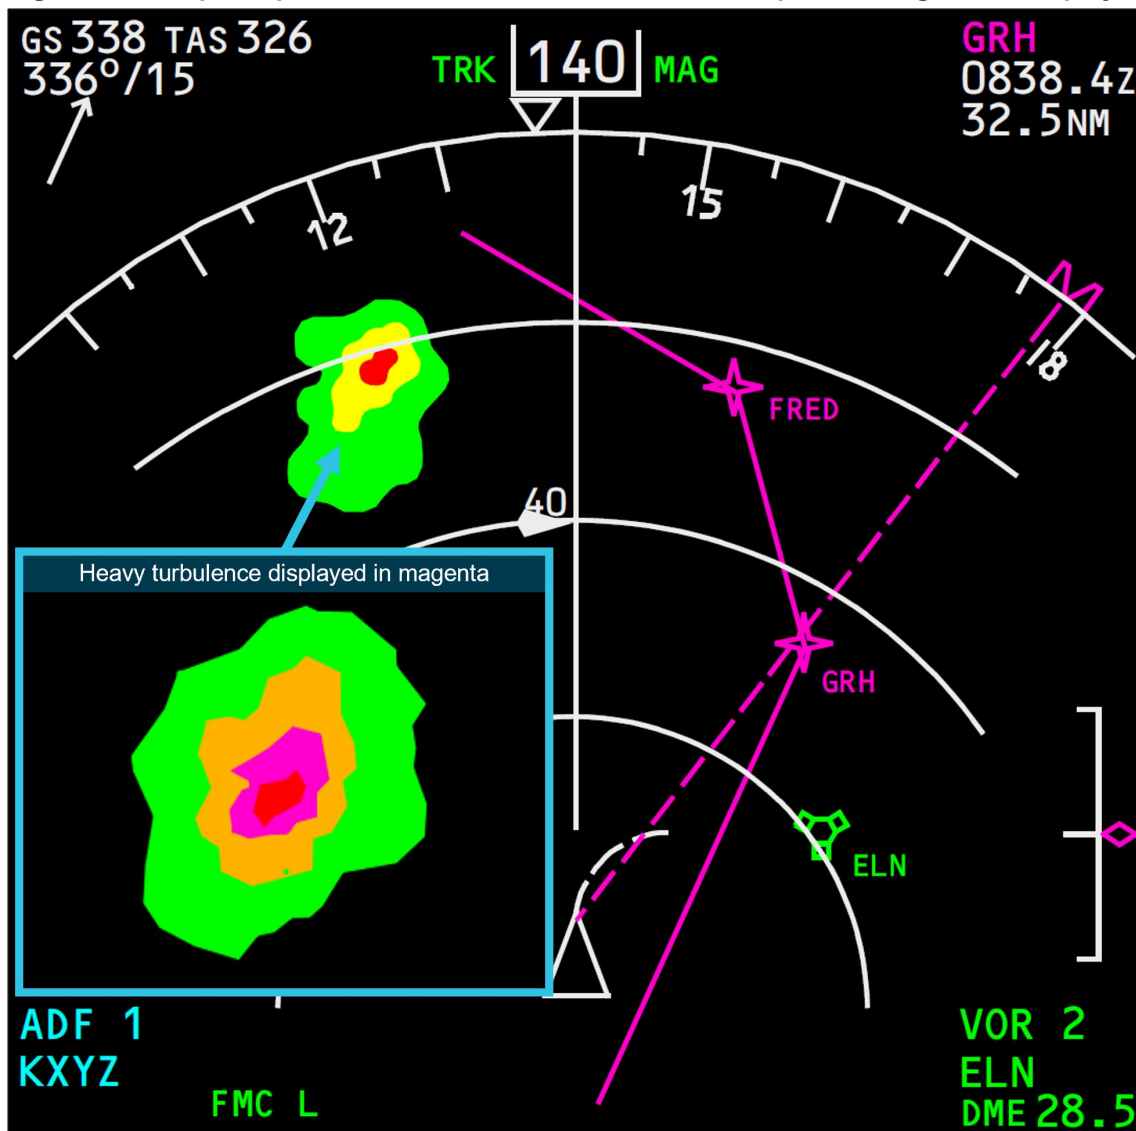
Figure 2: Example depiction of 737 weather radar returns on pilot's navigational display

The weather radar system fitted to the Boeing 737 detects and locates various types of precipitation bearing clouds along the flight path of the aircraft and gives the pilot a visual indication in colour of the cloud's intensity. The radar antenna sweeps a forward arc of 180°. The radar indicates a cloud's rainfall intensity by displaying colours contrasted against a black background. Areas of heaviest rainfall appear in red, the next level of rainfall in amber, and the least rainfall in green (Figure 2).

The turbulence mode displays normal precipitation and precipitation associated with turbulence. When the radar detects a horizontal flow of precipitation with velocities of 5 or more metres per second toward or away from the radar antenna, that target display becomes magenta. These magenta areas are likely associated with heavy turbulence.

The captain did not recall identifying areas of turbulence on the weather radar on descent or report that they were experiencing any difficulties operating the weather radar. Neither the captain nor the operator reported that the weather radar fitted to the aircraft was unserviceable during this occurrence.

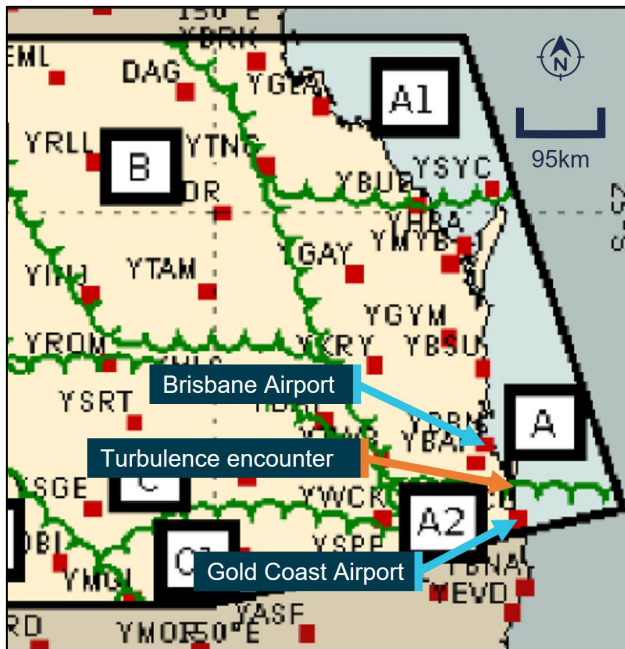
Figure 3: Graphical area forecast Queensland south

The flight transited through a region contained in the graphical area forecast for Queensland south, covering subdivisions A and A2 (Figure 3). Table 3 shows the

forecast conditions for the duration of the descent into Brisbane Airport which was issued at 0815 local time.

Area	Surface visibility and weather	Cloud	Turbulence
A	<ul style="list-style-type: none"> • Visibility greater than 10 km 	<ul style="list-style-type: none"> • Scattered⁶ cumulus/stratocumulus clouds between 2,500–8,000 ft AMSL • Scattered altocumulus/altostratus clouds from 8,000 ft to above 10,000 ft • Broken cumulus cloud between 2,000–9,000 ft 	<ul style="list-style-type: none"> • Moderate turbulence associated with stratocumulus and altocumulus clouds
A2	<ul style="list-style-type: none"> • Visibility 3 km in scattered showers of rain • Visibility 1 km in isolated thunderstorms with rain showers 	<ul style="list-style-type: none"> • Isolated towering cumulus cloud from 2,000 ft to above 10,000 ft • Broken stratus cloud between 800–2,000 ft • Broken cumulus cloud from 2,000 ft to above 10,000 ft 	<ul style="list-style-type: none"> • Moderate turbulence associated with cumulus cloud • Severe turbulence associated with thunderstorms, cumulonimbus and towering cumulus clouds

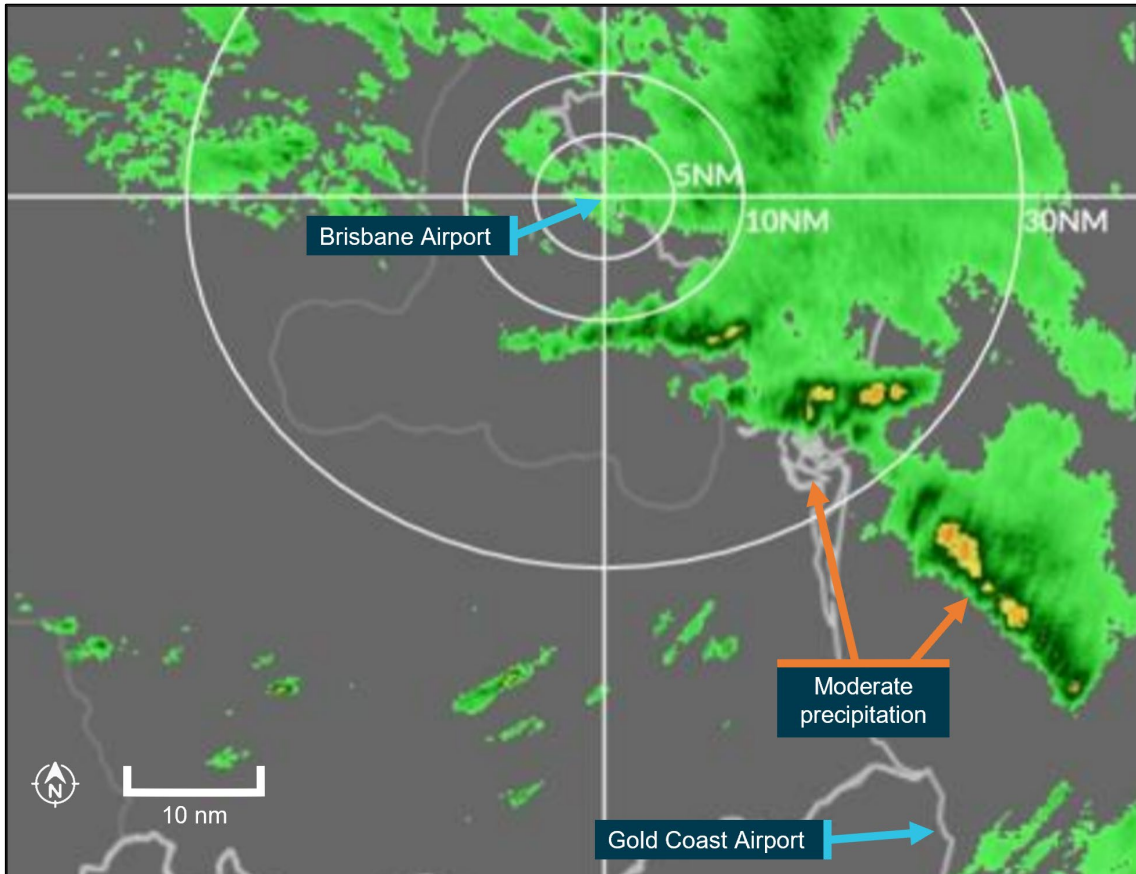
Figure 4: Brisbane Airport weather radar overlay on 4 May at 1200 local time (time of departure)

Prior to departure from Sydney, the flight crew conducted their pre-flight planning and reviewed the weather briefing package. The crew recalled that the weather briefing package contained forecast light showers and some cloud in the vicinity of Brisbane and that the forecast weather for departure at Sydney was worse.

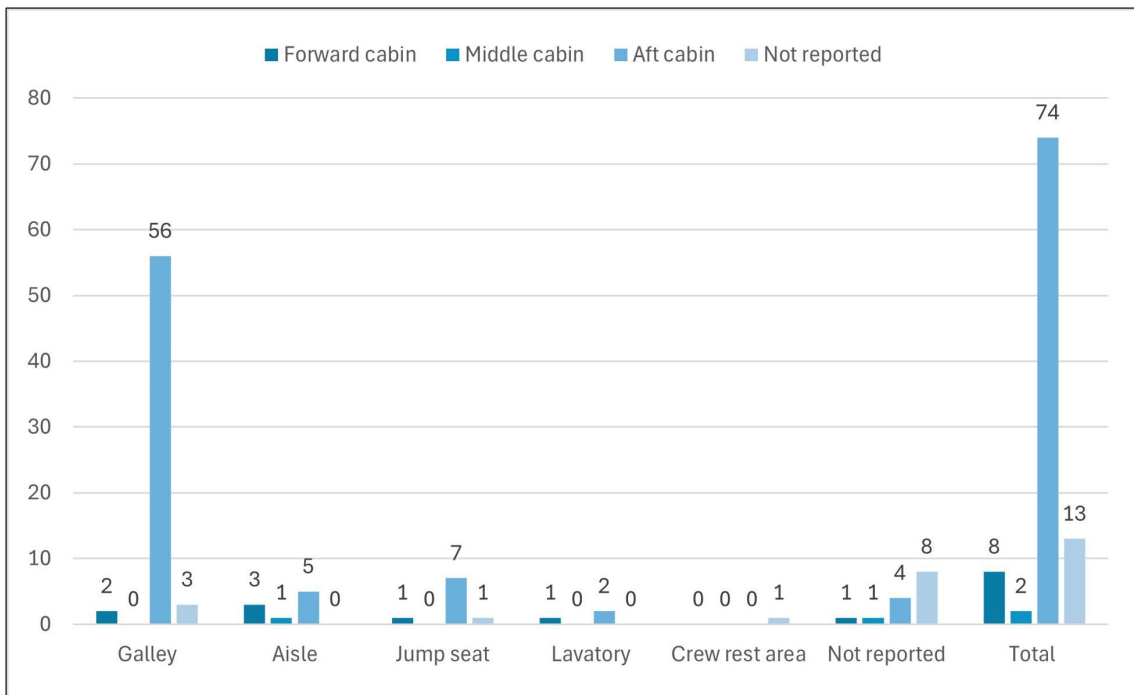
Figure 6: Location of cabin crew at time of turbulence-related serious injury, 2009–2018

The distribution of cabin crew injuries found most occurring in or near an aft galley (Figure 6), which likely reflects that the service-related duties of cabin crew often require

During this occurrence, the R2P and L2P sustained the most severe injuries while unrestrained in the aft galley as they prepared the cabin for landing, which is consistent with research on turbulence-related injuries.
