Flight below minimum sector altitude involving Cessna 310R, VH-ZMB

14 km west-north-west of Alice Springs Airport, Northern Territory, on 1 July 2024

ATSB Transport Safety Report

AO-2024-039

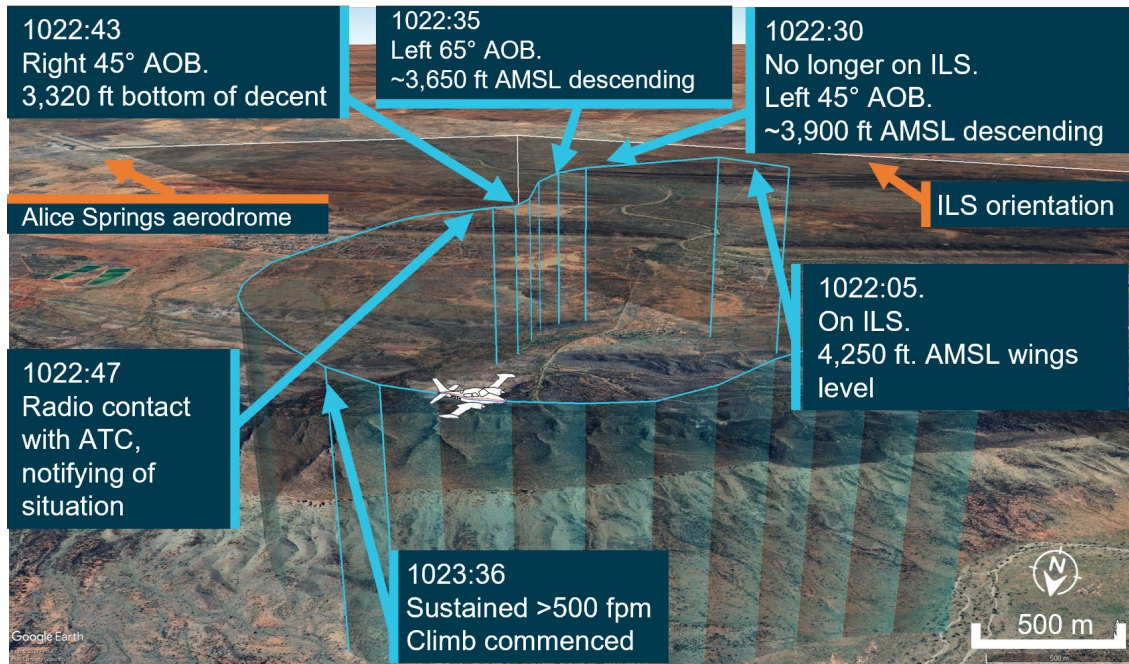
Figure 1: VH-ZMB flight path

At 1022:05, the aircraft was established at 4,250 ft above mean sea level (AMSL) on the approach into Alice Springs Airport on the published ILS approach profile. About 25 seconds later, the pilot recalled receiving erroneous instrument indications from the artificial horizon (AH). At 1022:30, flight data showed the aircraft departing the ILS to the left, and tracking at a perpendicular direction from the approach path with unusual aircraft bank angles (AOB) (Figure 1).

At 1022:30 the aircraft deviated significantly to the left of the approach path resulting in the aircraft no longer being established on the ILS approach. The aircraft was below the MSA at 3,900 ft and continued to descend to the lowest point of 3,320 ft.

- At about 8 NM from Alice Springs whilst established on the ILS approach in instrument meteorological conditions, the pilot likely experienced spatial disorientation that led to directional changes of up to 90° from the approach track as well as left and right angles of bank up to 65°, whilst continuing to descend.

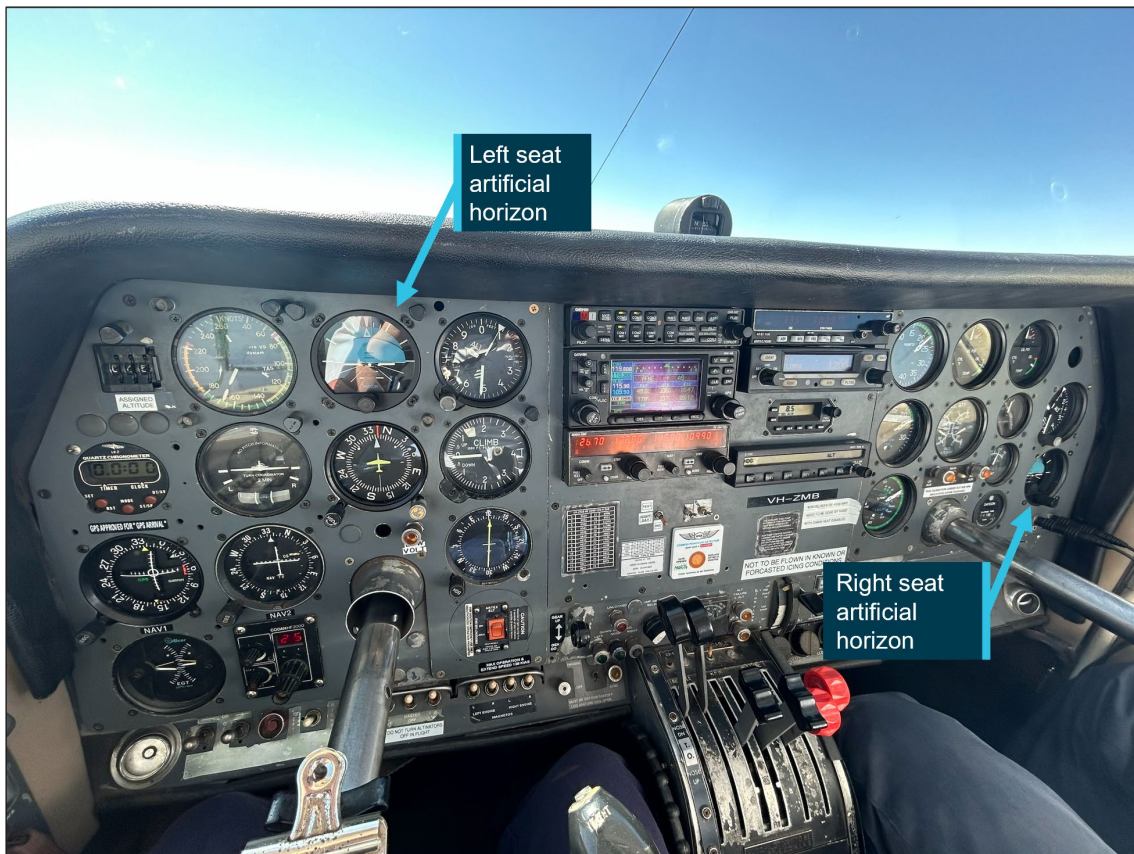
Figure 2: Photo of cockpit instruments from perspective of left (pilot) seat

The pilot reported that placement of the standby artificial horizon on the far right-hand side of the instrument panel (Figure 2) precludes the pilot from observing angles of bank (especially to the left). However, the pilot also reported utilising the standby AH as the primary means of spatial orientation, both during the occurrence and post-occurrence to fly the second approach and identified that recovery to a safe altitude was ultimately slowed by the significant workload of stabilising the aircraft on a limited instrument panel.

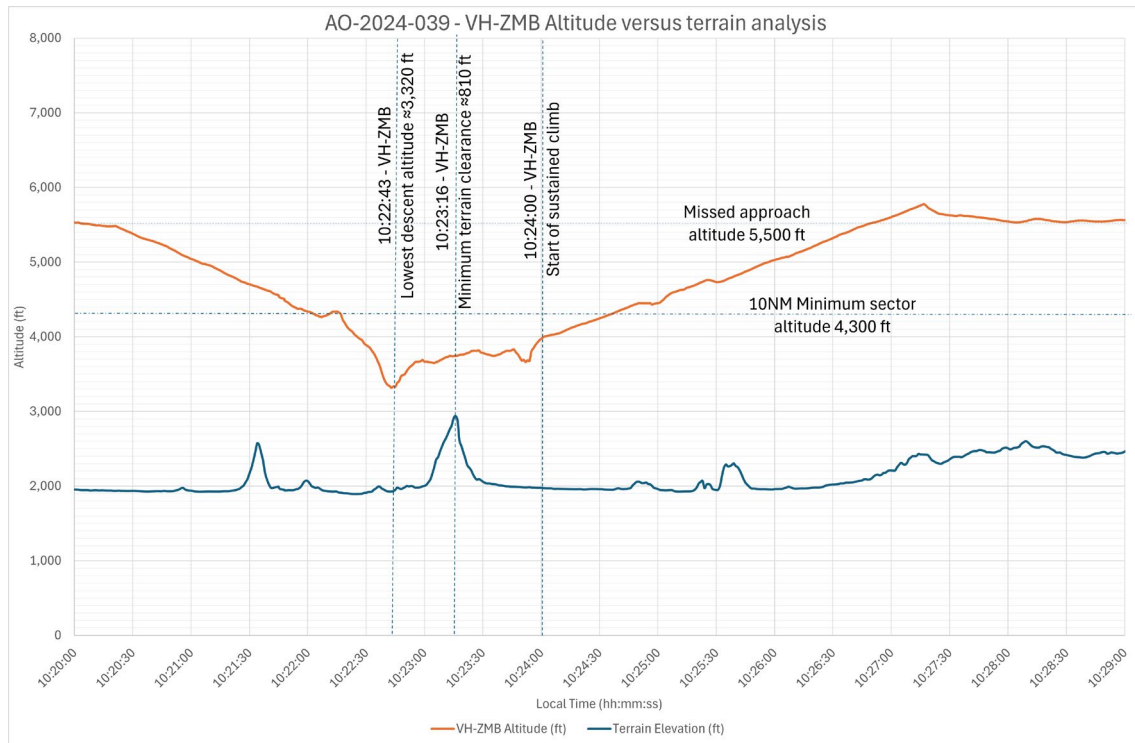
Figure 3: Aircraft vertical profile

About 35 seconds later the aircraft crossed a ridgeline, further reducing the vertical separation with terrain to 810 ft above ground level.

Recorded data indicated (Figure 3) that 30–40 seconds after speaking to ATC and approximately 70 seconds after leaving the ILS approach profile, the pilot commenced a sustained climb and began tracking to the initial approach fix of LISZT. During this time the aircraft was operated below the MSA.

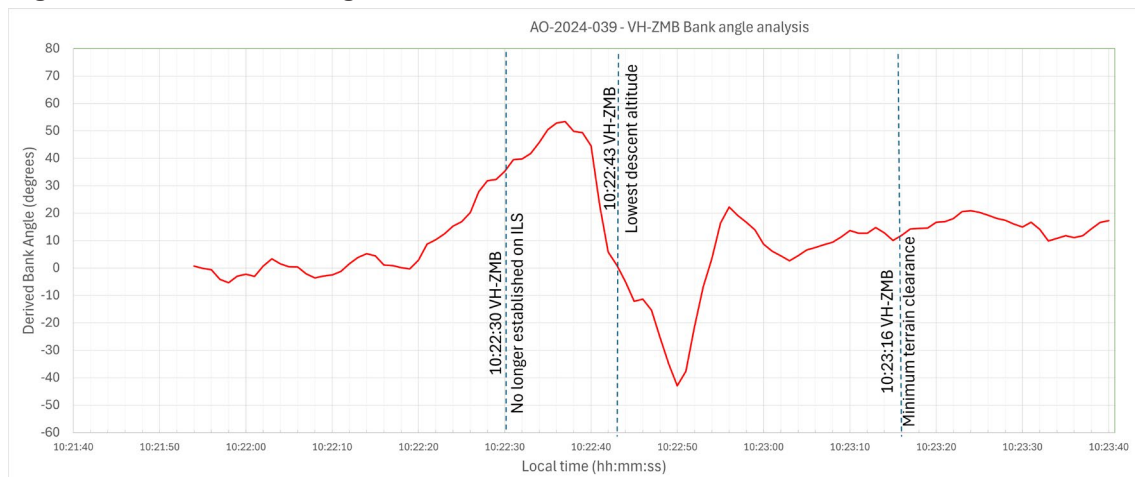
Figure 4: VH-ZMB bank angles

Recorded data identified a significant left turn, greater than 60° AOB, with a subsequent bank to the right of greater than 40° AOB and a further left correction (Figure 4). These occurred while the aircraft was still descending. The descent was arrested, at an altitude of about 3,320 ft. With minimal climb observed for about 30 seconds before approaching rising terrain, the aircraft then passed over the ridgeline at a height of approximately 810 ft (Figure 3). (Note: Graphical figures contain smoothed data profiles that may not precisely reflect the exact data point at an exact period).
