# **Collision with terrain during go-around involving Cessna U206F, VH-TDQ**

39 km south-east of Moora, Western Australia, on 1 September 2024

AO-2024-049

Final – 30 June 2025

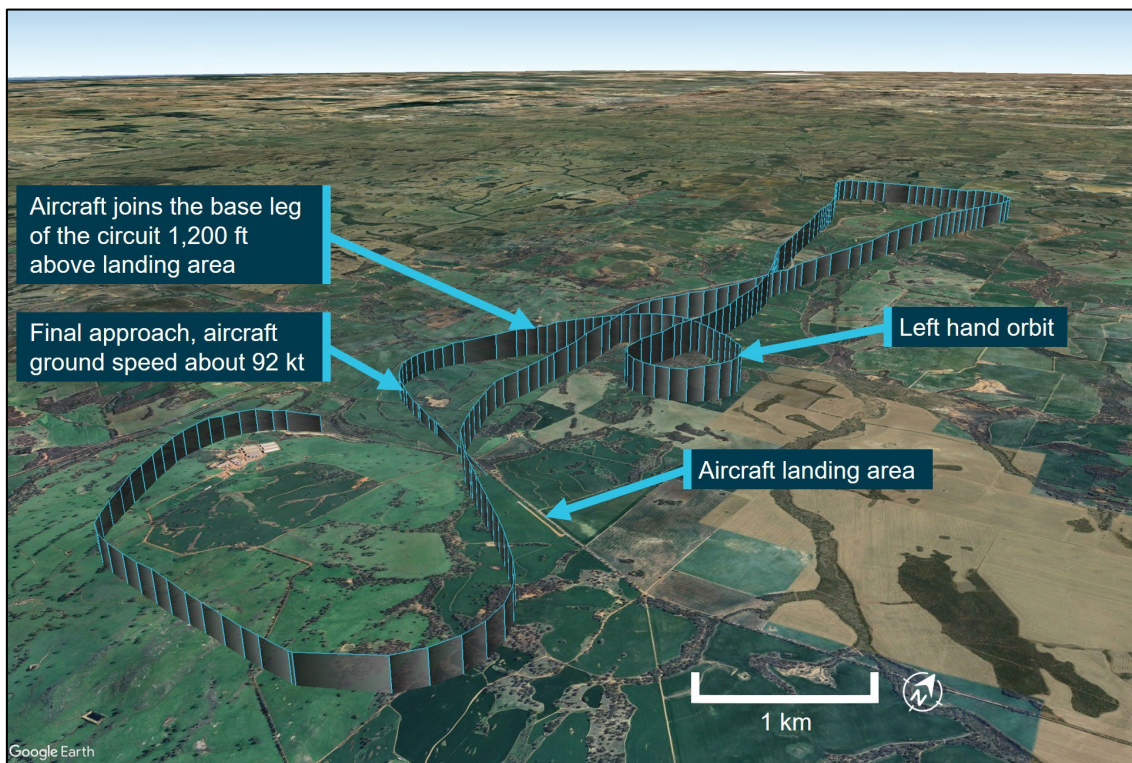
**Figure 1: VH-TDQ flight track**

The pilot reported they were advised the previous day by the local agricultural pilots to utilise the uphill slope for landing using the easterly runway and recalled, as there were no other aircraft in the vicinity, directly joining the base leg of the circuit for the easterly runway. They observed a 75 kt airspeed on final approach before configuring the aircraft for a full flap final approach for landing.

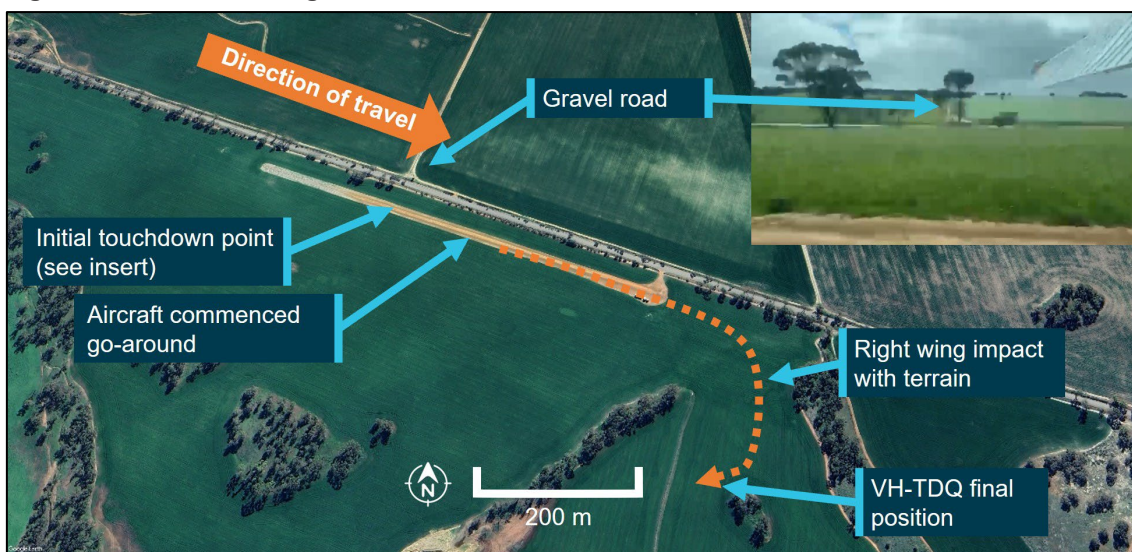
**Figure 2: Aircraft landing area**

The pilot landed the aircraft about 80 m (Figure 2) past the end of the easterly runway and bounced twice before they applied full power and commenced a go-around. The pilot was unable to recall their airspeed at the time of the flap reduction, however reported that the aircraft had probably dissipated a considerable amount of speed during the bounces prior to initiating a go-around. As the aircraft began the initial climb the pilot reduced the flap setting, unknowingly mis-selecting the 10° setting.

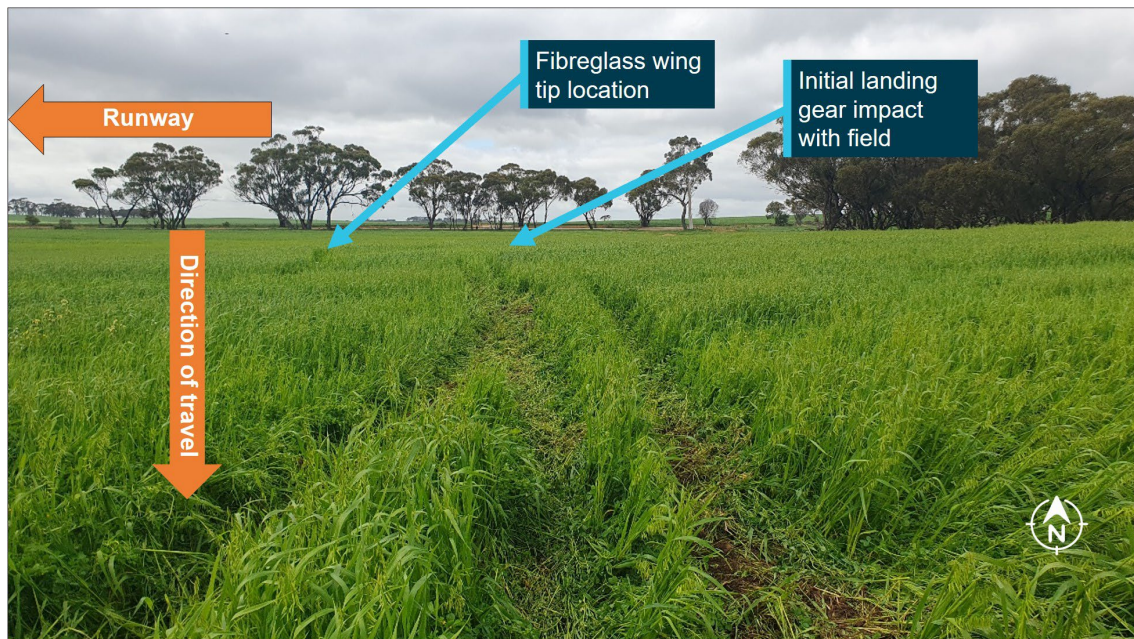
**Figure 3: Aircraft landing gear marks in field adjacent to the runway**

The right wingtip then raised above the crop height, however the propeller and landing gear remained partially in the crop (Figure 3) increasing drag and reducing speed. Shortly after, the aircraft touched down on its landing gear with the propeller making full contact with the crop and stopping the engine. The aircraft came to a stop upright, about 250 m from the runway, with the flaps extended in the 10° position. The pilot recalled at this point they switched off the aircraft's fuel and electrics.

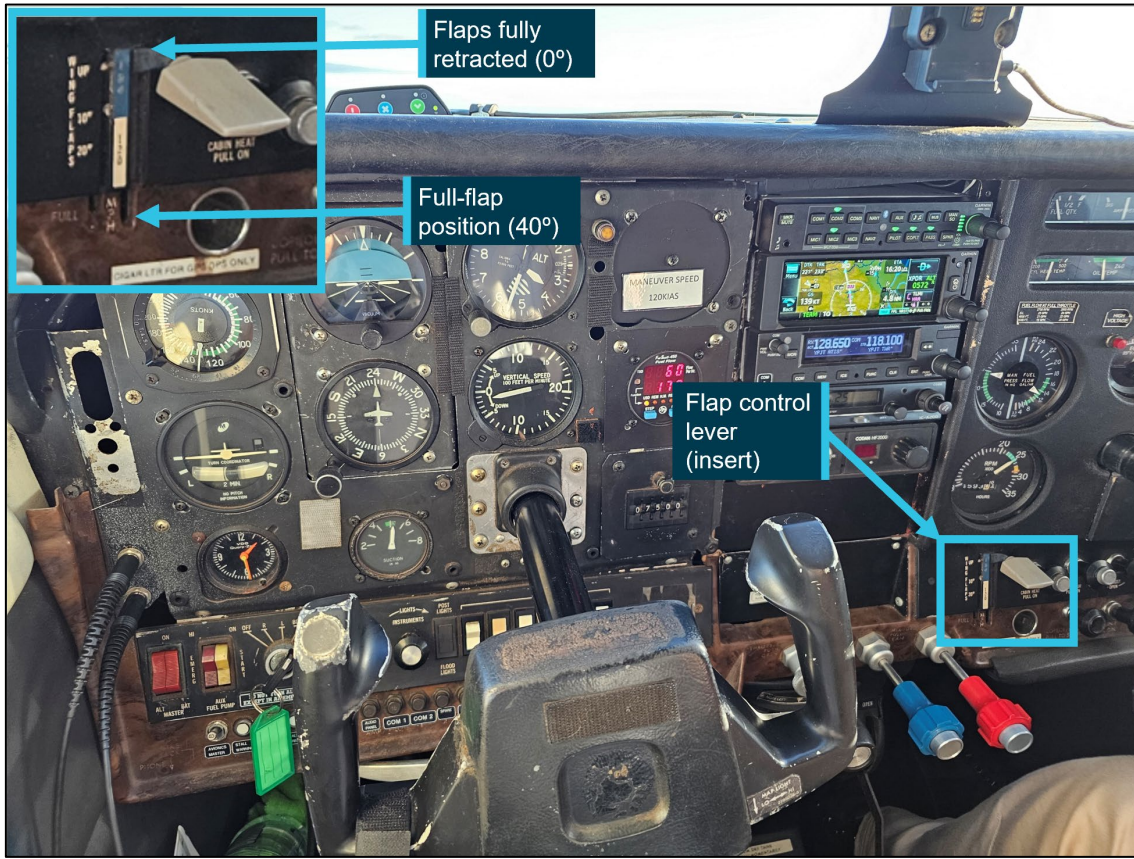
Figure 4: Cessna U206F cockpit

The operator's chief pilot reported they had not observed the pilot manipulating the lever like this during the 13 hours of in command under supervision (ICUS) flying they completed with the pilot.

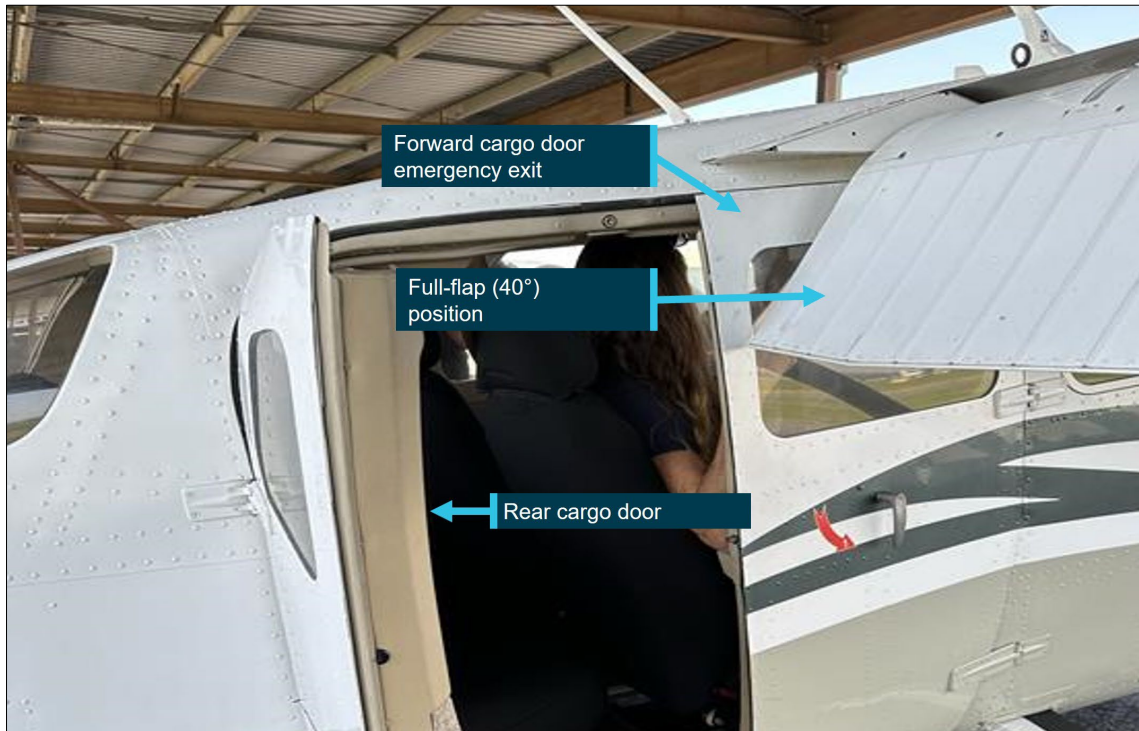
**Figure 6: Cessna 206H showing extended flap blocking forward cargo door**

Wing flap extension greater than 10° results in the flap blocking the forward part of the cargo door (Figure 6) and restricts the opening to about 8 cm. When the aircraft wing flaps remain extended, the forward cargo door must be opened as far as possible to then allow the rear door to be opened. Further detail is discussed below in *Cessna 206* rear passenger emergency egress.

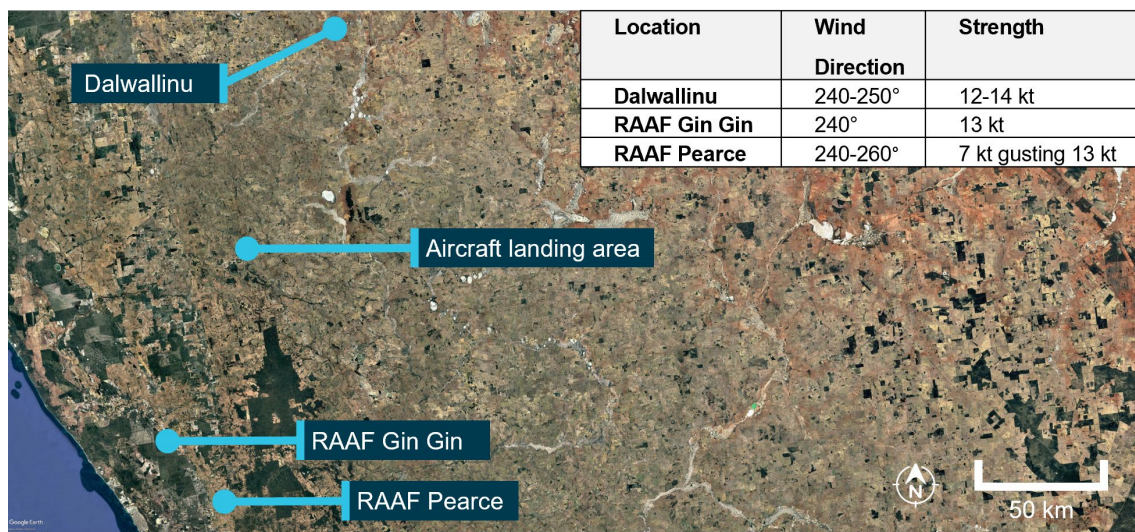
**Figure 7: Weather reporting locations in relation to the private aircraft landing area**

Bureau of Meteorology data from the nearest recorded locations at the time of the occurrence indicated local winds between 12–14 kt in a south-westerly direction (Figure 7).

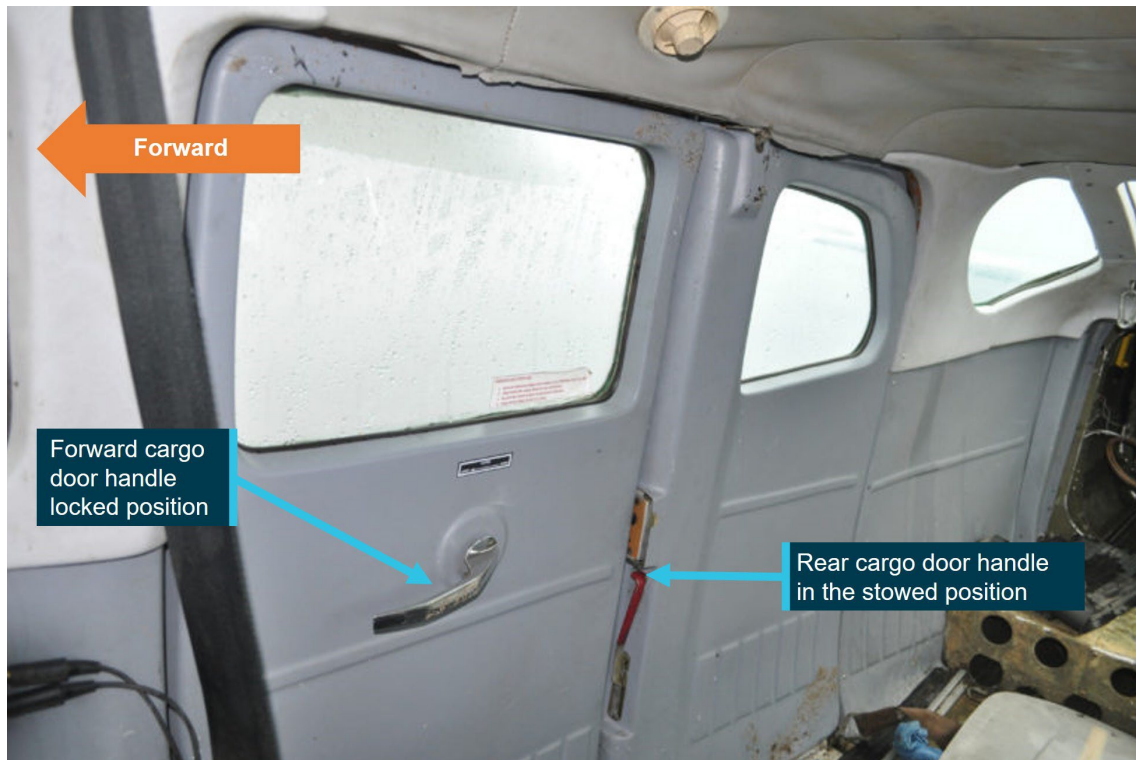
**Figure 9: Cessna U206G Cargo door**

The operator's chief pilot also reported that if the forward cargo door was blocked by the flap that passengers would be forced to egress the aircraft via the pilot's forward left cabin door, which would be difficult for passengers seated in the rear seats.
