# **Loss of control and collision with terrain involving Cessna 150L, VH-EYU**

Bacchus Marsh aircraft landing area, Victoria, on 22 October 2024

Aviation Occurrence Investigation (Short)

AO-2024-053

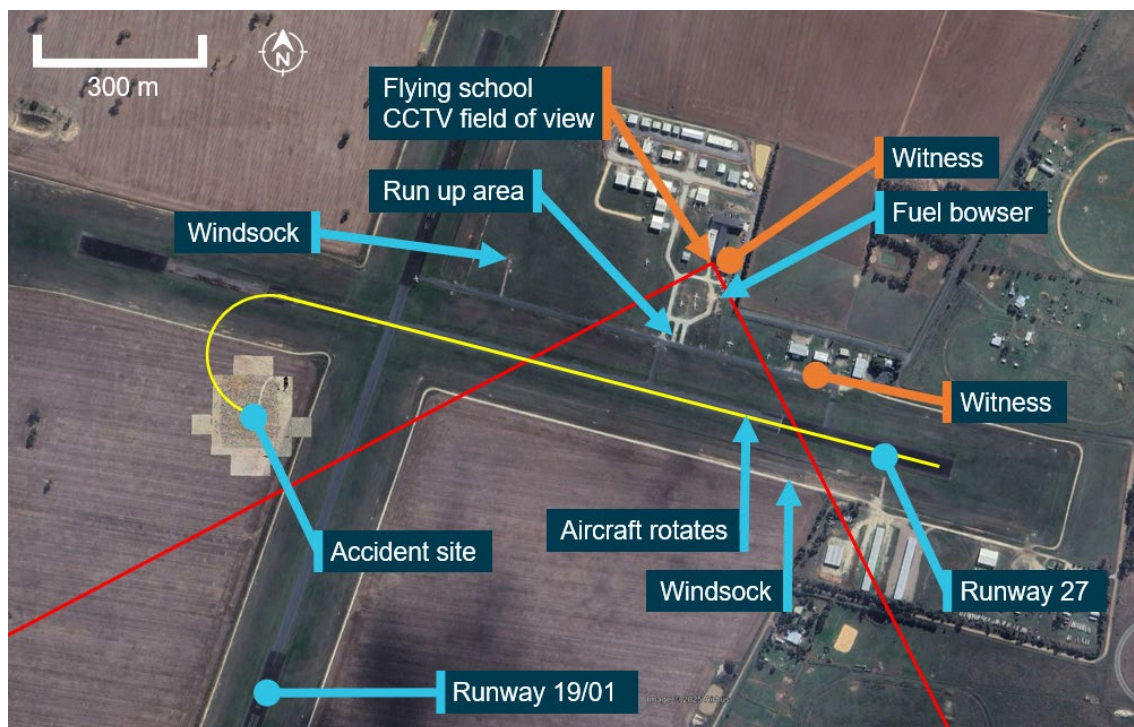
**Figure 1: Bacchus Marsh ALA and VH-EYU approximate flight path (yellow) and accident site**

After the aircraft had passed the runway intersection and reached an altitude of about 150 ft, it pitched steeply upward, before the nose and then the left wing rapidly dropped. The aircraft entered a nose down vertical descent to the left, rotating approximately 270° before colliding heavily with terrain. After the collision, personnel from the flying school attended the accident site and found the pilot fatally injured. The aircraft was destroyed.

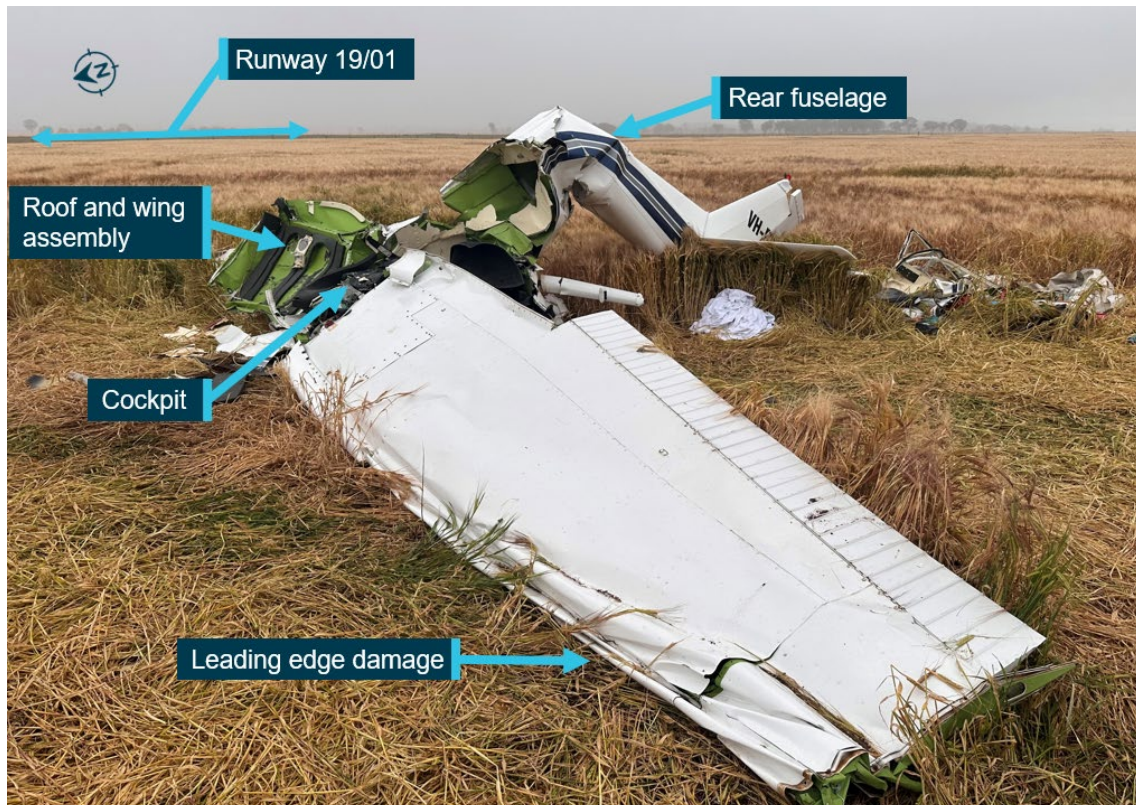
**Figure 3: VH-EYU at the accident site**

The accident site was in a barley field, 205 m south of the runway 27 centreline and to the west of runway 19/01 (Figure 1). The fuselage was orientated to the north. Ground impact marks were directly under the wreckage indicating no forward momentum. The damage signatures showed that the aircraft had impacted the field in a steep nose down attitude with the initial ground contact at the leading edge of the left wing. Severe disruption of the cockpit area, wing assembly and rear fuselage had occurred from the impact (Figure 3).

The wings and centre fuselage roof section had separated and moved forwards as a result of the impact. Portions of the airframe were removed by first responders prior to ATSB examination, and these were photographed prior to removal. The stall warning horn on the left wing was damaged in the accident sequence and could not be tested for functionality. The flaps were noted to be retracted, which is the position required in the normal take-off checklist.

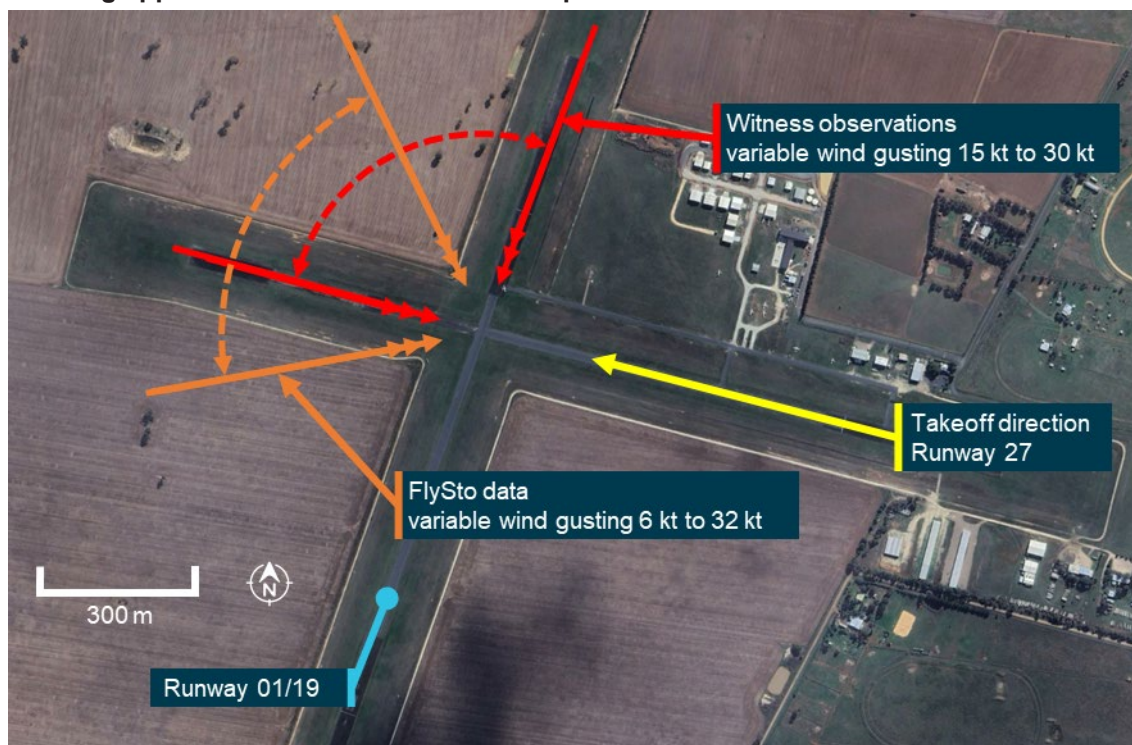
**Figure 7: Witness observation (red arc) and recorded data from FlySto (orange arc), showing approximate wind directions and speeds around time of VH-EYU take-off**

A number of witnesses described the temperature to be 'very hot' (27°C) with strong and gusting winds at the time of the accident. The winds were changing in strength (15–30 kt) and direction (between runways 27 and 01) (Figure 7). A flight instructor, who was an eyewitness to the accident stated that they had cancelled a student's flight which was to occur later in the day due to the gusty conditions.
