# Loss of control during marine pilot transfer operations involving Agusta A109E, VH-XUM and bulk carrier *Star Coral*

About 200 km north-east of Mackay, Queensland, on 25 February 2025

AO-2025-009

Final – 29 July 2025

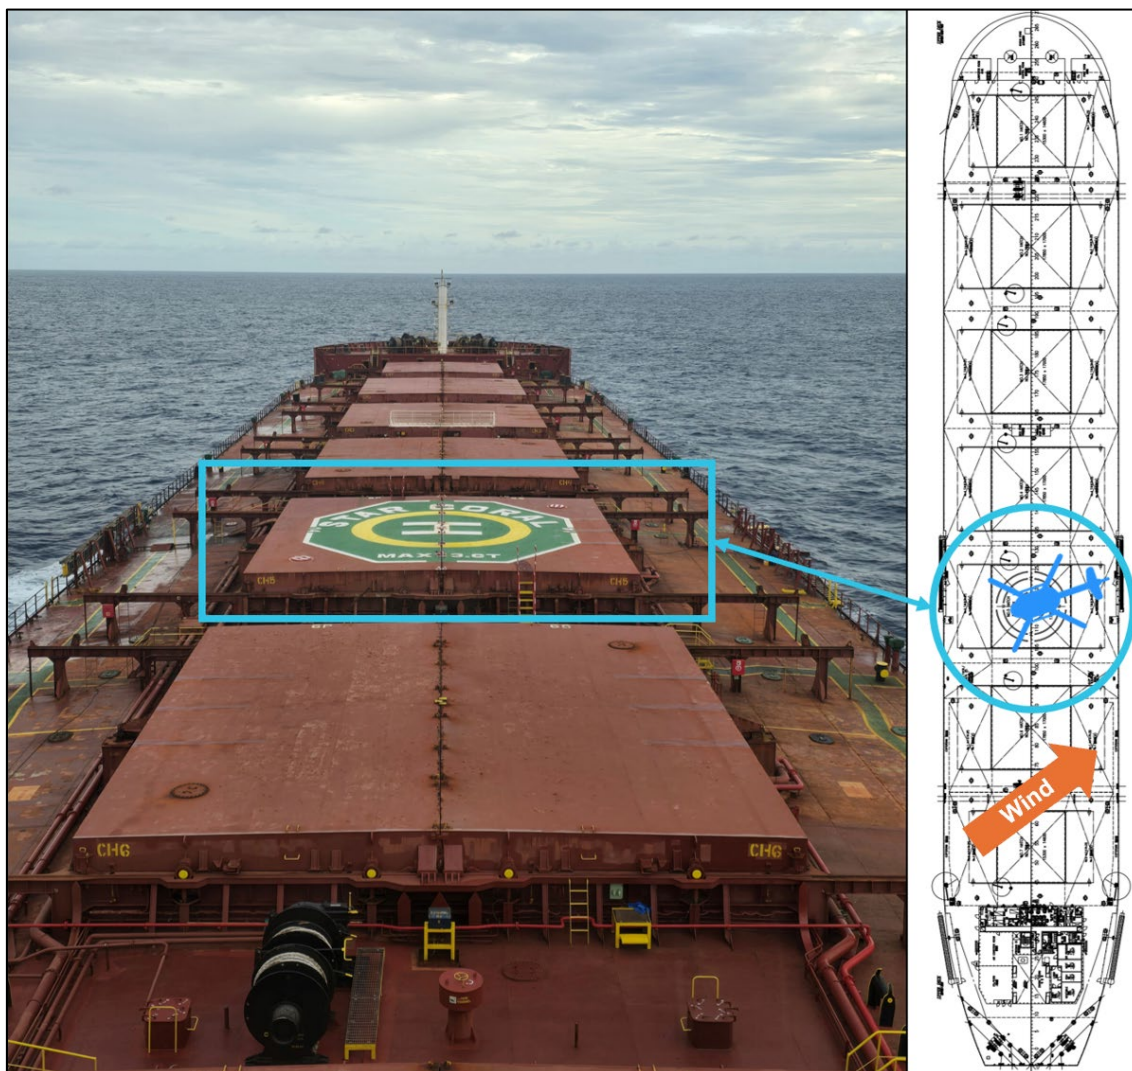
**Figure 2: Landing position of VH-XUM aboard *Star Coral***

This figure is a representation of the helicopter's orientation relative to the wind during the take-off.  
Source: Flyon Helicopters and *Star Coral*, annotated by the ATSB

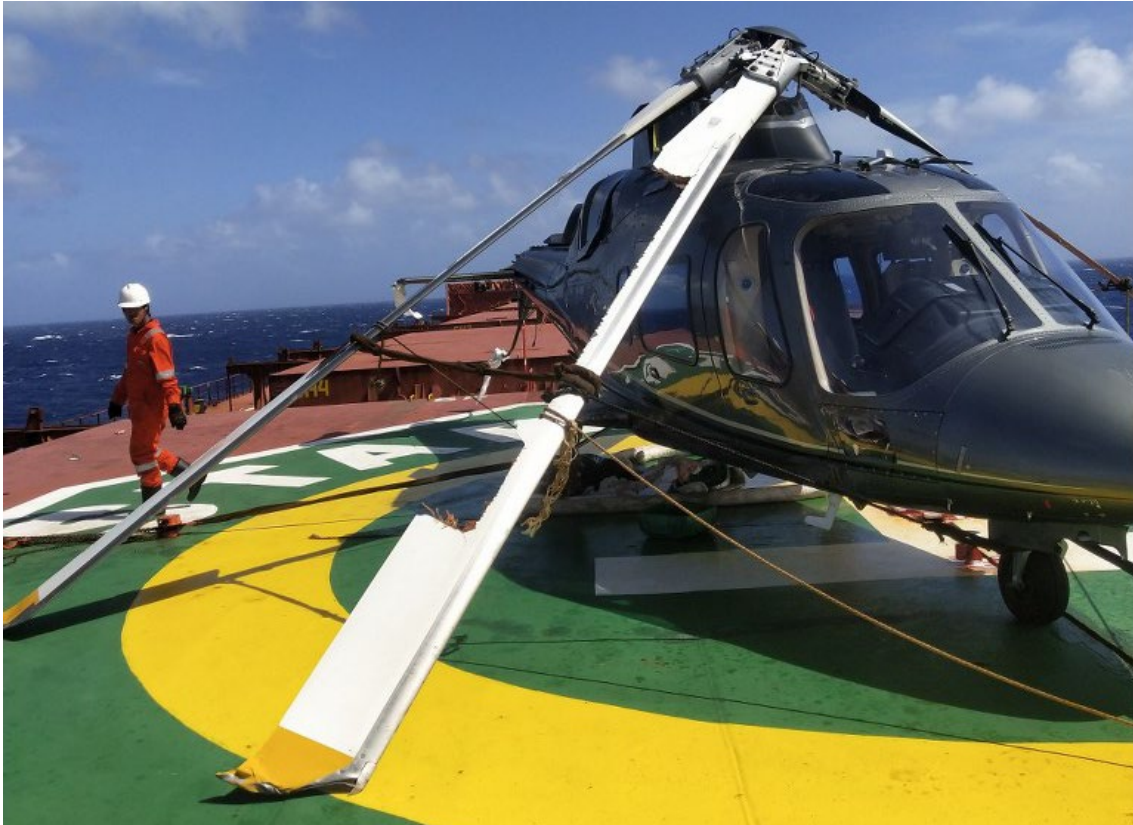
**Figure 3: Helicopter wreckage**

Soon after, the pilots exited the wreckage and inspected the damage. The tail rotor was separated from the helicopter and had come to rest on the main deck between cargo hatches 4 and 5. Items of debris, including main rotor fragments, laid scattered on the deck along with some hydraulic fluid pooled beneath the substantially damaged fuselage (Figure 3).

In that context, it is most likely that the helicopter encountered ground resonance. Assessment of the damage to the helicopter following the occurrence revealed significant similarities to that seen in previous A109E incidents attributed to this phenomenon.

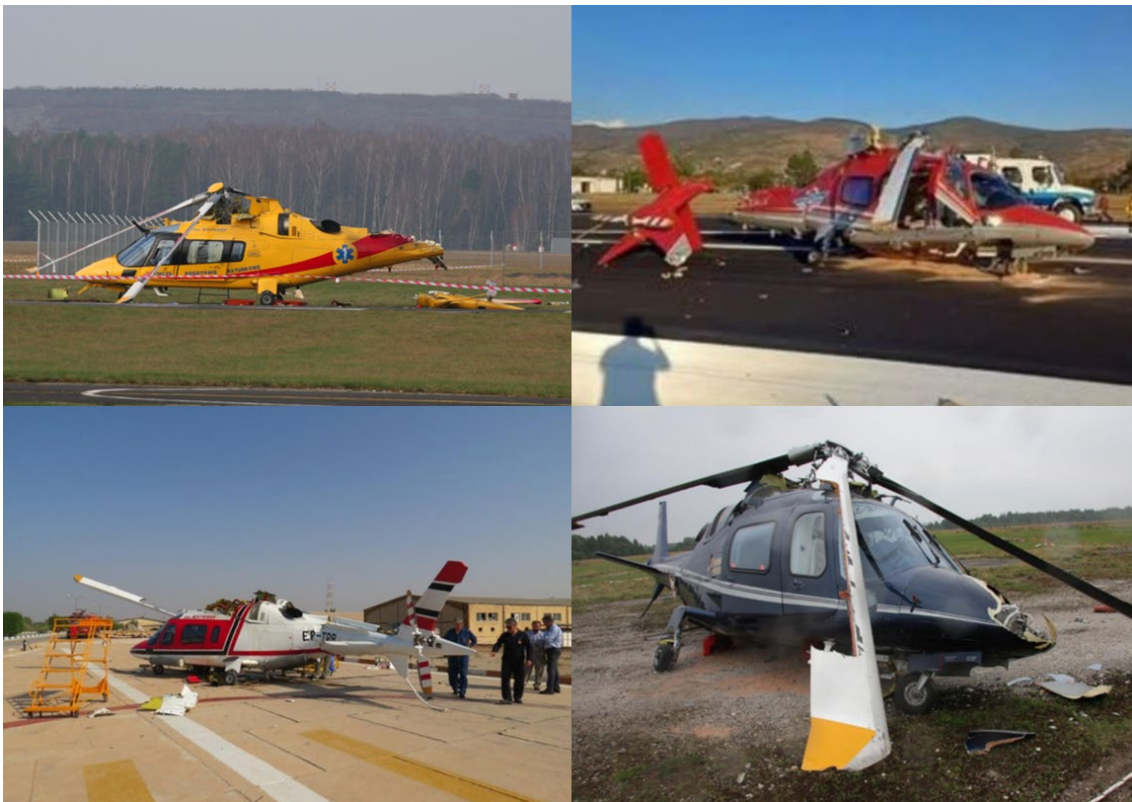
**Figure 4: Previous occurrences of ground resonance involving the Agusta A109E**

Details of the previous incidents bear similarity to the occurrence involving XUM, particularly in respect to subsequent damage to the helicopter (Figure 4).
