# Collision with terrain involving Wolf Pitts S1-11X, VH-PVX

Avalon Airport, Victoria, on 28 March 2025

**ATSB Transport Safety Report**  
Aviation Occurrence Investigation  
AO-2025-017  
Preliminary – 9 July 2025

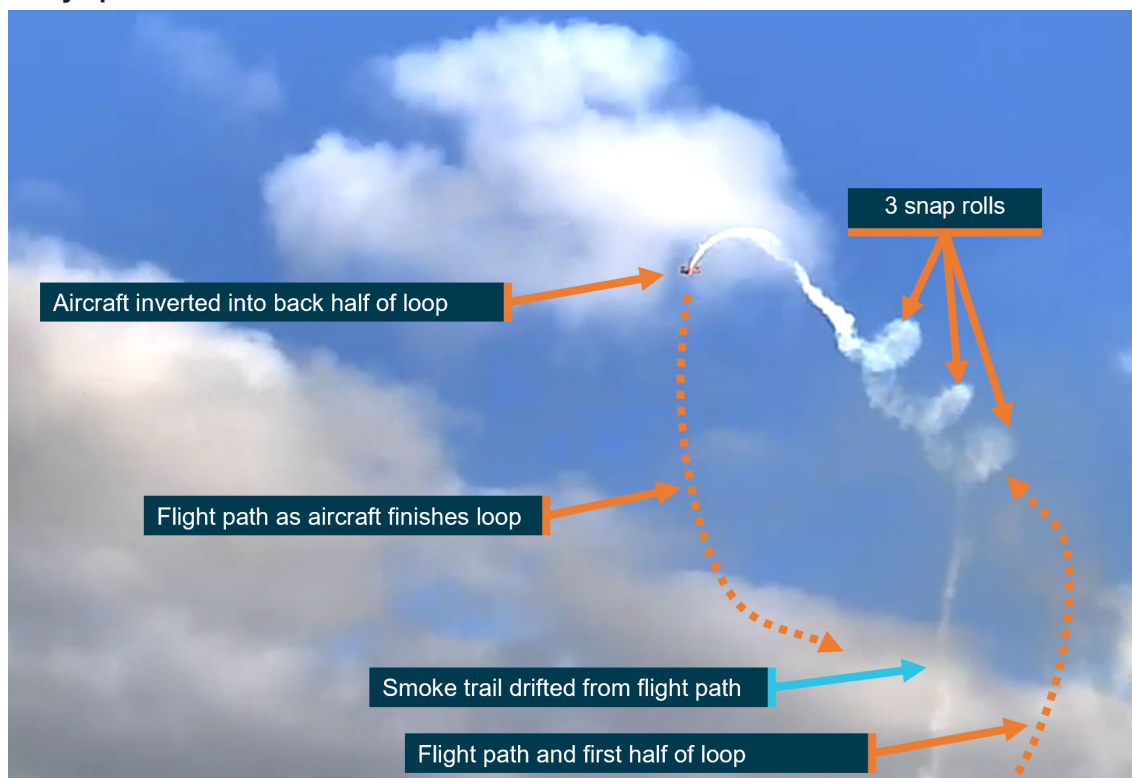
**Figure 1: A successful triple avalanche manoeuvre performed by the pilot in VH-PVX 2 days prior to the accident**

A review of training videos showed that previous triple avalanche manoeuvres performed by the pilot in VH-PVX were started at approximately 200 ft above ground level (AGL)<sup>9</sup> and an airspeed of 165 kt. The recordings showed the aircraft would reach an altitude of approximately 800 ft prior to entering the snap rolls. The aircraft would climb during the rolls to about 1,100 ft before beginning the back half of the loop. After the accident, the pilot reported that their normal minimum altitude for commencing the snap rolls was 1,000 ft.

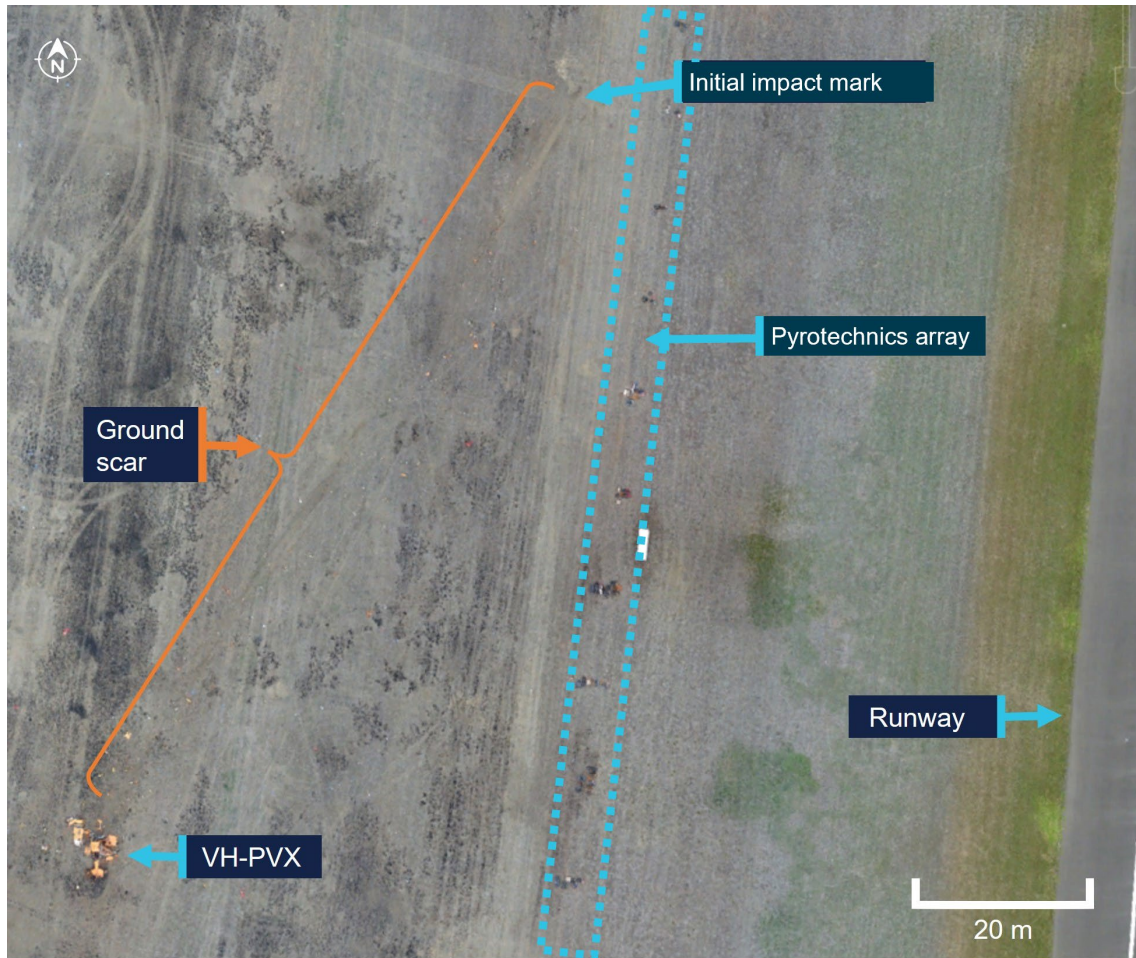
**Figure 3: Accident site overview showing the location of the initial impact mark, pyrotechnics array, and the wreckage of VH-PVX**

A ground scar, approximately 95 m long, was on a south-south-west heading (Figure 3). The aircraft came to rest upright and oriented toward north, almost opposite the direction of the impact sequence and debris trail. The initial impact point occurred several metres from the fuel boxes within the pyrotechnics array.

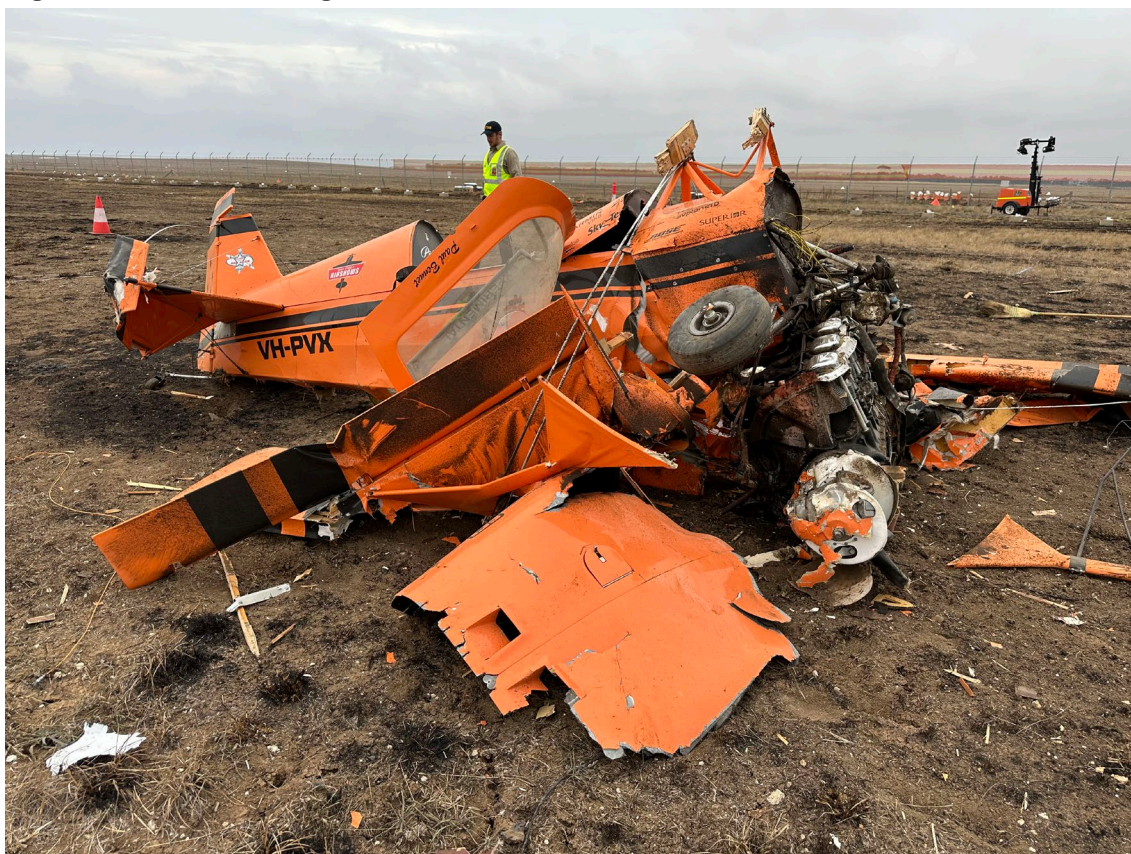
**Figure 4: Aircraft wreckage at the accident site**

The aircraft sustained substantial damage from the impact with terrain (Figure 4). Examination of the wreckage at a secure facility identified:

- no evidence of pre-impact defects with the flight control system or fuselage structure to the extent that could be determined
- the uppermost section of the canopy was fractured and parts of the airframe had departed the main structure
- the engine had separated from the airframe
- the propeller blades had fragmented, however, the propeller hub remained attached to the engine
- the front landing gear was distorted
- the upper and lower wings had separated, and the lower fuselage section had sustained compression damage
- the rigid outlet lines from the fuel tanks were fractured resulting in post-accident leakage of fuel.

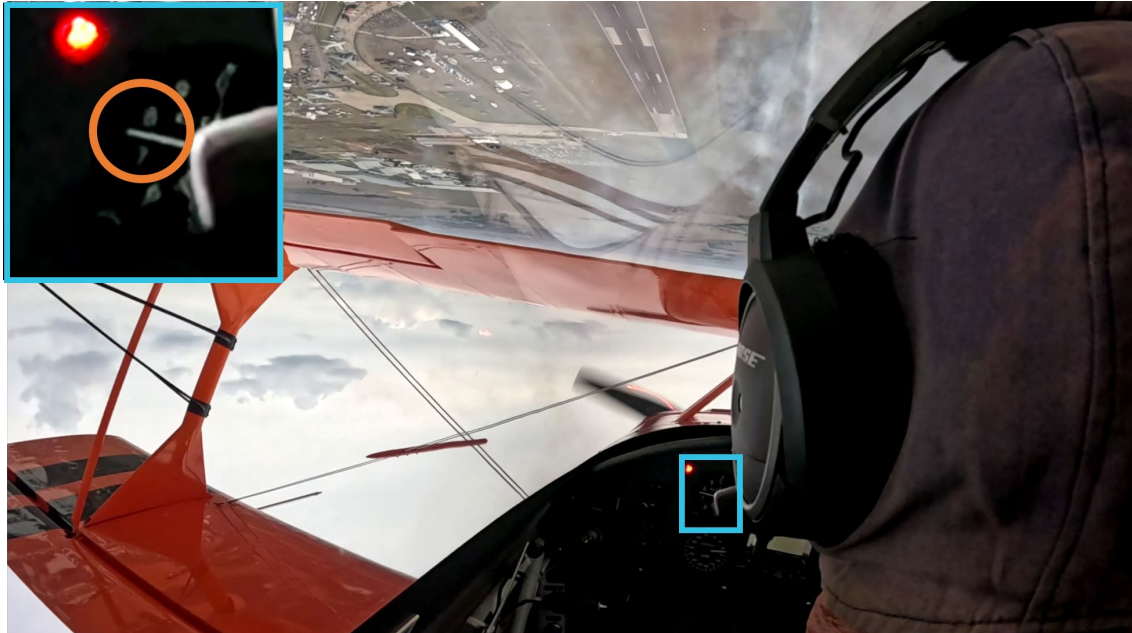
**Figure 5: Still image from the accident flight recording showing the altimeter just prior to the first snap roll during the triple avalanche manoeuvre**

During entry to the triple avalanche, the indicated airspeed was approximately 165 kt and the altitude was 100 ft. Just before the aircraft reached its peak altitude, the altimeter was

showing 700–800 ft (Figure 5). After this point, the altimeter was blocked from the camera's view by the pilot's body position just prior to the collision with terrain.

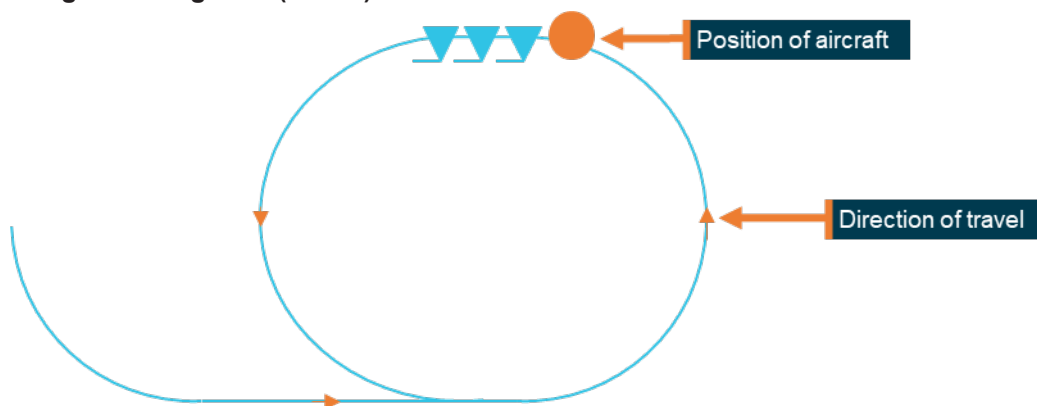
**Figure 6: Triple avalanche profile and the approximate position in the manoeuvre where the still image from Figure 5 (above) was taken**

Figure 6 provides a representation of the triple avalanche manoeuvre, showing the loop with the 3 snap rolls (indicated by inverted triangles) and the approximate position where the image shown in Figure 5 was taken.
