# Wake turbulence encounter and forced landing involving Robinson R44, VH-EWM

About 15 km north-east of Bankstown Airport, New South Wales on 7 April 2025

**ATSB Transport Safety Report**

AO-2025-018

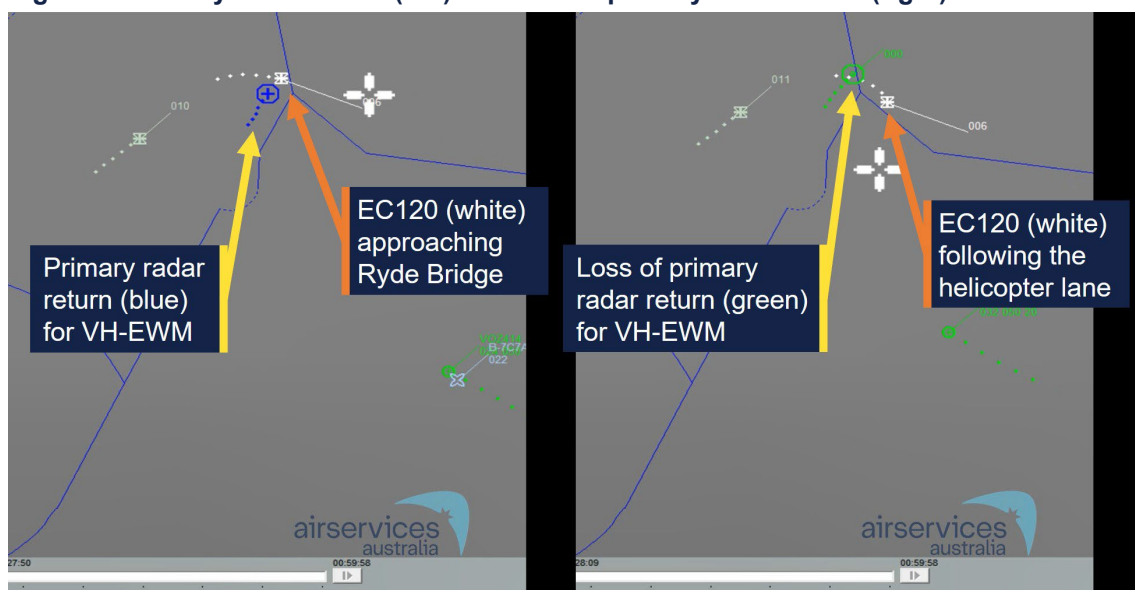
**Figure 2: Primary radar return (left) and loss of primary radar return (right) for VH-EWM**

The pilot of EWM reported that they descended the helicopter to 500 ft as they approached the river. Just before the pilot turned EWM right to join the helicopter lane, another larger helicopter (the EC120) suddenly appeared in front of them (Figure 2). The pilot of EWM estimated the EC120 was about 500–600 ft (150–180 m) in front of them and about 100 ft above them. While there was no recorded altitude for EWM, primary radar data indicated that EWM entered the lane about 9 seconds behind the EC120.<sup>3</sup> Primary radar data for EWM was lost about 10 seconds later, just after 1028, indicating it had descended below radar coverage.

The pilot of EWM made a radio broadcast that they were entering the helicopter lane as they crossed the Ryde Bridge behind the EC120. They then experienced what they described as very strong turbulence from a vertical motion in the atmosphere. A passenger later described it as ‘like heavy turbulence ... rolling left and right’ followed by ‘diving towards the water’.

Primary radar data and the pilot's report indicated that EWM entered the Parramatta River helicopter lane and passed over the Ryde Bridge about 9 seconds behind and slightly below the EC120 helicopter. At this point, EWM encountered heavy turbulence, an uncontrolled descent and a low rotor speed when the pilot applied full collective to avoid a collision with the water.

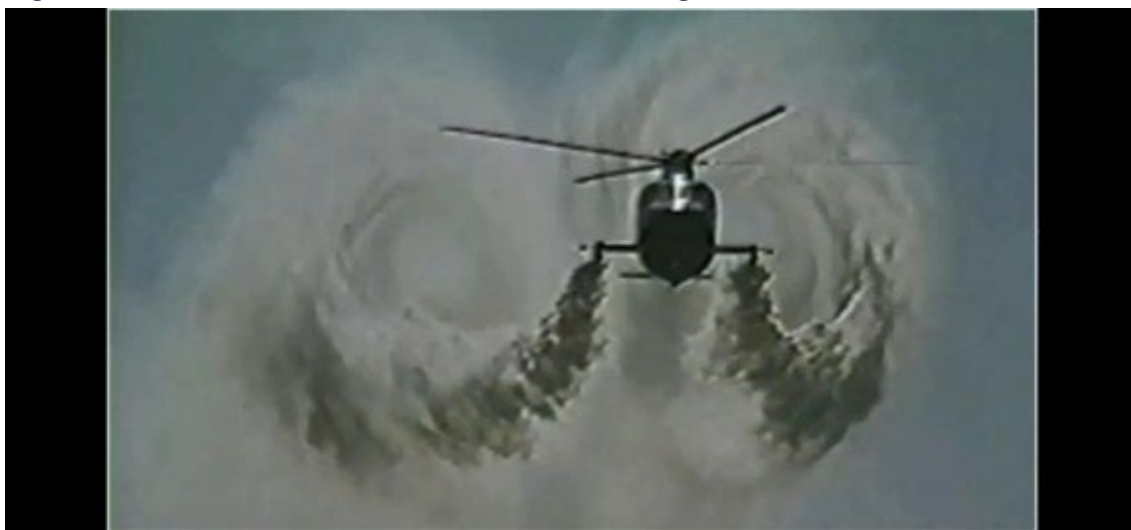
**Figure 3: Rotor wake vortices visualised with smoke generators**

- The measured vortex circulation diminished with decreasing airspeed for helicopter airspeeds below 40 knots. At these lower speeds, the wake vortex structure begins to break down and changes to a distinct downwash.
- Vortex duration depends strongly on ambient weather conditions and a variance of 300% was observed on those days most conducive<sup>7</sup> to vortex persistence and duration compared with those observed on typical days.
- Typically, helicopters with higher gross weight, larger rotor diameters, and larger numbers of rotor blades generated vortices of larger core diameters.
- Probe tests revealed that helicopter vortices did not descend in the same predictable manner as for fixed-wing aircraft. Some vortices descended; some remained level; and some initially descended, levelled off, and then ascended above the altitude of the generating helicopter.

Visualisation of the wake vortices behind an S-76A helicopter in forward flight with smoke generators from the FAA (1996) flight tests.  
Source: Reddit

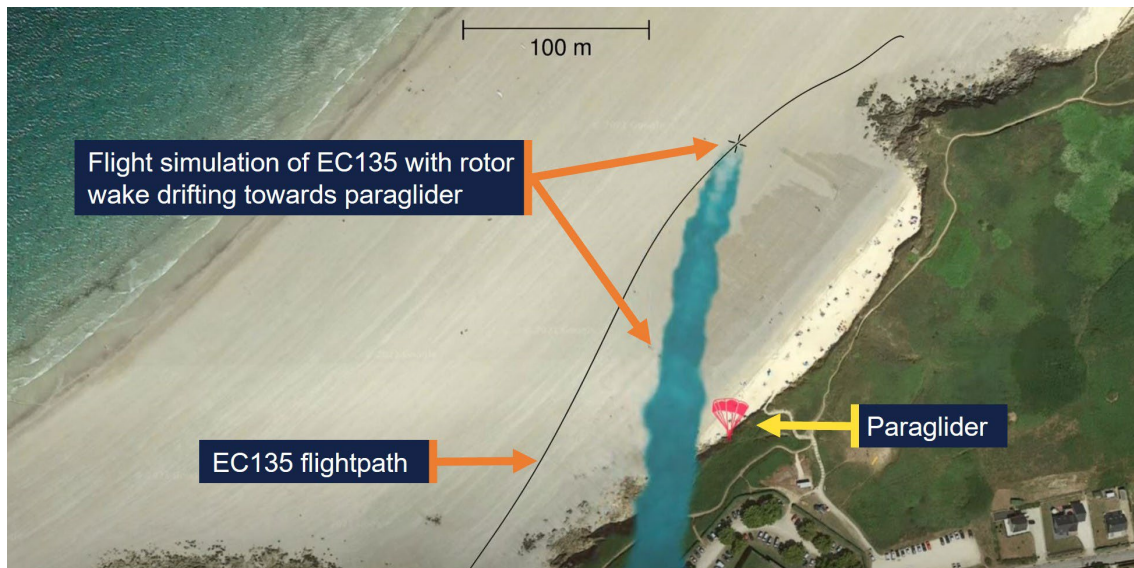
**Figure 4: Simulation of rotor wake drifting onto the paraglider**

The French Bureau of Enquiry and Analysis for Civil Aviation Safety investigation [BEA2019-0234](#), *Accident to a paraglider involving the Airbus - EC135 - T2 PLUS registered F-HTIN*, examined a fatal paraglider accident in 2019. The paraglider's wing collapsed after encountering the rotor wake from an Airbus EC135 helicopter, which drifted with the wind from the helicopter's flightpath onto the paraglider (Figure 4).

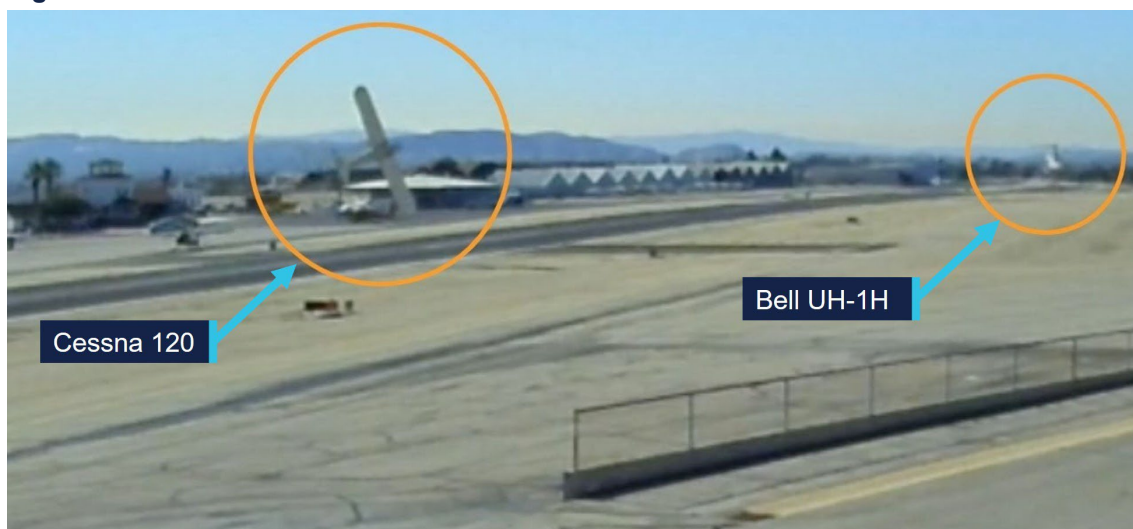
**Figure 5: Loss of control accident from rotor wake**

The 2022 United States National Transportation Safety Board investigation [WPR22LA072](#) found that the pilot of a Cessna 120 attempted a go-around about 20 seconds behind the passage of a Bell UH-1H helicopter. During the go-around the Cessna encountered wake turbulence, resulting in a loss of control and collision with terrain (Figure 5). The report indicated light wind conditions of 4 kt at the airport.
