Wake turbulence encounter and forced landing involving Robinson R44, VH-EWM

About 15 km north-east of Bankstown Airport, New South Wales on 7 April 2025

ATSB Transport Safety Report

AO-2025-018

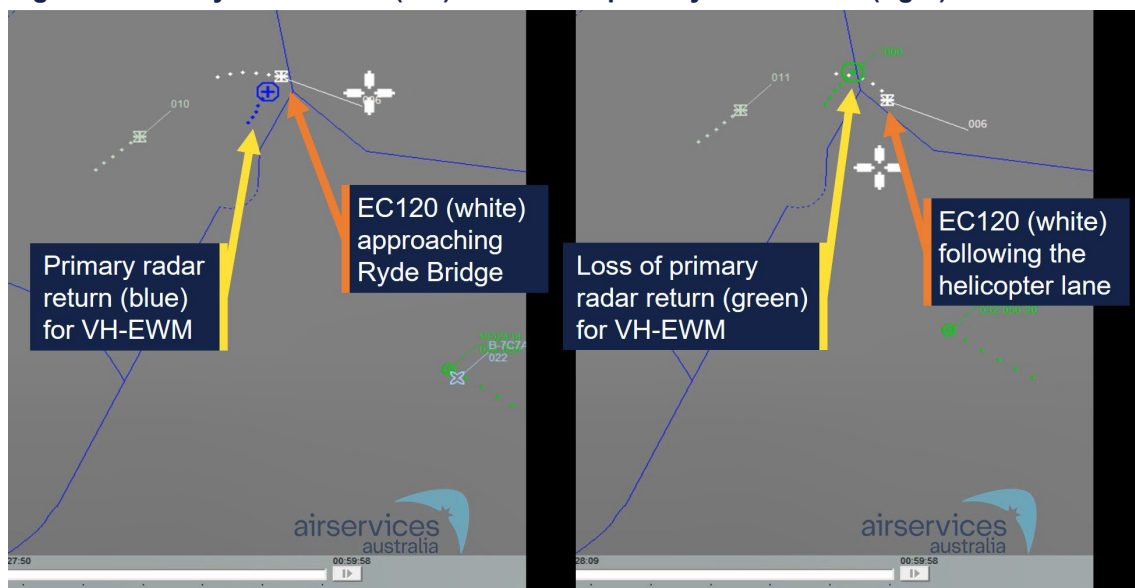
Figure 2: Primary radar return (left) and loss of primary radar return (right) for VH-EWM

The pilot of EWM reported that they descended the helicopter to 500 ft as they approached the river. Just before the pilot turned EWM right to join the helicopter lane, another larger helicopter (the EC120) suddenly appeared in front of them (Figure 2). The pilot of EWM estimated the EC120 was about 500–600 ft (150–180 m) in front of them and about 100 ft above them. While there was no recorded altitude for EWM, primary radar data indicated that EWM entered the lane about 9 seconds behind the EC120.³ Primary radar data for EWM was lost about 10 seconds later, just after 1028, indicating it had descended below radar coverage.

Primary radar data and the pilot's report indicated that EWM entered the Parramatta River helicopter lane and passed over the Ryde Bridge about 9 seconds behind and slightly below the EC120 helicopter. At this point, EWM encountered heavy turbulence, an uncontrolled descent and a low rotor speed when the pilot applied full collective to avoid a collision with the water.

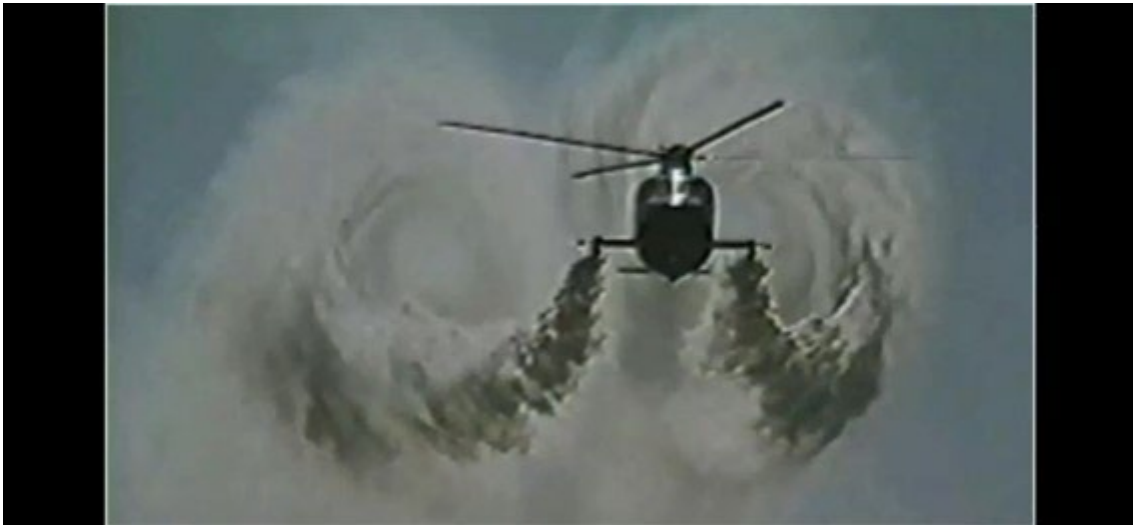
Figure 3: Rotor wake vortices visualised with smoke generators

- The measured vortex circulation diminished with decreasing airspeed for helicopter airspeeds below 40 knots. At these lower speeds, the wake vortex structure begins to break down and changes to a distinct downwash.
- Vortex duration depends strongly on ambient weather conditions and a variance of 300% was observed on those days most conducive⁷ to vortex persistence and duration compared with those observed on typical days.
- Typically, helicopters with higher gross weight, larger rotor diameters, and larger numbers of rotor blades generated vortices of larger core diameters.
- Probe tests revealed that helicopter vortices did not descend in the same predictable manner as for fixed-wing aircraft. Some vortices descended; some remained level; and some initially descended, levelled off, and then ascended above the altitude of the generating helicopter.

Visualisation of the wake vortices behind an S-76A helicopter in forward flight with smoke generators from the FAA (1996) flight tests.
Source: Reddit

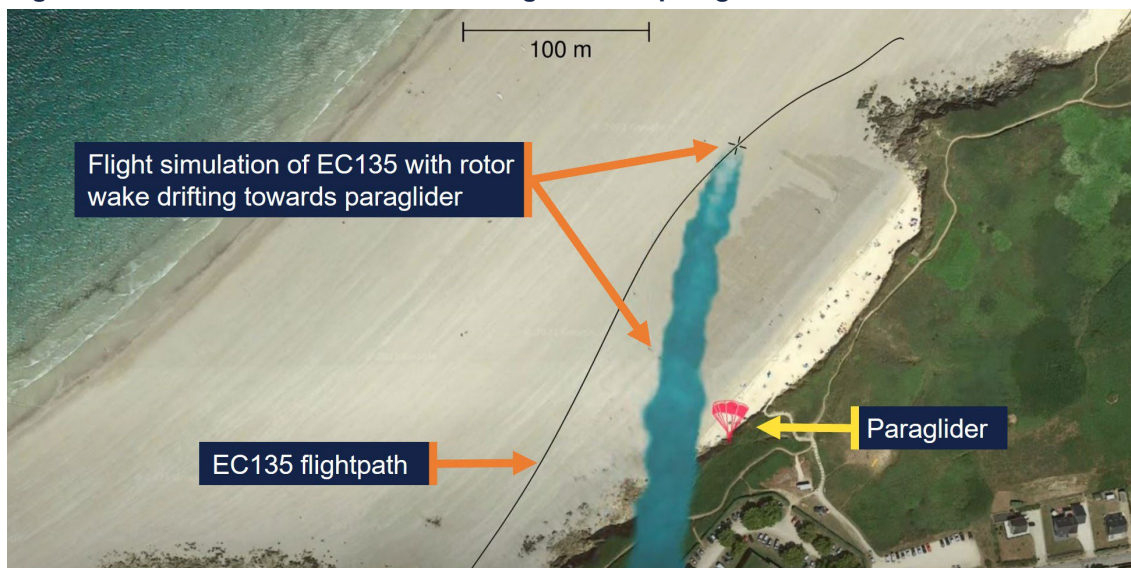
Figure 4: Simulation of rotor wake drifting onto the paraglider

The French Bureau of Enquiry and Analysis for Civil Aviation Safety investigation [BEA2019-0234](#), *Accident to a paraglider involving the Airbus - EC135 - T2 PLUS registered F-HTIN*, examined a fatal paraglider accident in 2019. The paraglider's wing collapsed after encountering the rotor wake from an Airbus EC135 helicopter, which drifted with the wind from the helicopter's flightpath onto the paraglider (Figure 4).

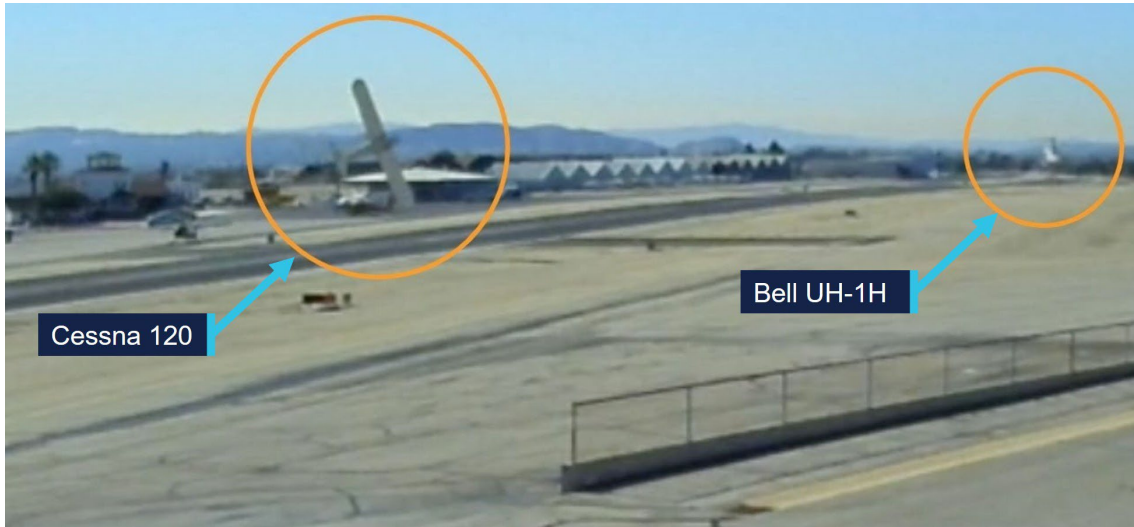
Figure 5: Loss of control accident from rotor wake

The 2022 United States National Transportation Safety Board investigation [WPR22LA072](#) found that the pilot of a Cessna 120 attempted a go-around about 20 seconds behind the passage of a Bell UH-1H helicopter. During the go-around the Cessna encountered wake turbulence, resulting in a loss of control and collision with terrain (Figure 5). The report indicated light wind conditions of 4 kt at the airport.
