Near grounding of *Rosco Poplar*

Bond Reef, Hydrographers Passage, Queensland on 4 May 2022

ATSB Transport Safety Report

MO-2022-005

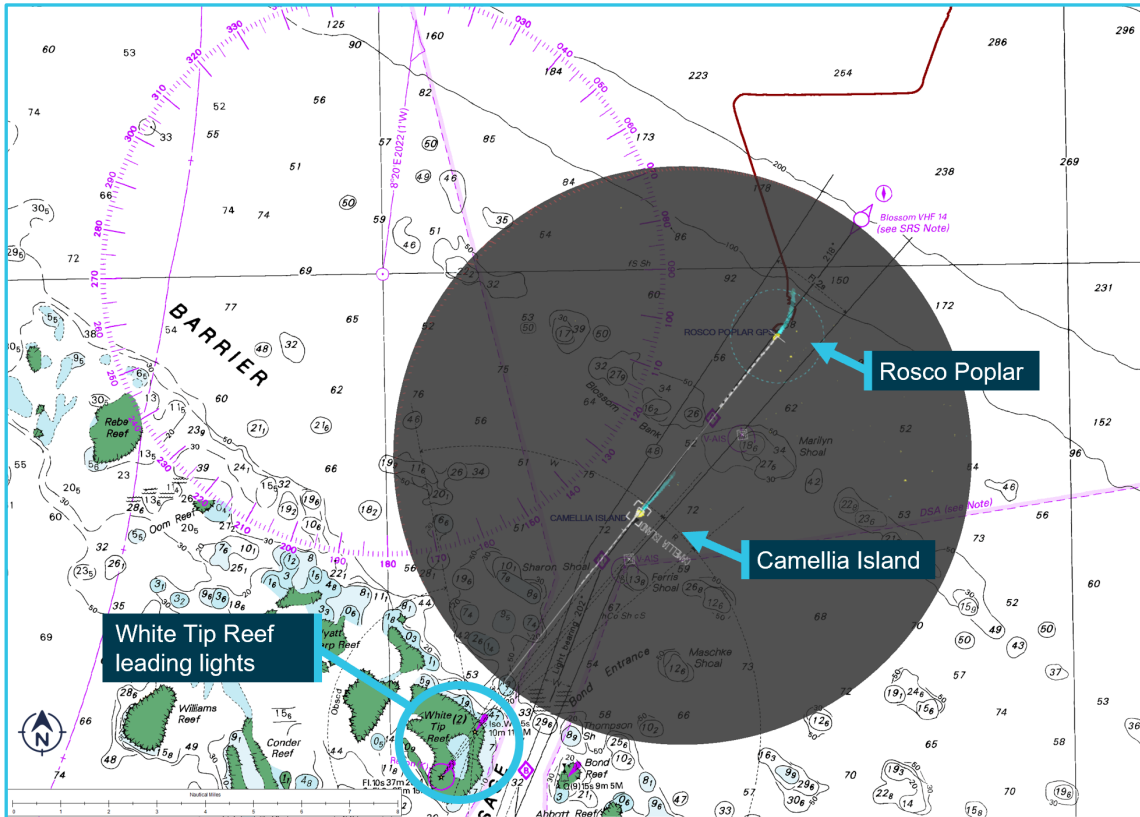
Figure 3: Navigational chart with *Rosco Poplar's* radar display overlaid (grey) at 0217

At about the same time, the second mate moved to the x-band radar to input waypoints. The pilot reported that at this time, he was monitoring the ship's progress visually and on the 2 ECDIS displays, which the pilot compared to the position displayed on the PPU. At 0234, the second mate completed the waypoint input for the x-band radar and returned it to operational mode.
