Collision between a truck and V/Line train 7727

Barwon Terrace level crossing, South Geelong, Victoria on 3 April 2023

ATSB Transport Safety Report
Rail Occurrence Investigation (Defined)
RO-2023-003
Final – 27 June 2025

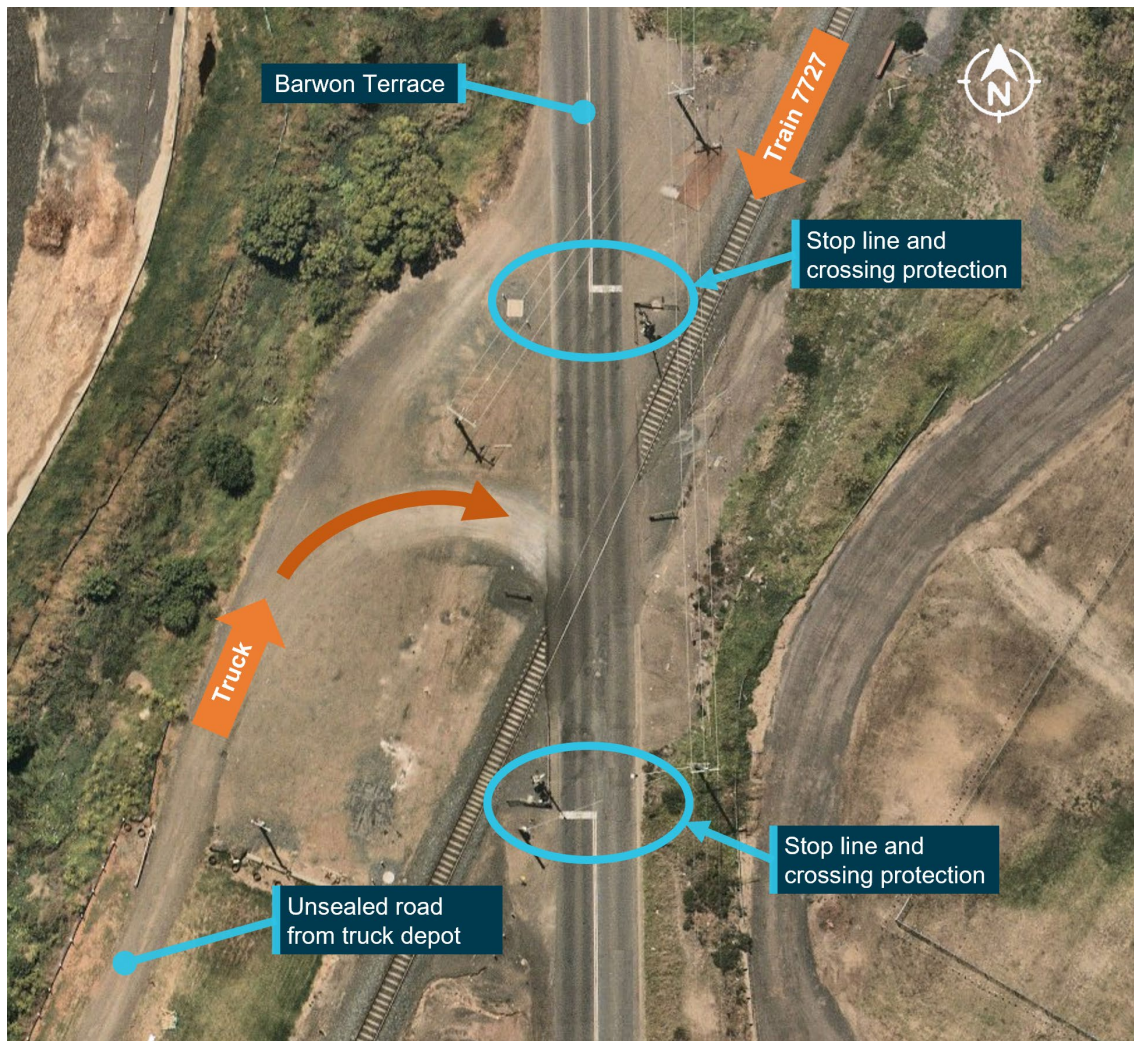
Figure 2: Direction of travel of train and route of truck onto the level crossing

At about 0635, the truck left the depot and travelled north along the unsealed road towards Barwon Terrace. It was dawn (shortly before sunrise), overcast and dry. As the truck approached the northern end of the unsealed road, the truck turned to the right and drove slowly onto the level crossing (Figure 2). This positioned the truck between the protection equipment located on each side of the crossing. The level crossing flashing lights and bells were operating, and booms had descended. At the same time, train 7727 approached the level crossing from the north.

The truck entered the level crossing between the level crossing protection equipment on either side of the track and stopped on the track. The driver probably realised a train was approaching and reversed the truck but was unable to clear the track in time.

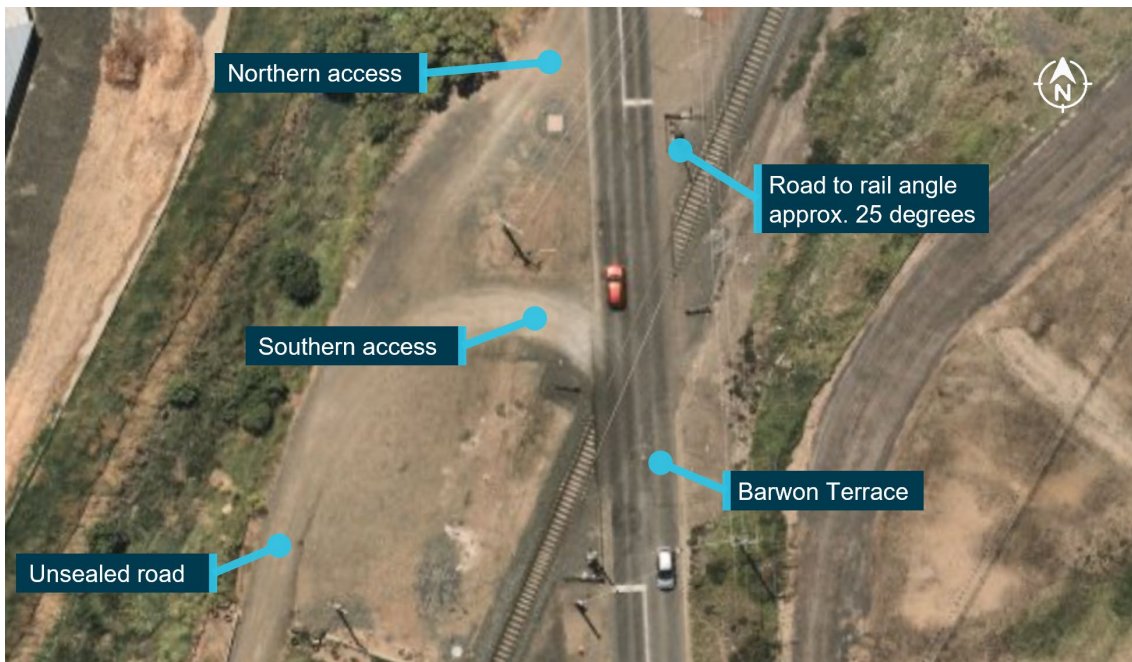
Figure 3: Barwon Terrace interface with rail line

Barwon Terrace was a sealed bi-directional dual lane motor vehicle carriageway managed by the City of Greater Geelong (COGG). At its intersection with the rail line, Barwon Terrace ran in a north / south direction. Travelling south away from Geelong, Barwon Terrace intersected the rail track at the level crossing at an angle of about 25 degrees to the road user’s left (Figure 3). The maximum speed permitted on Barwon Terrace was 60km/h.

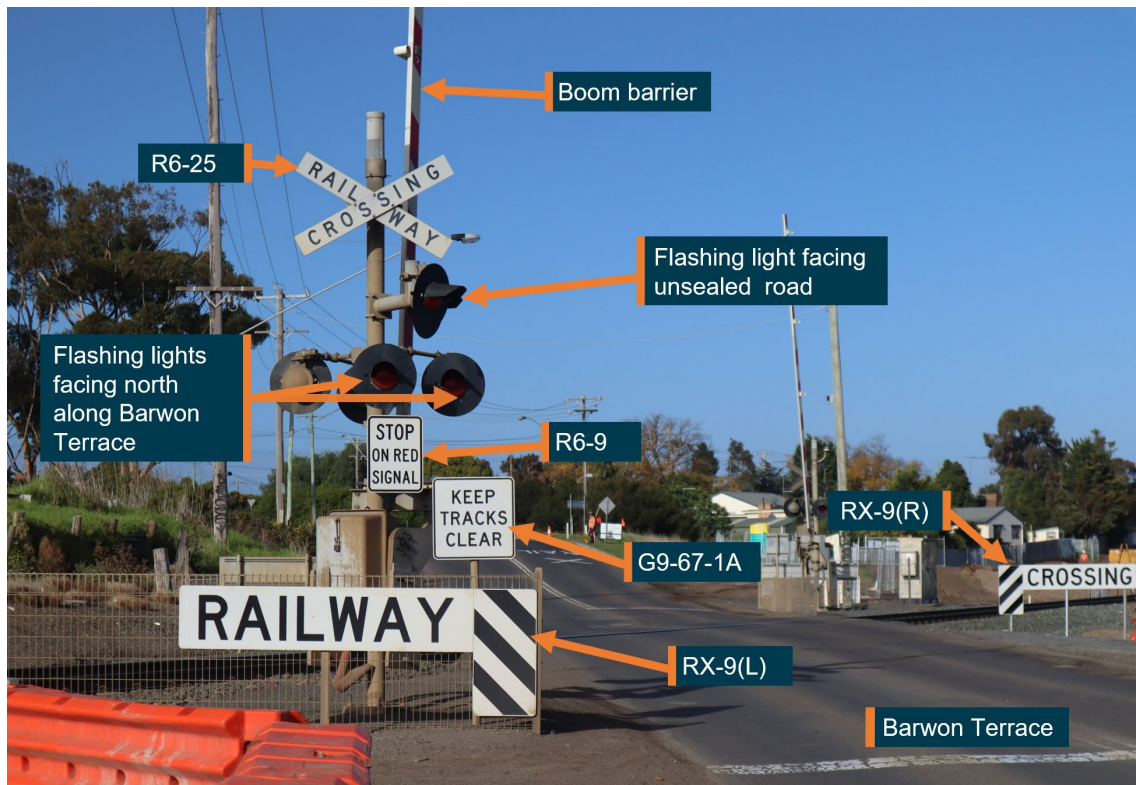
Figure 4: Level crossing protection for southbound traffic

For road traffic approaching from the north, railway crossing warning signage included an RX-5 railway crossing flashing signal assembly,⁶ a Keep Tracks Clear Sign (G9-67-1A) and a Railway Crossing with marker assembly sign (RX-9) (Figure 4).⁷ There was a pair of standard flashing lights for southbound Barwon Terrace traffic and an additional flashing light directed towards the exit of the unsealed road. This single flashing light was directed to the northern access of the unsealed road and could not be clearly seen from the southern exit nearer the track crossing and used by the truck.

The protection equipment at the crossing was working at the time of the incident. This was confirmed by CCTV, download data taken from the crossing equipment following the incident and eyewitnesses accounts.

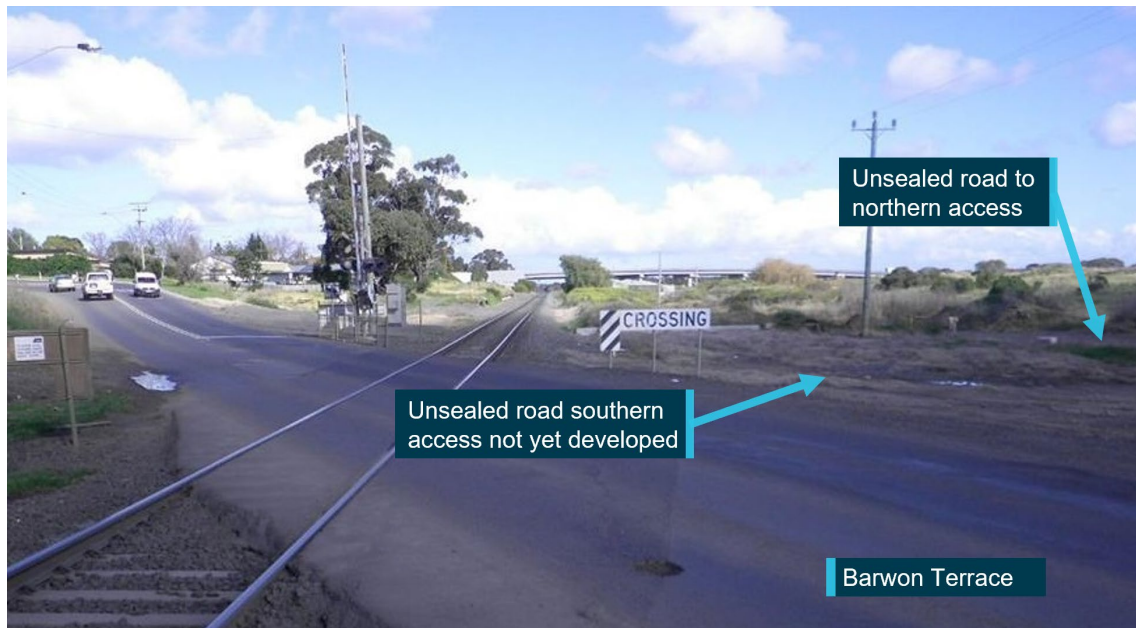
Figure 5: Junction between the access road and Barwon Terrace in 2017

The most recent (prior to the collision) full ALCAM survey at the Barwon Terrace level crossing was conducted in July 2017 and reviewed in 2018. The assessment and review noted that flashing lights, bells and audible warning devices and the relevant level crossing signage were deployed at the crossing. The survey drawing prepared from the survey in 2017 and associated photographs at that time indicated that the used route to and from the unsealed road was on its northern interface, and not the southern access later used nearer to the track (Figure 5).

In 2017, the unsealed road joined Barwon Terrace north of the level crossing. The access pathway used by the truck on the day of the incident had not yet developed.

- The unsealed road access route close to the level crossing probably developed after the 2017 survey of the Barwon Terrace level crossing using the Australian Level Crossing Assessment Model (ALCAM), and the ALCAM survey report did not identify the route.
- There was a missed opportunity for identified hazards associated with the level crossing configuration to be brought to the attention of the appropriate operational area within V/Line.

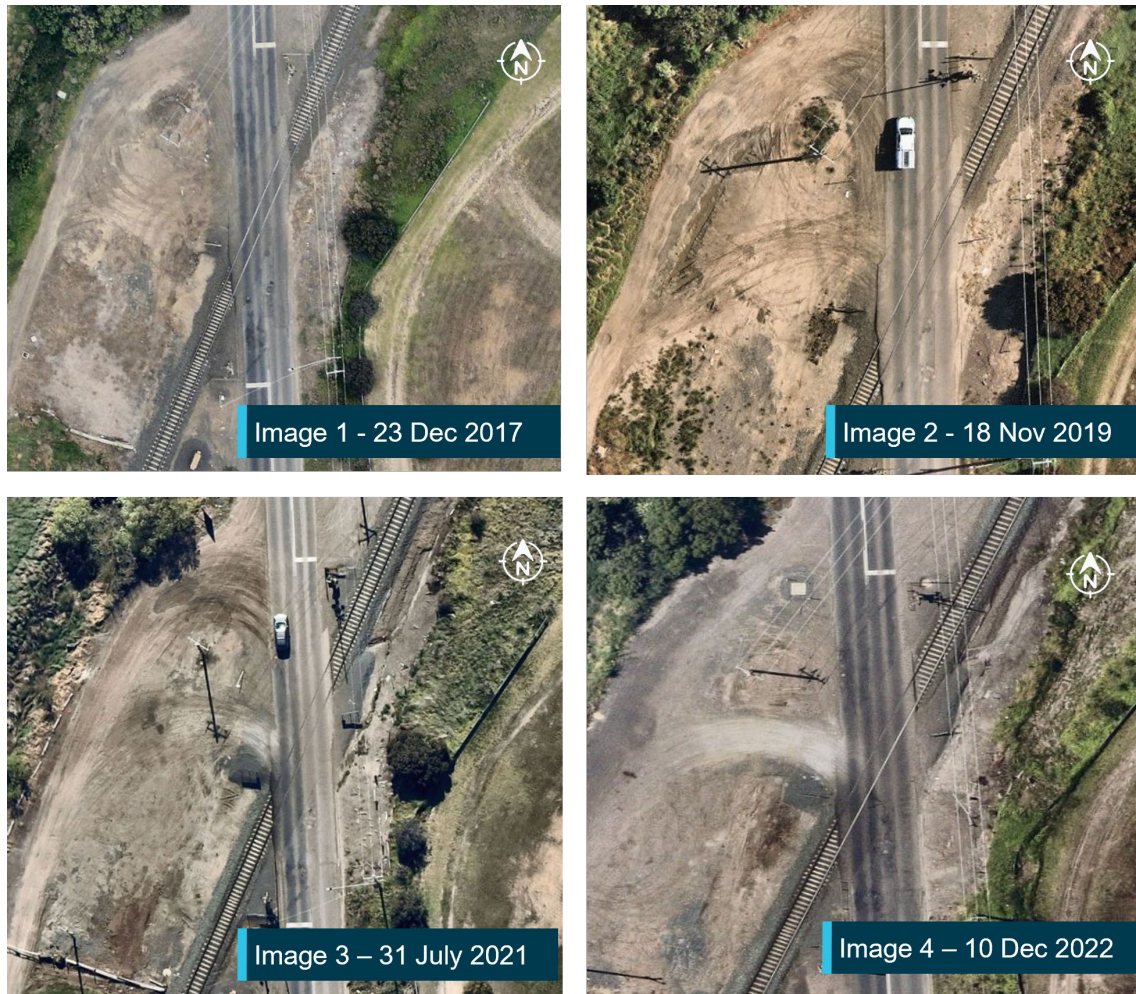
Figure 6: Train route and location of Barwon Terrace level crossing

nearby power pole. Over time, access had developed closer to the rail corridor and track (Figure 6).

An overhead photograph of the intersection taken 4 months before the collision (Figure 6, Image 4) showed that use of the access near the track and south of the power pole had increased. This access was probably used by vehicles turning right from the unsealed road onto Barwon Terrace and vehicles turning left off Barwon Terrace onto the unsealed road.

Imagery indicated that usage of the unsealed side road had increased over recent years. This increase was probably coincidental with increased usage by vehicles from the heavy vehicle depot located about 220 m south of the level crossing. The owner of the land at the depot had not submitted a planning permit application for the land use and correspondence from 2020 and 2021 between the City of Greater Geelong and the landowner had not resolved the permit issue.

V/Line inspection regime did not identify that the interface between the unsealed road and Barwon Terrace level crossing was a safety risk. Inspections did not extend to the routine review of any changing road conditions that may heighten risk.

V/Line advised that a maintenance alert has been issued with actions for track inspectors to identify roads or access tracks which may be able to bypass crossing controls and raise corrective work orders and incident reports in response. In addition, V/Line advised that the Level Crossing Roadway Inspection Report form has been revised to include an assessment of hazardous access points.

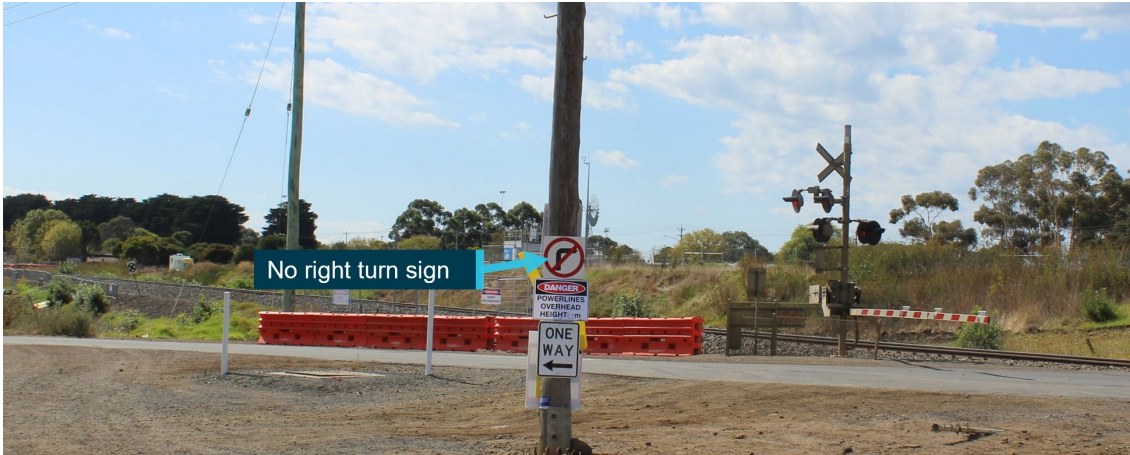
Figure 7: No right turn sign on the power pole

On 9 March 2023, prior to the collision and after an Alliance safety officer observed an Alliance vehicle turning right onto Barwon Terrace into the middle of the level crossing, a no right turn sign¹³ was affixed to the power pole (Figure 7). The sign faced south towards traffic approaching from along the unsealed road. During 'Pre-start' and 'Safe Talks' at team meetings, Alliance personnel were also advised that they were not to turn right when exiting the unsealed road onto Barwon Terrace. V/Line personnel were present at some safety meetings.

Photograph showing the no right turn sign on the power pole.
Source: The Office of the Chief Investigator

In addition to briefing rail project workers about the hazard, additional signage prohibiting a right turn from the unsealed road onto Barwon Terrace was erected as a risk control. However, there was a missed opportunity for the safety concerns to be raised with the appropriate operational area of V/Line, either by the rail project directly or V/Line representatives onsite.

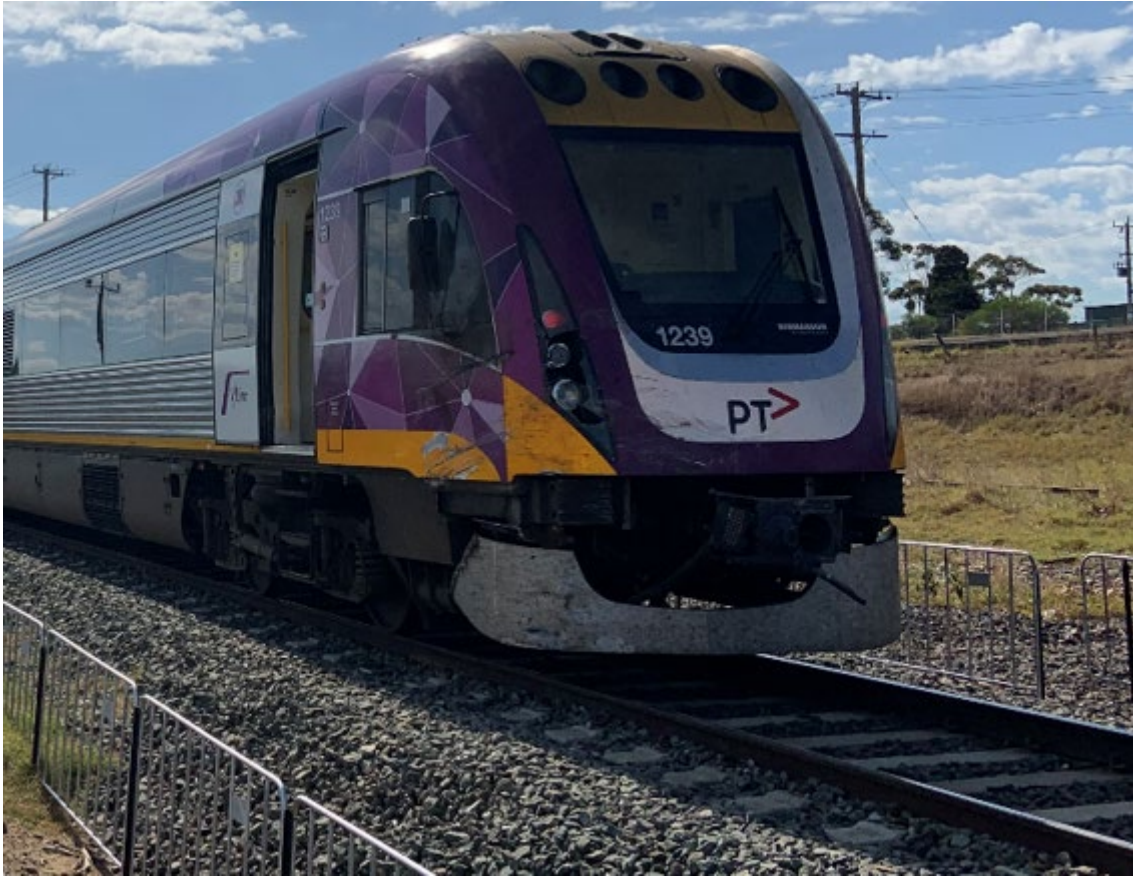
Figure 9: Damage to the front of train 7727

The train driver was qualified, assessed as competent and medically fit at the time of the collision. The train sustained minor damage to its front, did not derail and was able to be driven to the Waurm Ponds stabling yard.

*The damage to the front of VLocity train 7727 following the incident.
Source: The Office of the Chief Investigator*
