Collision with terrain involving Cessna U206G, VH-JVR

124 km west of Norseman, Western Australia, on 3 March 2022

ATSB Transport Safety Report

AO-2022-011

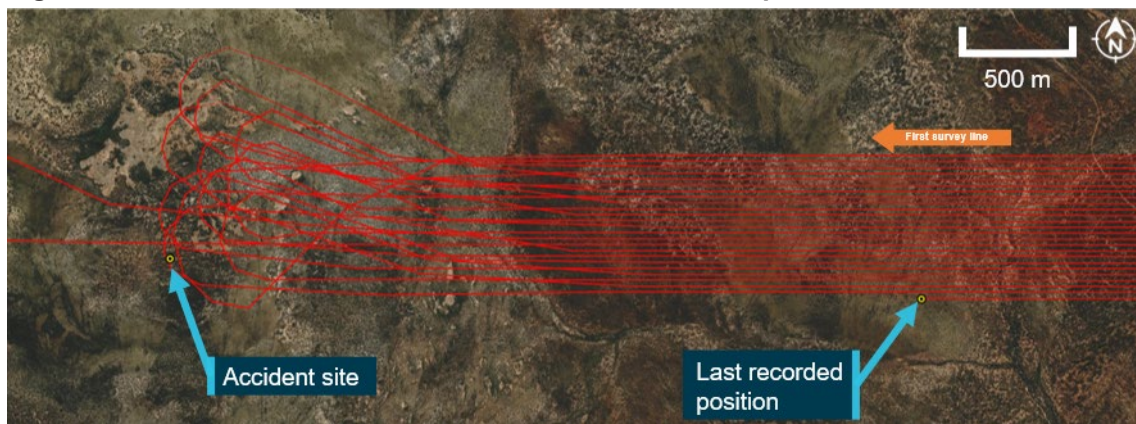
Figure 2: VH-JVR's accident site location and last recorded position

The JRCC initiated a search and rescue operation at 1739. The aircraft wreckage was located at 1852, approximately 3.2 km west of its last recorded position (Figure 2). The search aircraft’s crew were unable to establish communications with the pilot of VH-JVR. The JRCC also deployed a rescue helicopter to the site, and at 0042, they found the pilot, fatally injured a short distance from the wreckage.

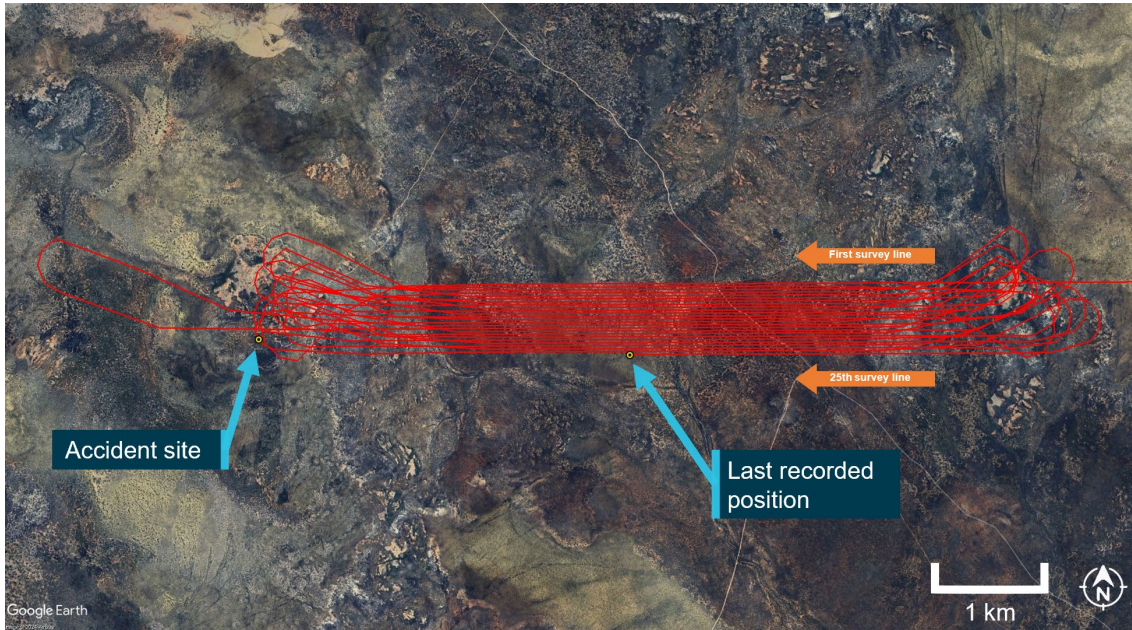
Figure 3: Recorded flight path (excluding transit from Kalgoorlie)

The recovered data showed that the pilot had conducted procedure turns (refer to section titled *Survey pattern*) at the end of each of the completed 24 survey lines, over a period of about 50 minutes. Although all turns were observed to be conducted in a similar manner, one particular turn commenced at a greater distance away from the survey area. During interview, the CP suggested that the pilot may have done so in order to have a drink or attend to a flight-related task. The ATSB noted no evidence to suggest any concern with this particular turn. The aircraft was on the 25th survey line when the data stopped, and the accident site was in the vicinity of the expected 25th procedure turn (Figure 3).

The recorded data showed the survey lines were being conducted in an east-west orientation, with left turns conducted to the west and right turns to the east. The average survey line speed was 114 kt at an average height of about 78 ft above ground level (AGL).

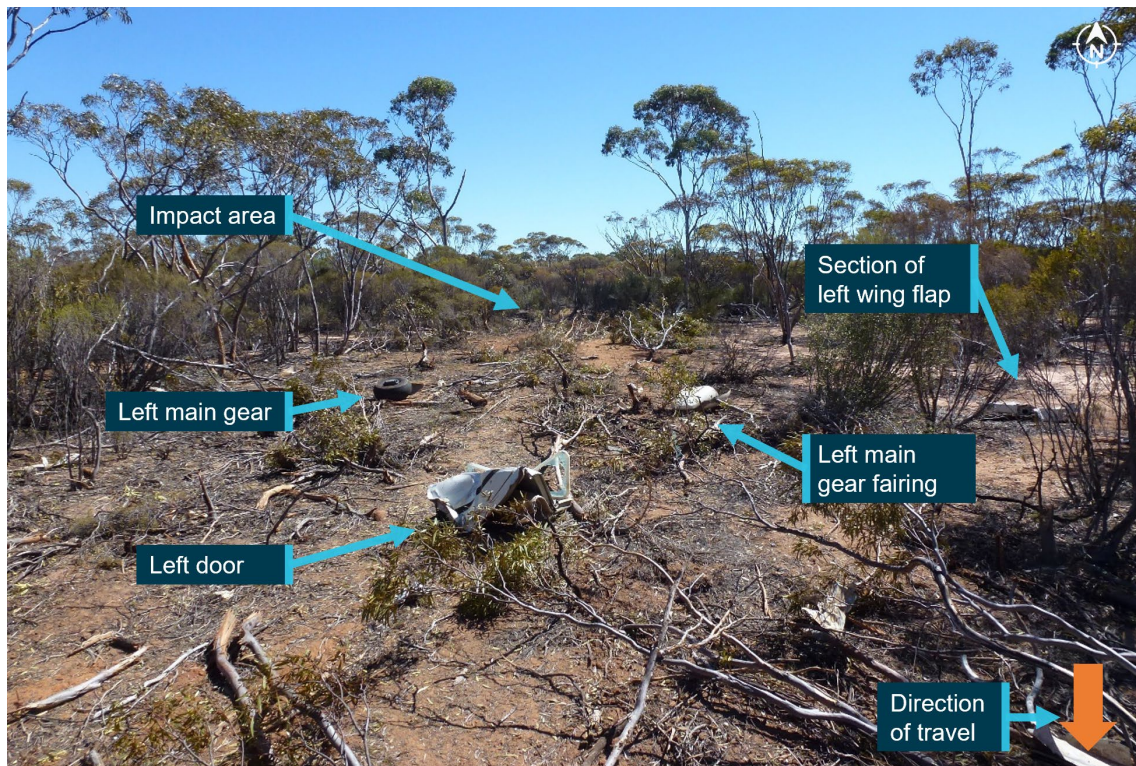
Figure 4: Wreckage trail looking north towards the impact area

The wreckage trail consisted of a number of felled trees and aircraft components, including the nose gear assembly, left main gear and fairing, left door, section of the left wing flap, windscreen and sections of the lower engine cowling and lower engine components. There was no indication of fire in the wreckage trail or detached aircraft components (Figure 4).

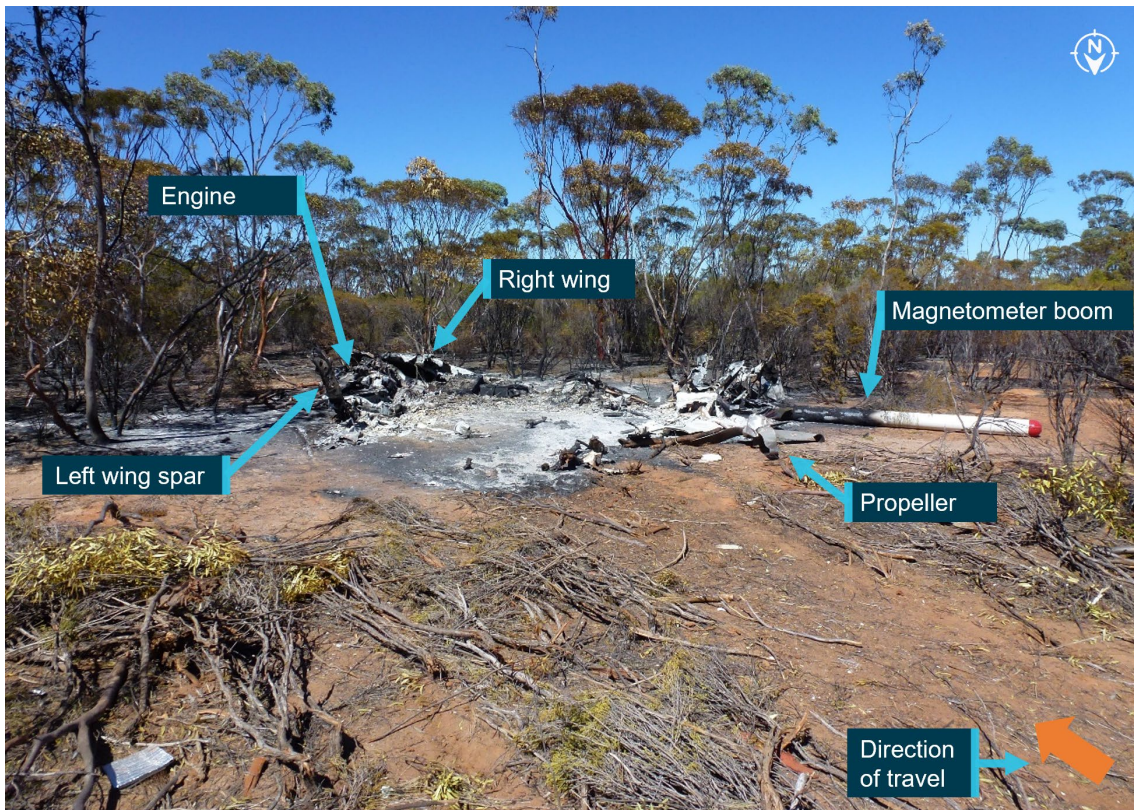
Figure 5: Main wreckage

The propeller had separated from the engine and was located towards the rear of the wreckage and the engine was upside down and detached from its mounts. Although the left wing was significantly affected by fire, the wing spar was still distinguishable. The right wing was relatively intact as was the magnetometer boom, albeit damaged by fire (Figure 5).

- no evidence of any pre-existing structural, mechanical or flight control defects that would have prevented normal operation
- the wing flaps were in the fully up (retracted) position
- a small, yet intense fire zone indicative of a significant amount of fuel, with ignition occurring from the left-wing integral fuel tank rupturing during the accident sequence
- the fuel selector was in the 'BOTH' orientation
- damage to the propeller indicated that the engine was producing power at the time of the impact.
