Interrupted engine start and evacuation involving Saab 340B, VH-ZRK

Melbourne Airport, Victoria, on 5 April 2022

ATSB Transport Safety Report

AO-2022-019

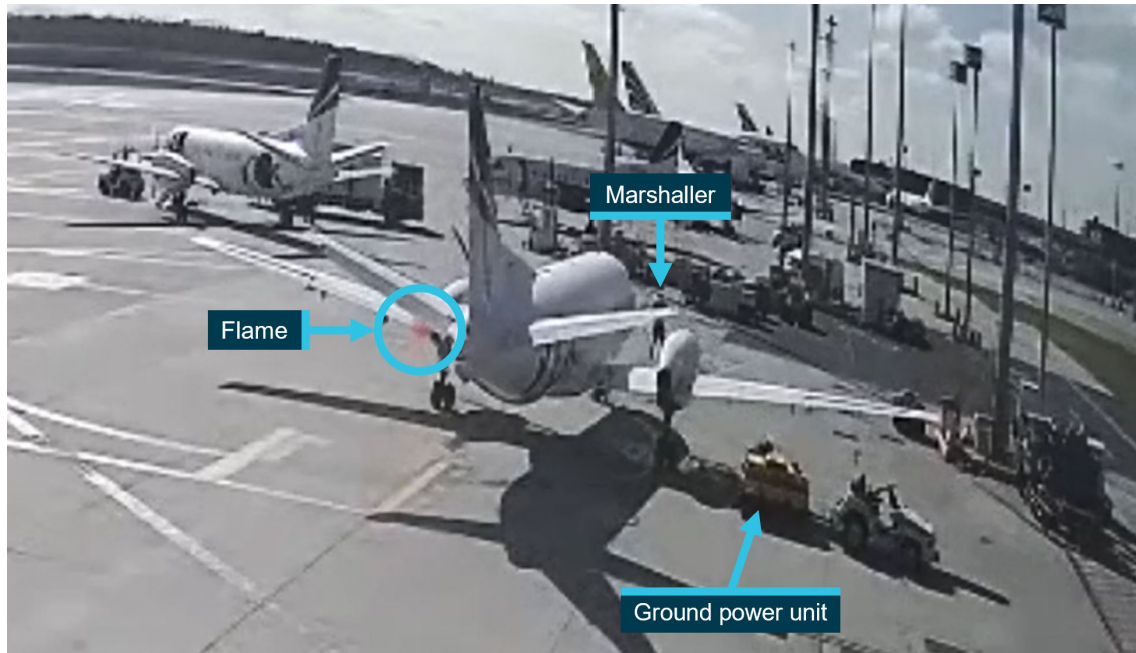
At 1445:28, as the left engine propeller began to rotate again as part of the engine motoring procedure, a tailpipe fire had developed as indicated by flame and smoke coming from the rear of the engine. The marshaller, who was still positioned at the front of the aircraft, saw a 'burst of flame' from the back of the engine (Figure 1) and began to signal to the flight crew to stop what they believed to be an additional engine start (as they were unaware of the motoring procedure). As the marshaller and flight crew were not able to communicate verbally (there was no radio and no communications headset for the Saab 340), the marshaller reported they tried to signal to the captain to shut the engine down using a 'cut-throat' hand signal. They also tried to indicate that there was a fire coming from the back of the engine, however, the marshaller could not recall the hand signal for fire and instead attempted to communicate it by mouthing the word 'fire' and gesturing to the left engine. CCTV recorded the marshaller waving their hands at this time. The captain was responding to the marshaller verbally (noting the marshaller could not hear) advising that they had to continue, however the marshaller continued to try to advise that they had seen fire from the left engine. As a result of the marshaller indicating they observed flames from the engine, the captain ceased motoring the engine and the left propeller stopped rotating.

Figure 1: Still image of CCTV showing flame during first motoring attempt

However, during this process burning fuel was blown through the tailpipe, appearing as a plume of flame and smoke behind the engine. As the left propeller began to rotate during this motoring attempt, the marshaller (unaware of the motoring required by the procedure) mistakenly thought that the flight crew were attempting to restart the engine. Having observed the flame and smoke, the marshaller signalled to the flight crew, which prompted the captain to stop motoring the engine. Residual fuel would have continued to burn inside the engine.

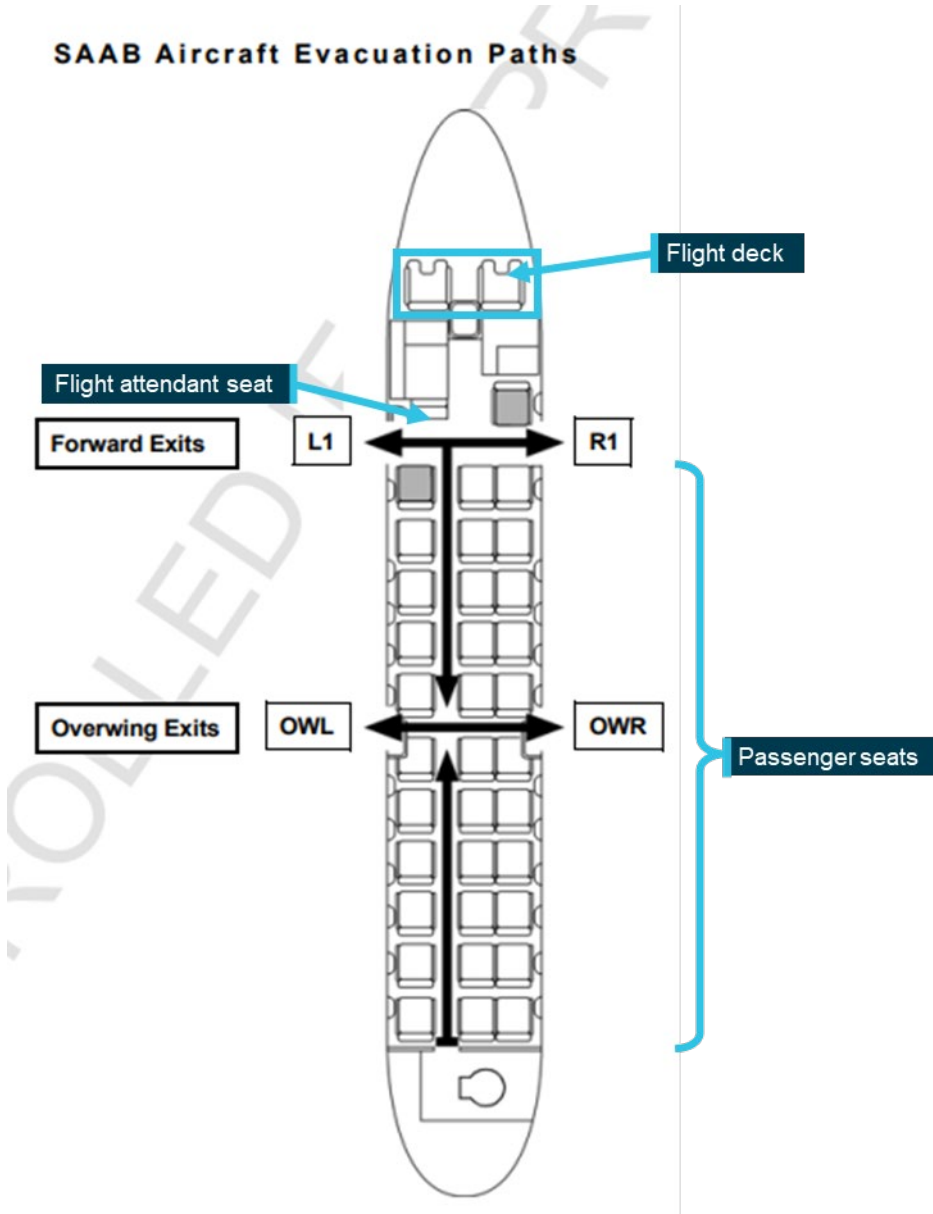
There are 4 emergency exits on the Saab 340 type aircraft. There are 2 exits at the front of the cabin in row 1, and 2 overwing exits in row 6. The sill height of the 2 forward exits is 1.68 m, with no emergency escape slides fitted (Figure 3).

Figure 3: Emergency exit locations

For this occurrence, the evacuation, from when the evacuation announcement was made until all passengers and crew had evacuated, was completed in about 4 minutes utilising one of the 4 exits.

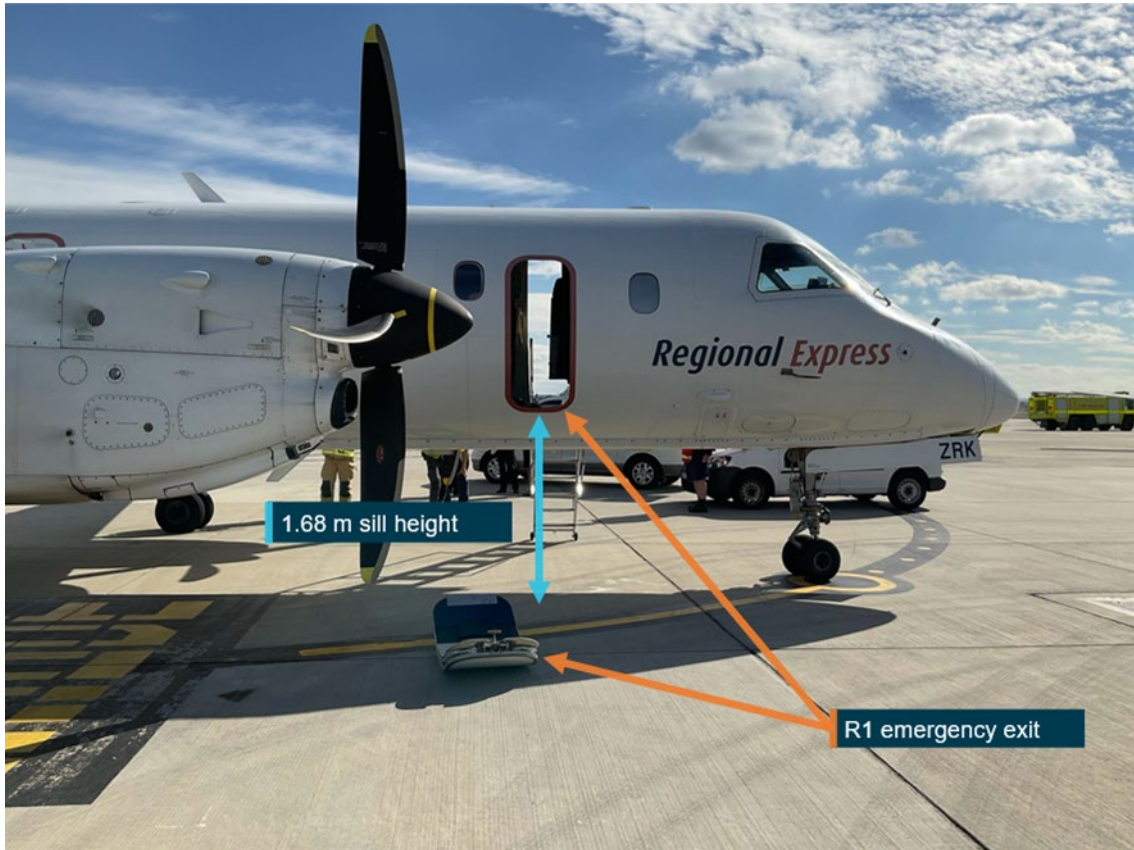
The first passenger at the R1 exit hesitated due to the height of the door sill (1.68 m without steps or escape slide) but was encouraged by the flight attendant to exit. This passenger received a minor injury. The FO exited the aircraft after the first passenger, and a refueller and ground staff assisted the remainder of passengers to evacuate. The flight attendant continued to instruct passengers to evacuate and to 'sit and jump'. Some passengers attempted to bring their bags during the evacuation and the flight attendant and the captain (after exiting the flight deck) instructed them to leave everything behind. After receiving these instructions, a small number of passengers still exited the aircraft with their bags.

Figure 4: R1 emergency exit on the Saab 340B
