Australian Government

Australian Transport Safety Bureau

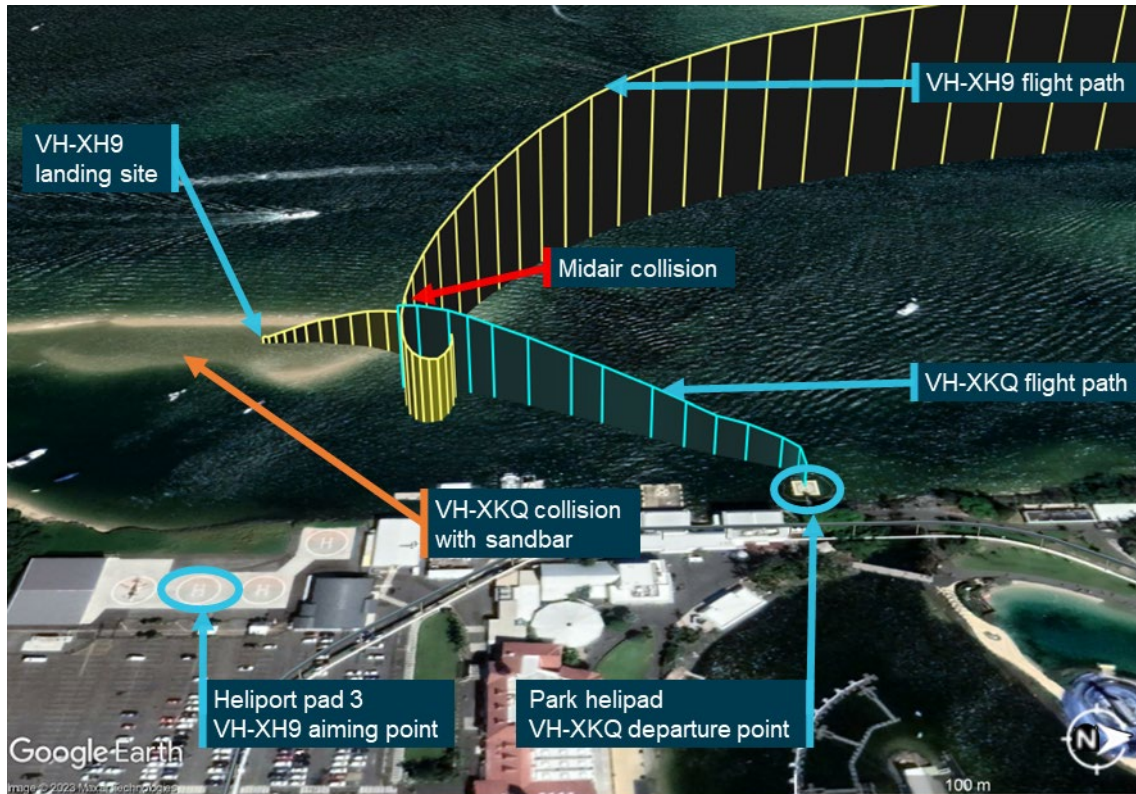
*Note: Satellite image was taken near high tide. Sandbar was exposed at the time of the accident.
Source: Google Earth, annotated by the ATSB*

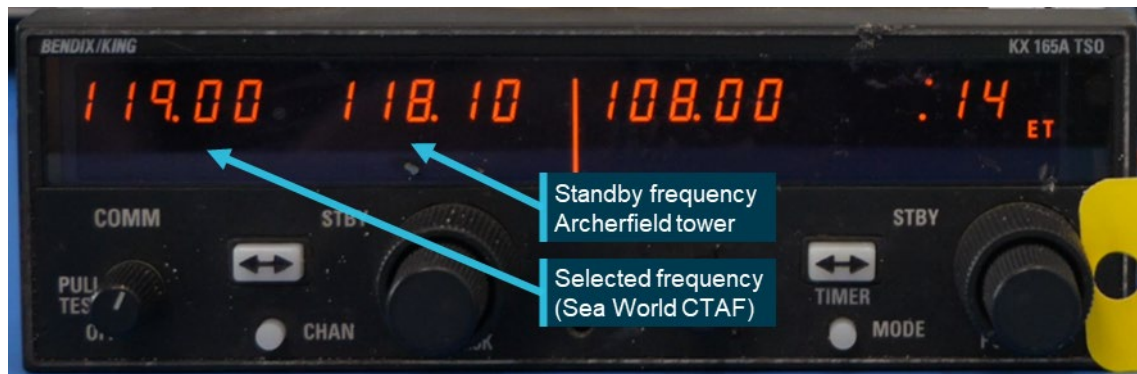
Figure 20: Bendix King KX-165A from VH-XH9 – indication on power up

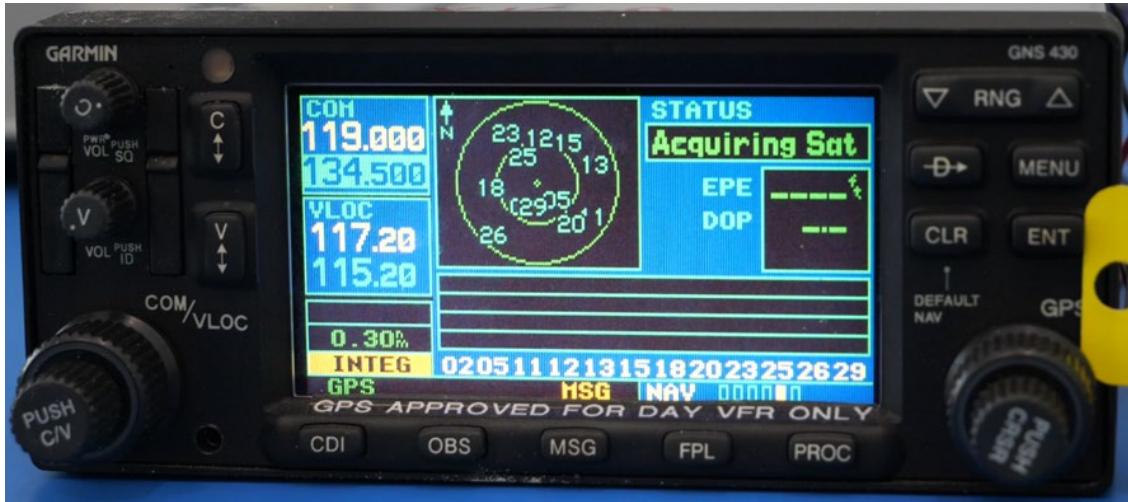
Figure 21: Garmin GNS430 (Com 1) from VH-XKQ – indication on power up after self-test

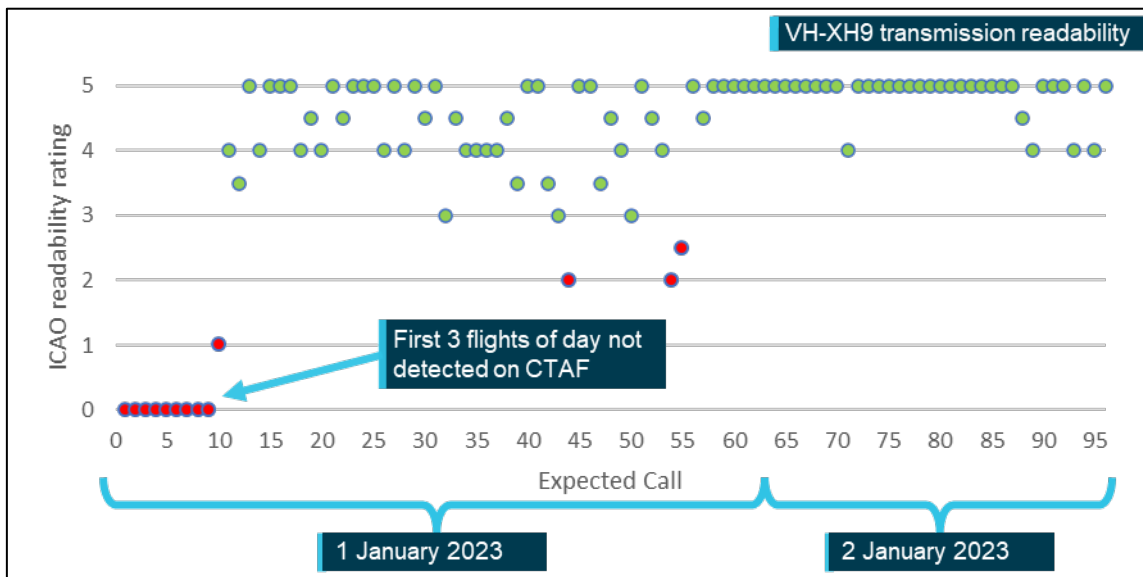
Figure 24: VH-XH9 transmission readability of scenic flight calls

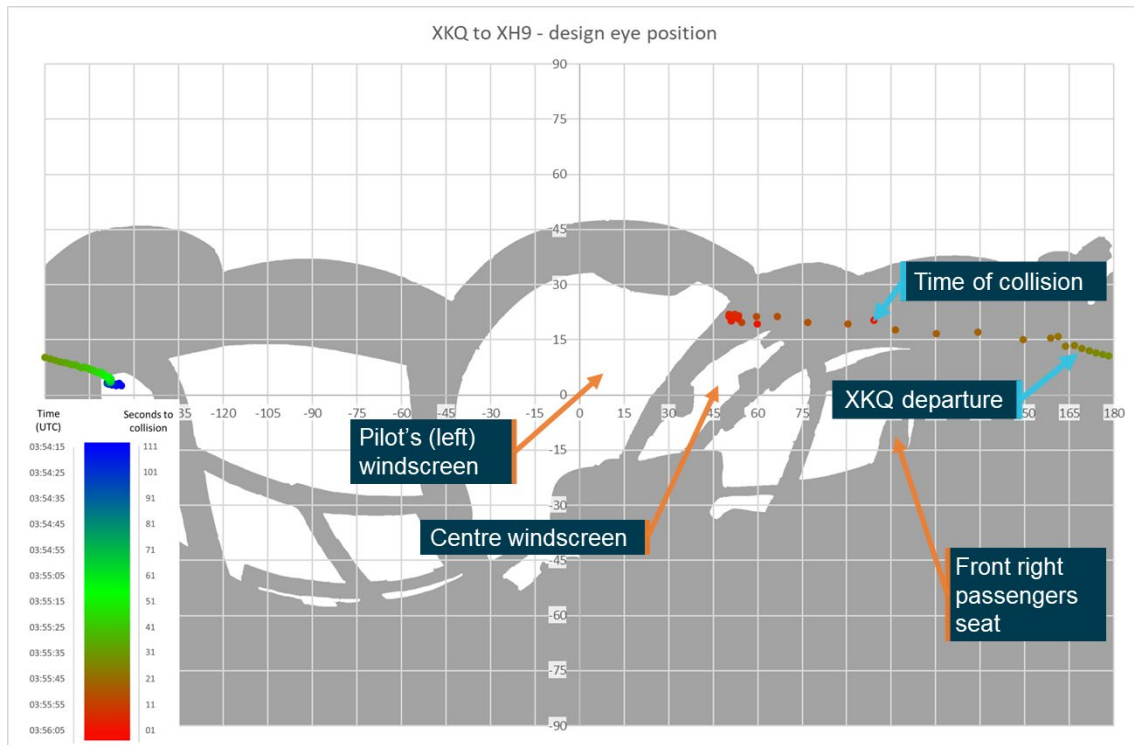
Note: Time scale reads from 111 seconds to collision (blue) to time of collision (red).
Source: ATSB

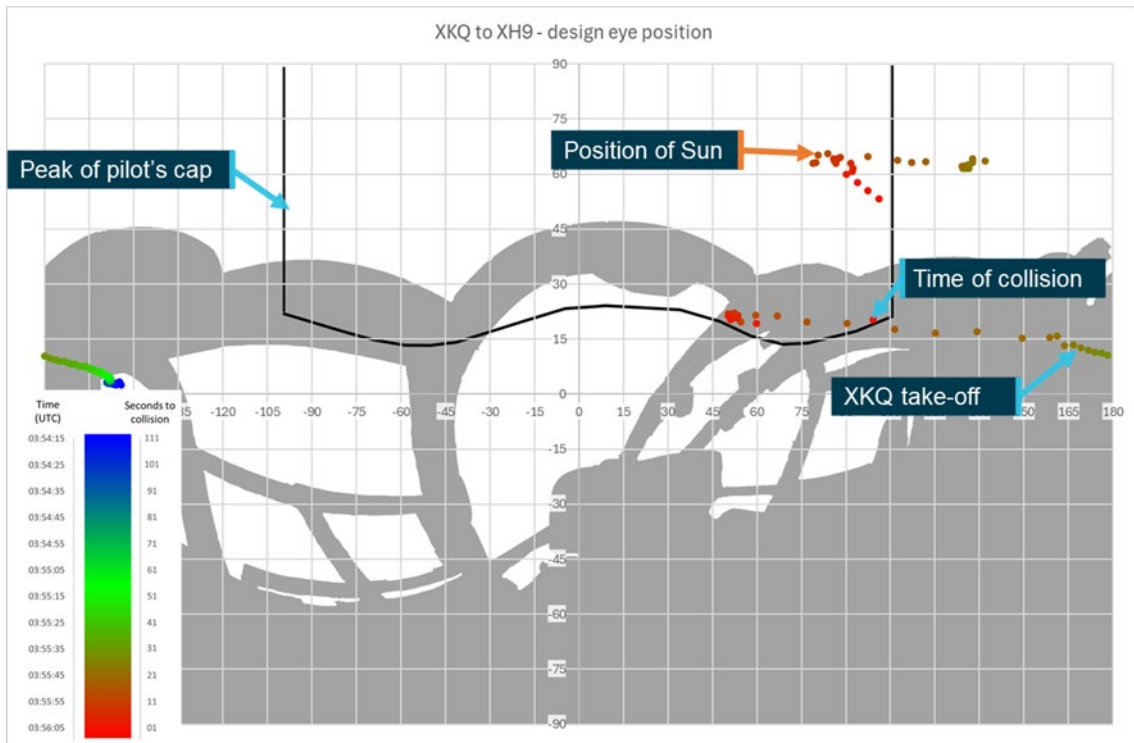
Note: Time scale reads from 111 seconds to collision (blue) to time of collision (red).
Source: ATSB

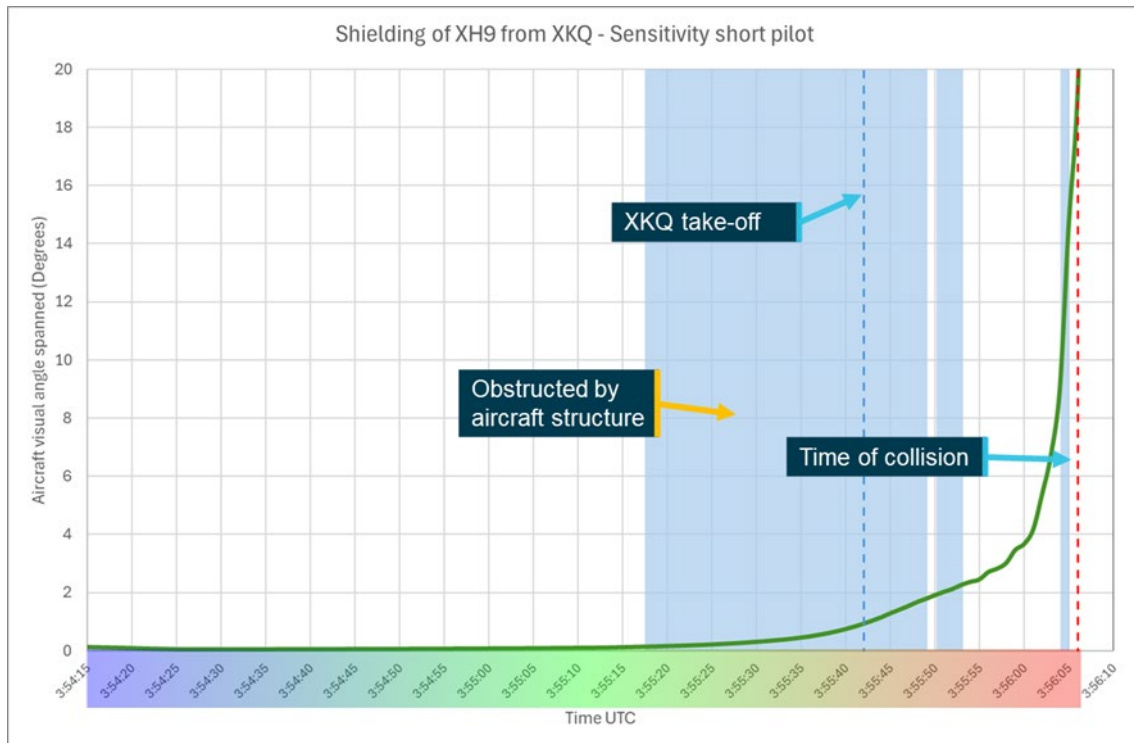
Figure 42: Sensitivity chart for short position

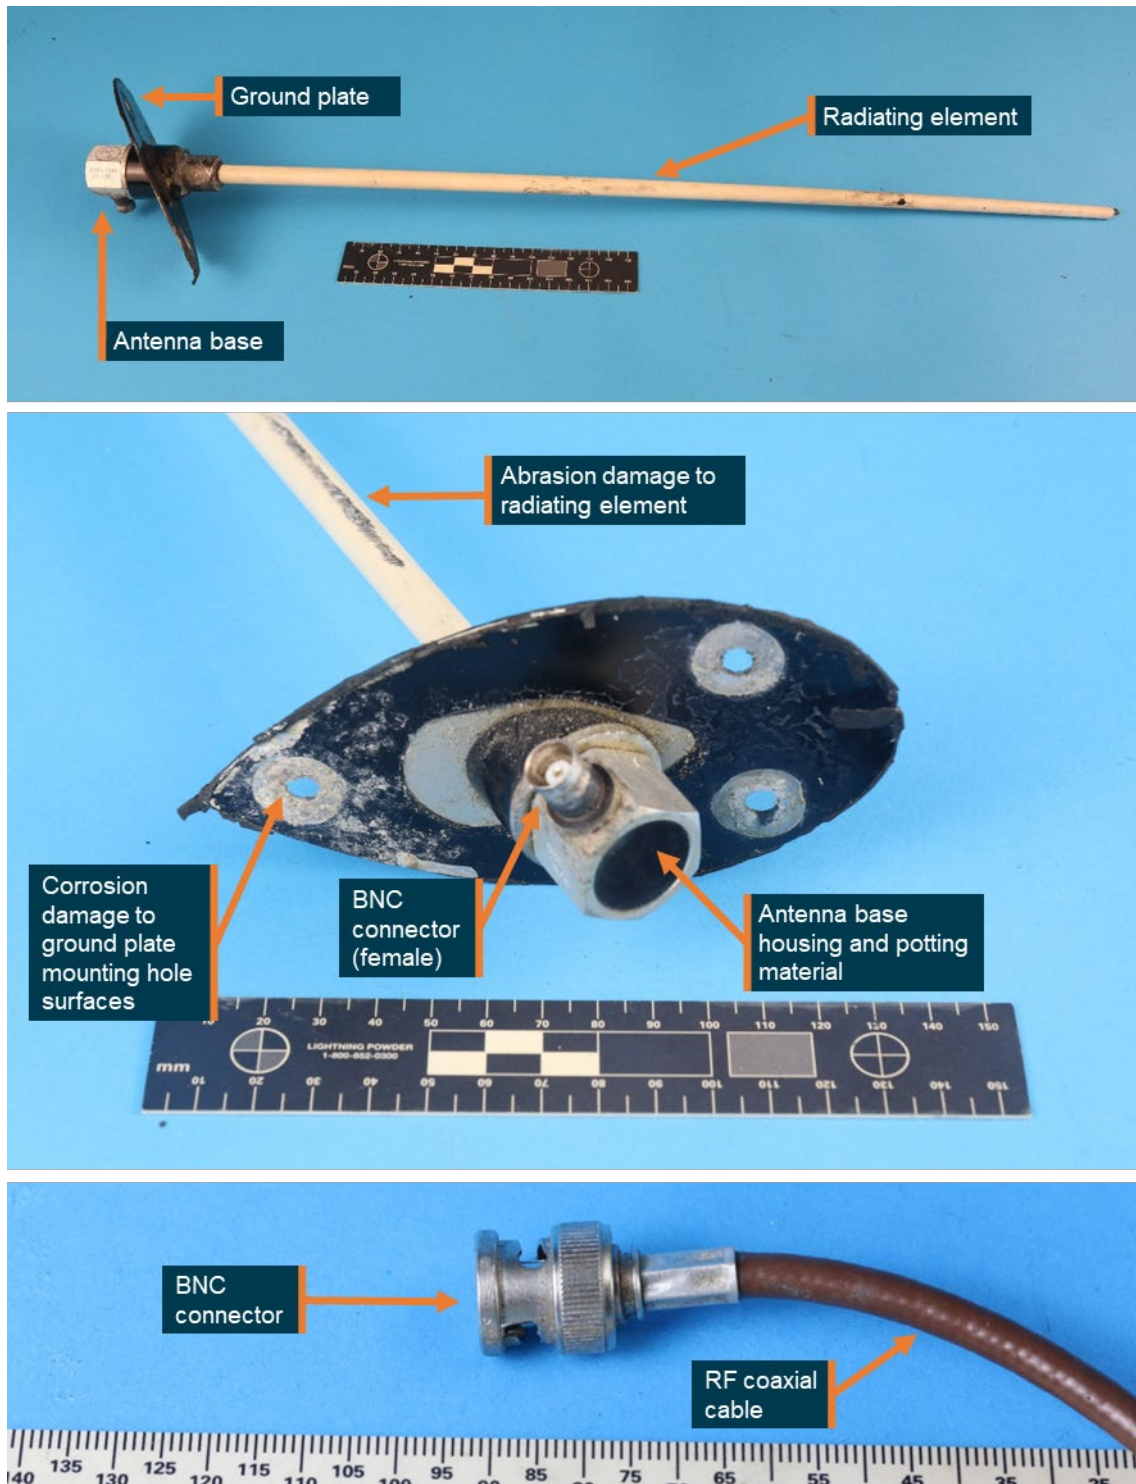
Surface corrosion was identified to each of the underside mounting holes of the ground plate.
Source: ATSB

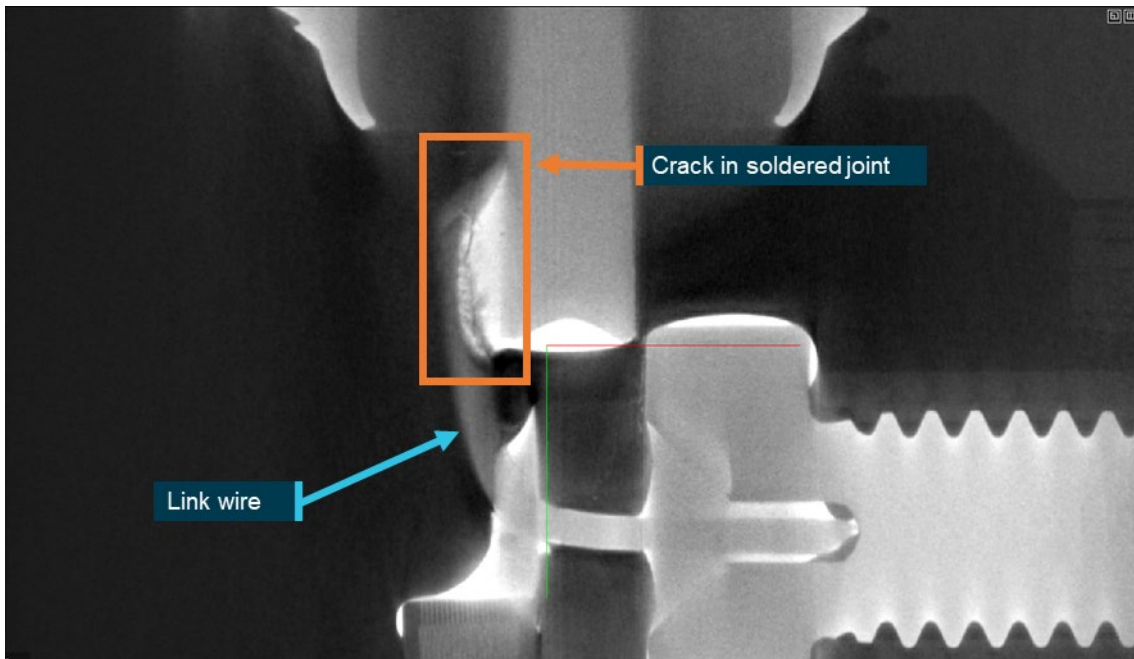
The X-ray image was captured when the antenna was intact.
 Source: Australian National University CTLab, annotated by the ATSB

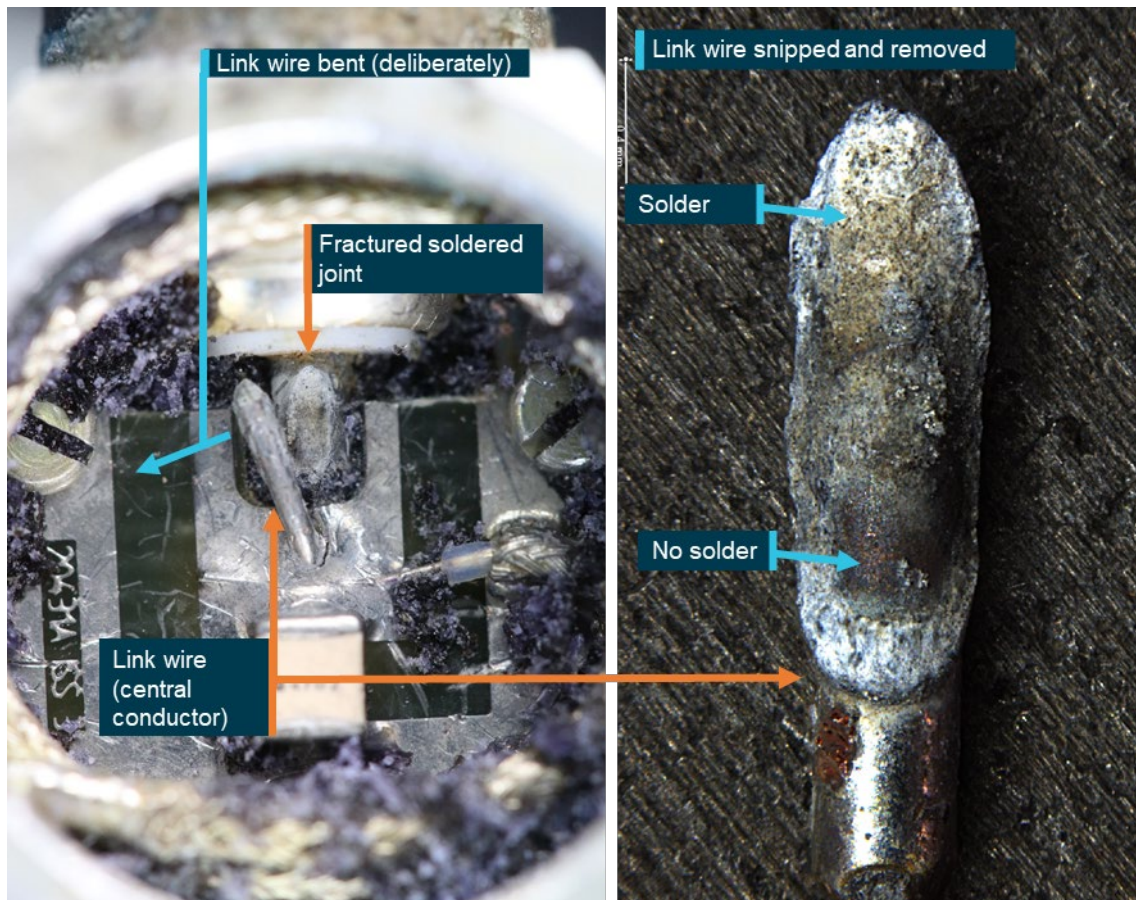
Upon removal of the potting compound, the link wire (central conductor) was able to be moved to the side, confirming that it had fractured from the circuit board.
Source: ATSB

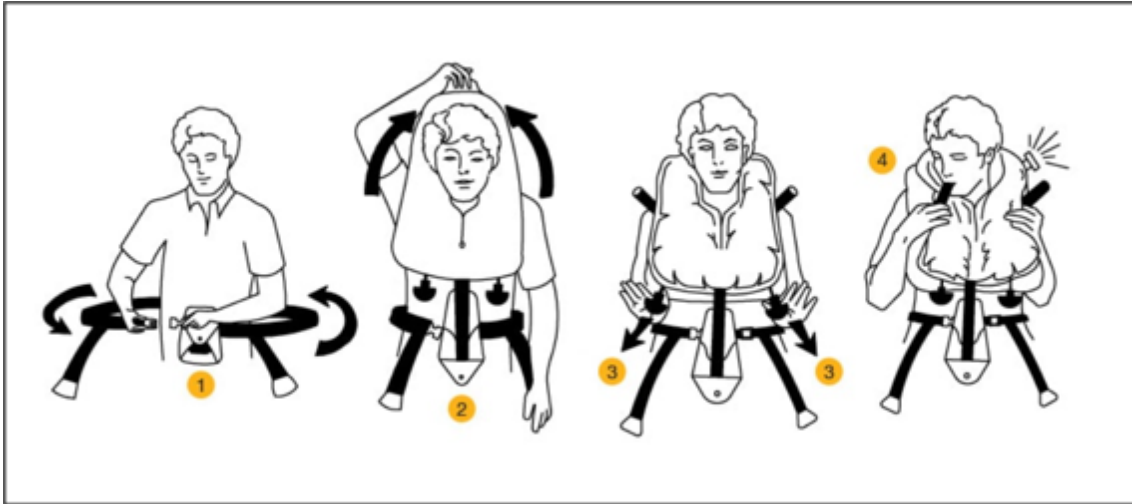
Source: Eastern Aero Marine

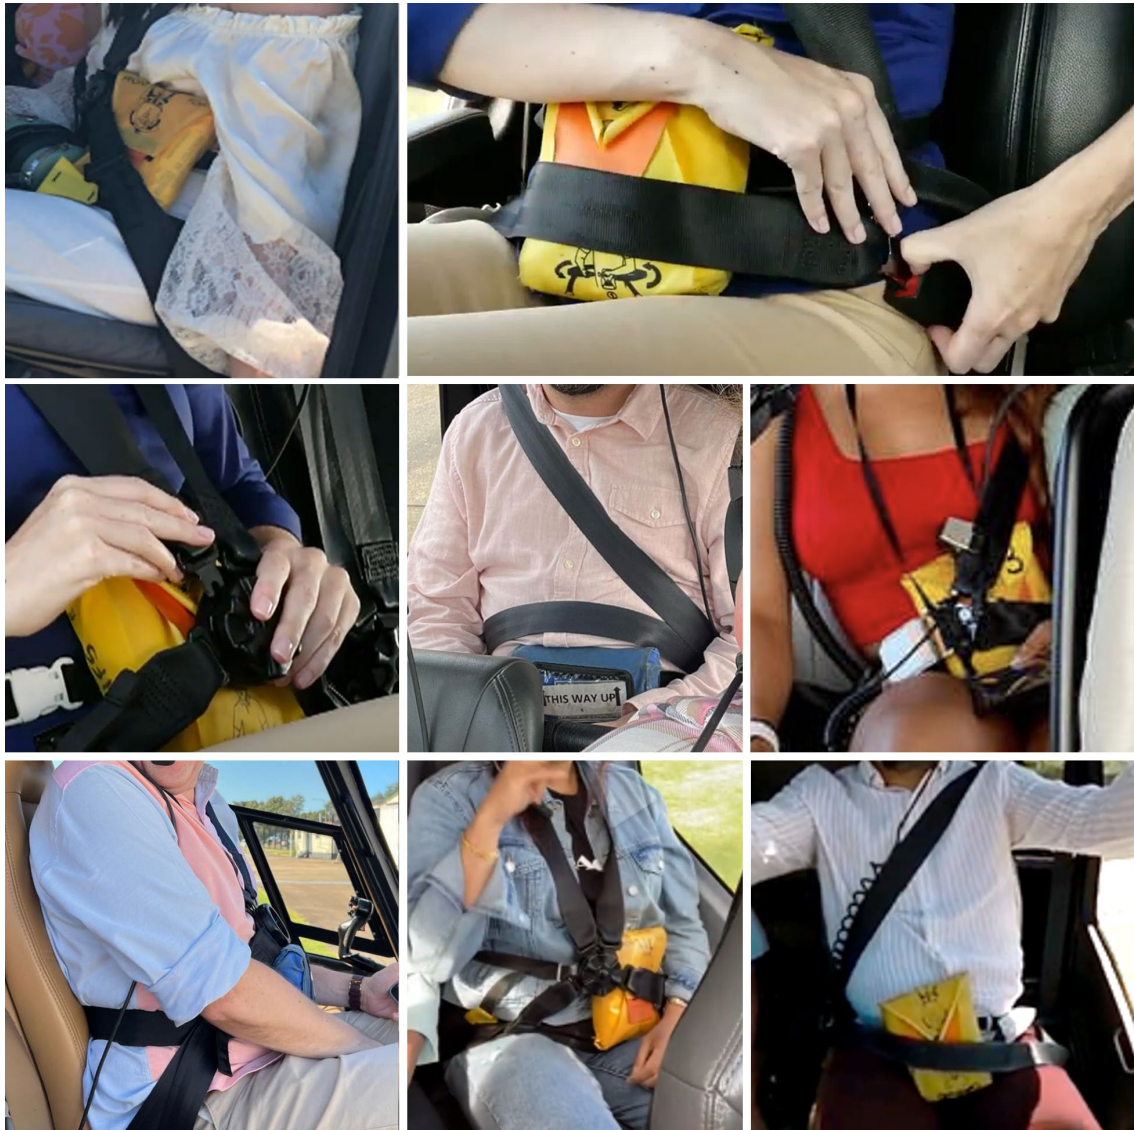
Source: Safety briefing videos from YouTube and other social media

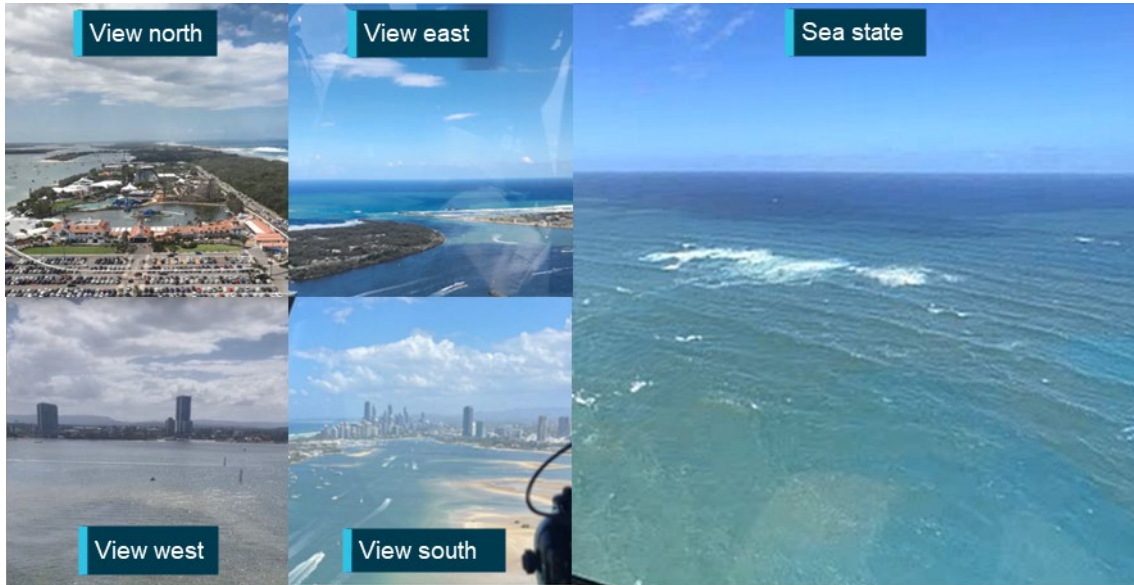
Source: Passengers on board XH9

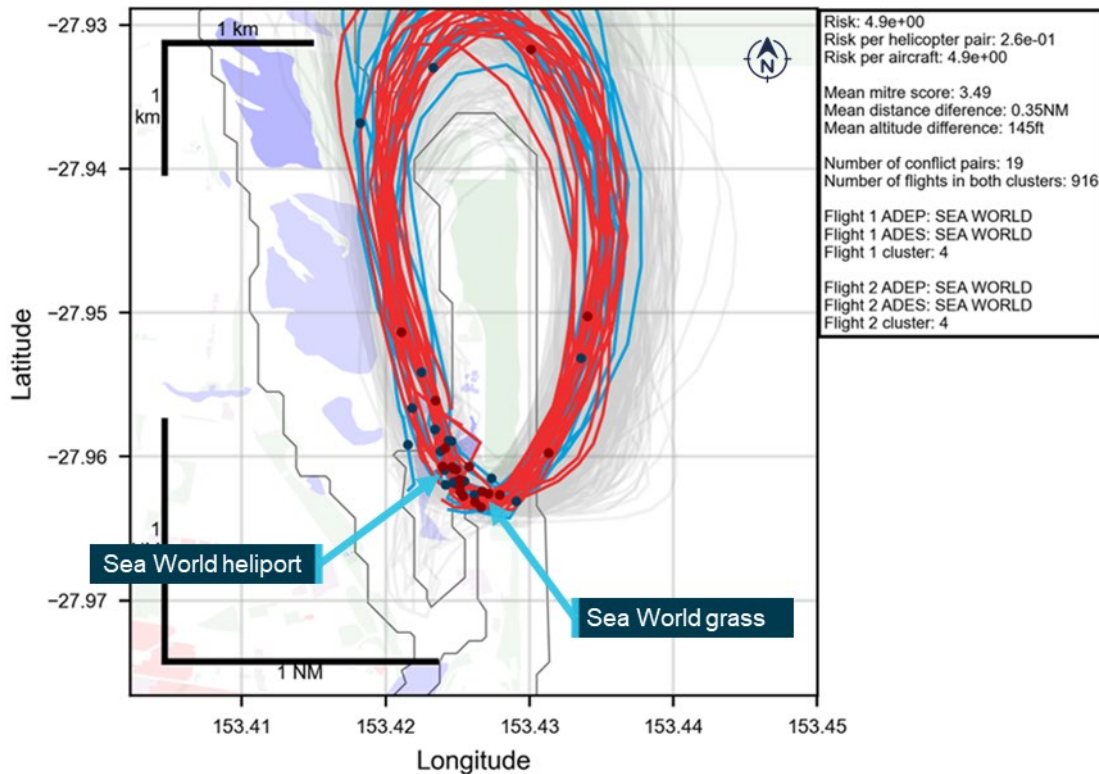
Each simultaneous pair has one red track and one blue track. The remainder of the tracks are grey. Blue dots on plot represent the location of blue trajectories at their closest point to a midair red trajectory; red dots on plot represent the location of red trajectories at their closest point to a midair blue trajectory.
 Source: Airservices Australia

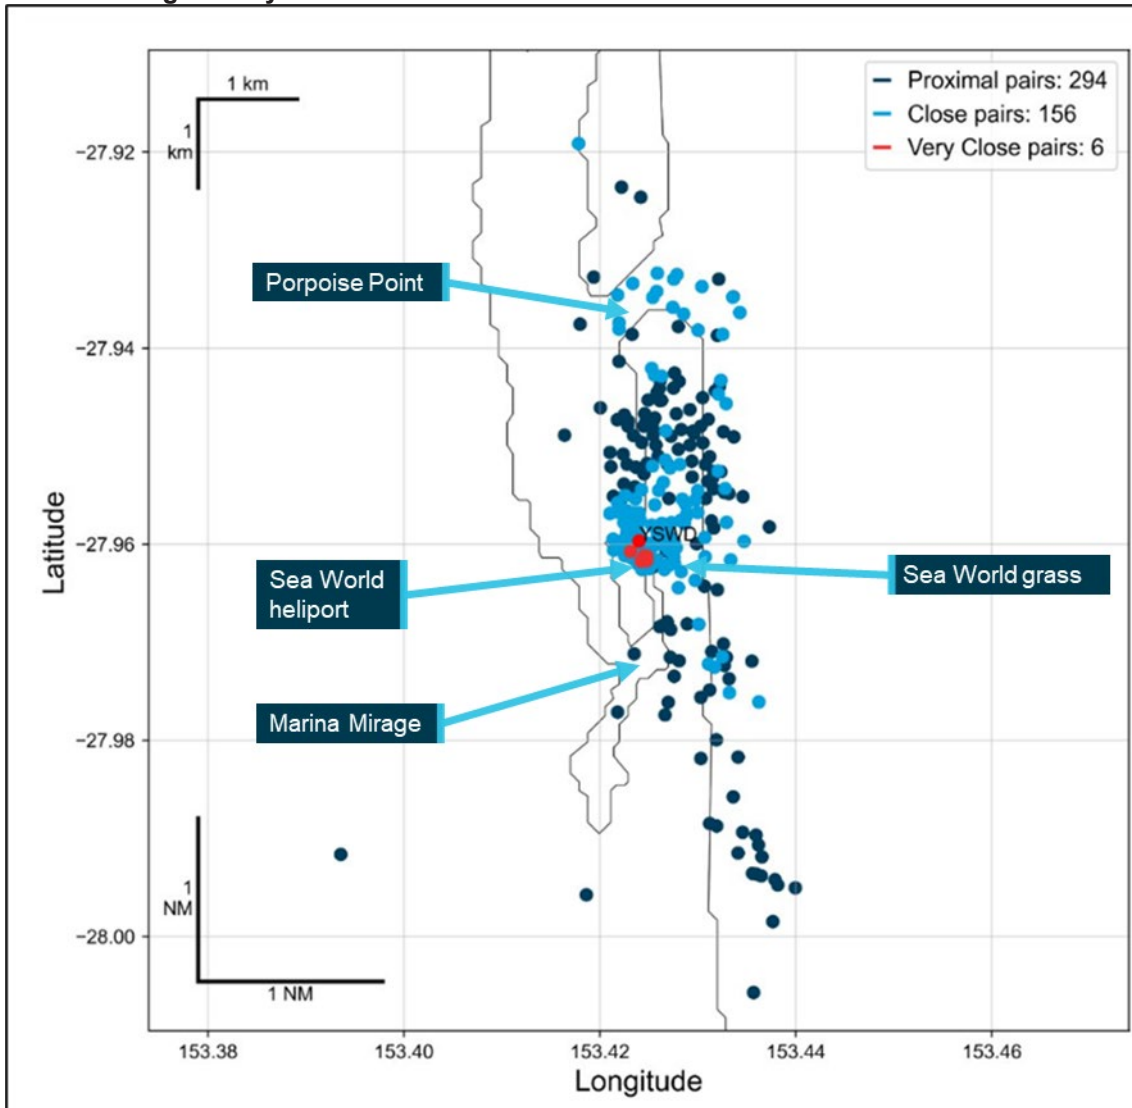
Note: Each dot represents the mid-point between the 2 helicopters at their closest point when they register as either proximal, close or very close in distance. Helicopters do not overfly the theme park.
Source: Airservices Australia

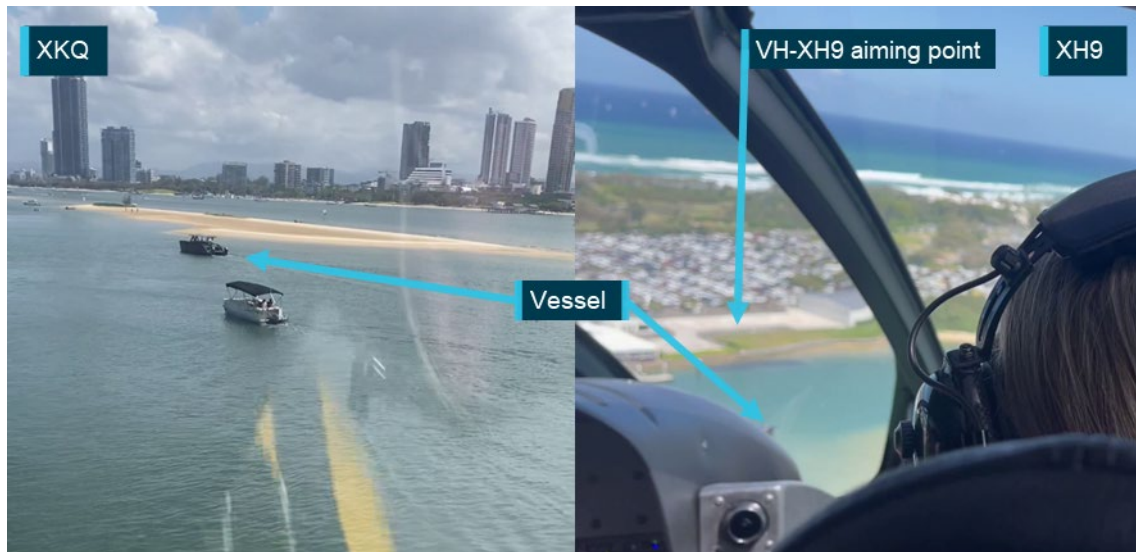
Source: passengers on board VH-XH9, annotated by the ATSB

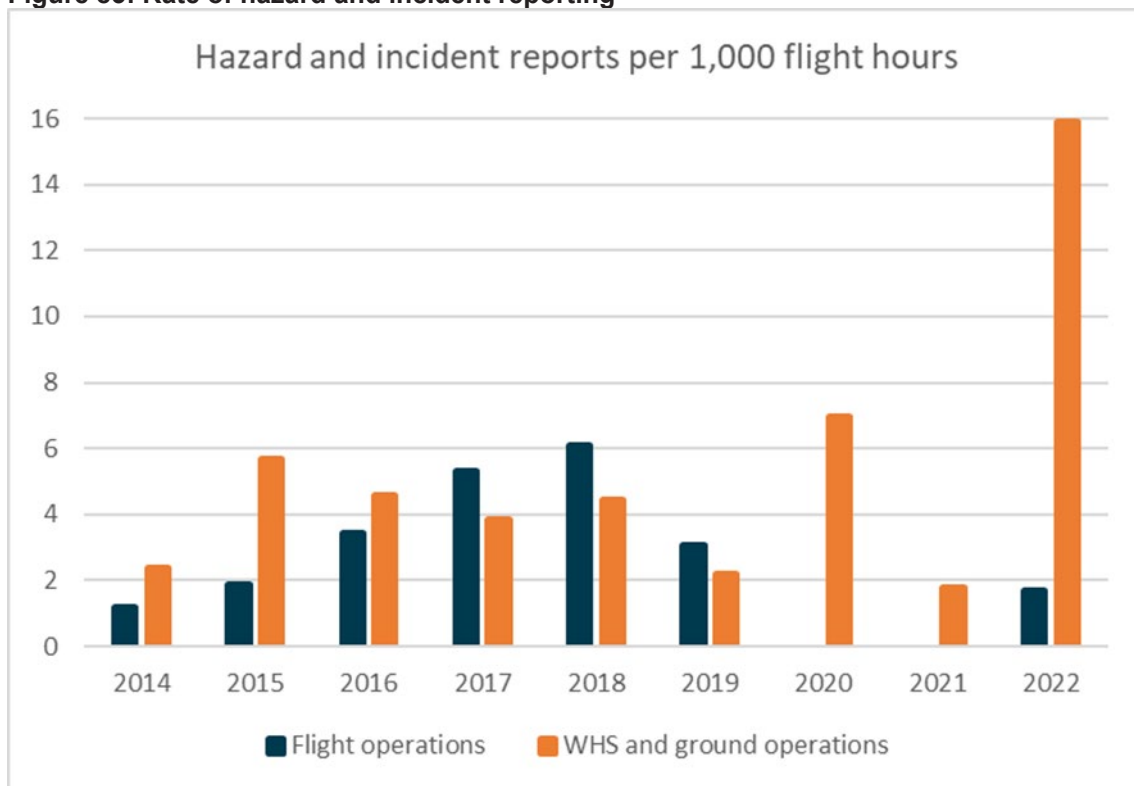
*Note: Operator-supplied flight and hazard reporting data has been normalised to a rate of reports per 1,000 flight hours.
Source: ATSB from operator flight and reporting data*

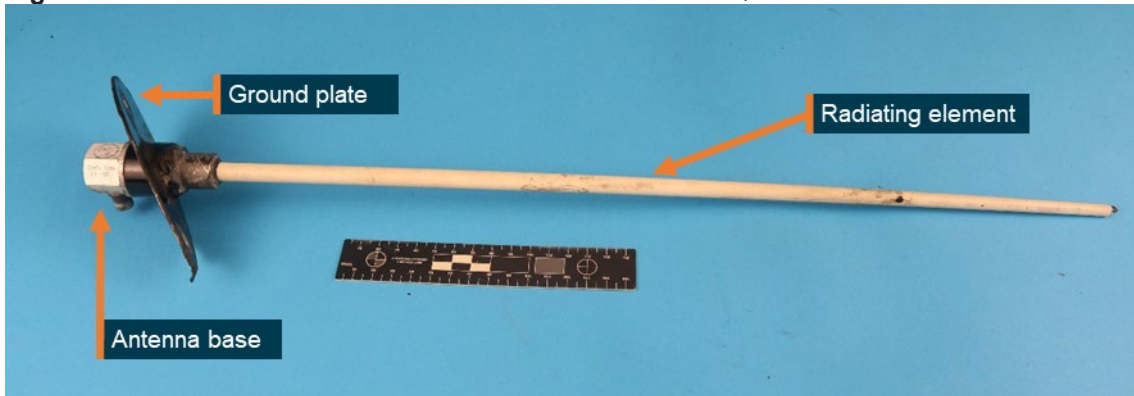
Surface corrosion was identified to the underside mounting holes of the ground plate.
Source: ATSB

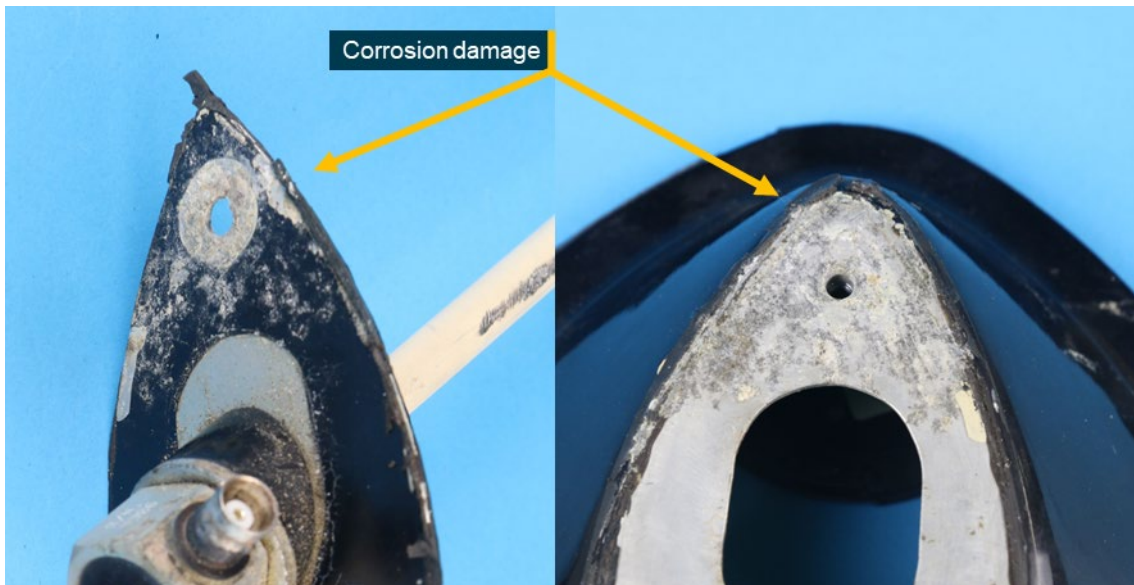
Figure A3: Corrosion damage to the fix hole surfaces surrounding where the antenna mounting plate (left) was attached to the blister panel (right)

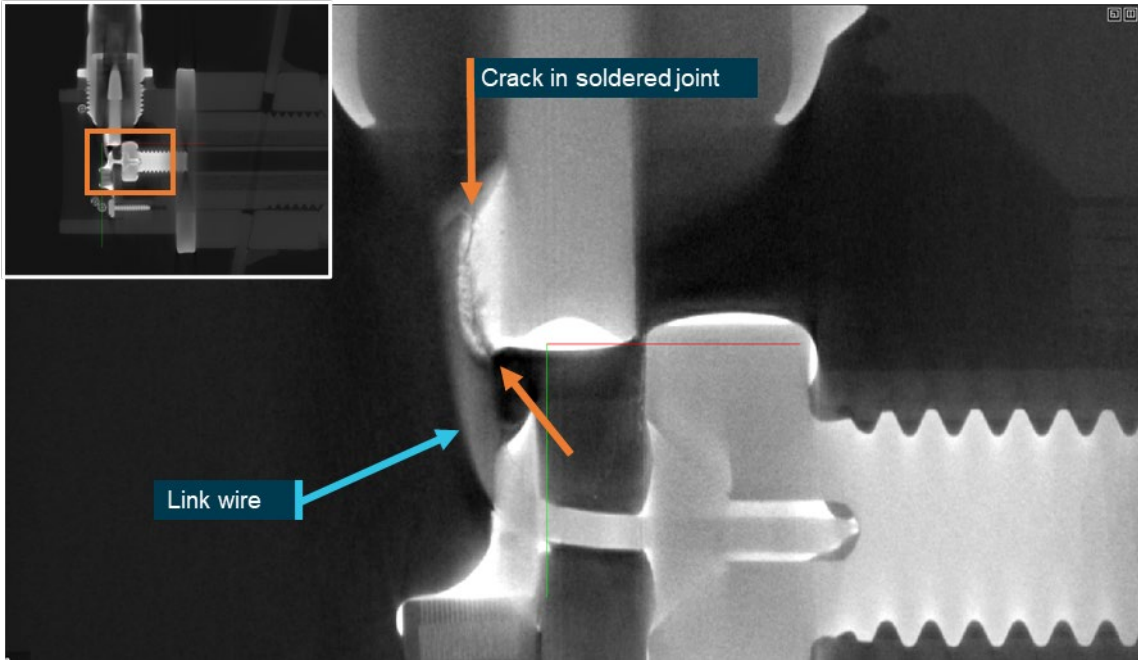
Source: CTLab, annotated by the ATSB

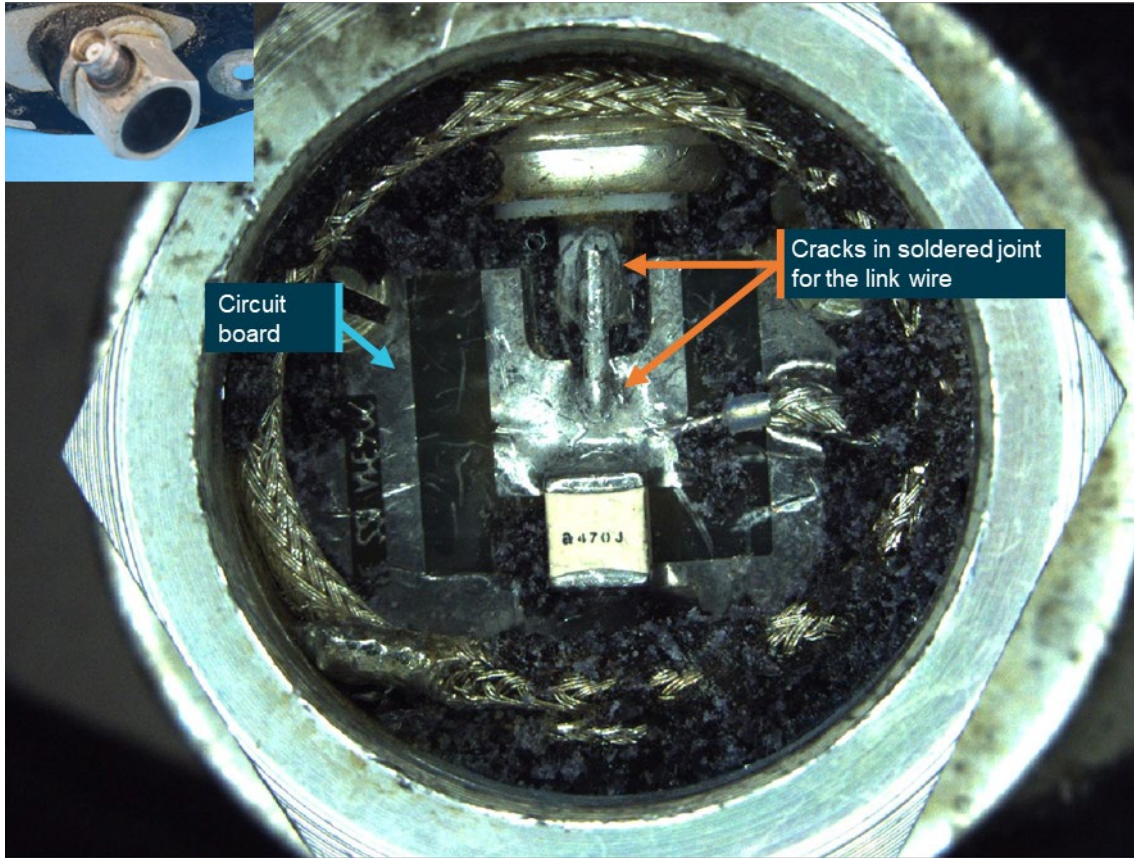
Figure A7: Antenna base: removal of the potting compound from within the antenna base confirmed the soldered joint containing the link wire had cracked and fractured from the circuit board

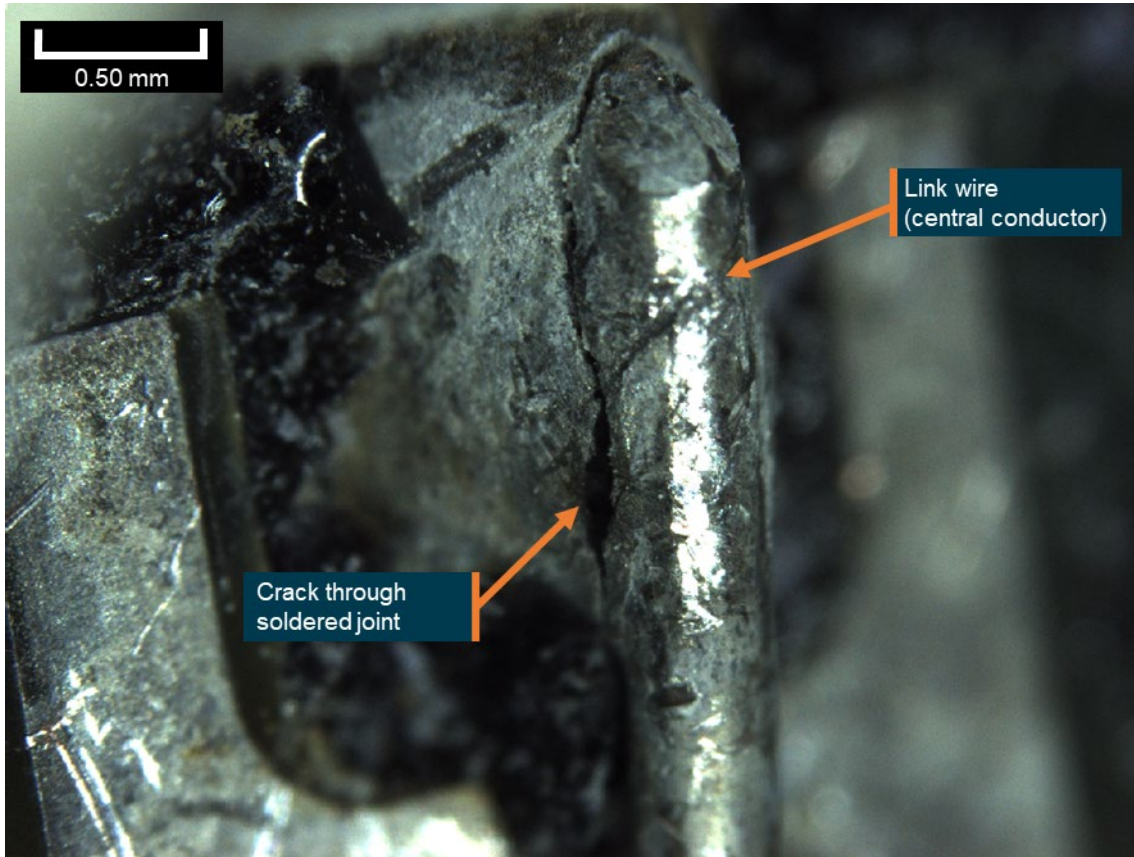
Figure A8: Antenna base: close view of the crack in the soldered joint between link wire and circuit board

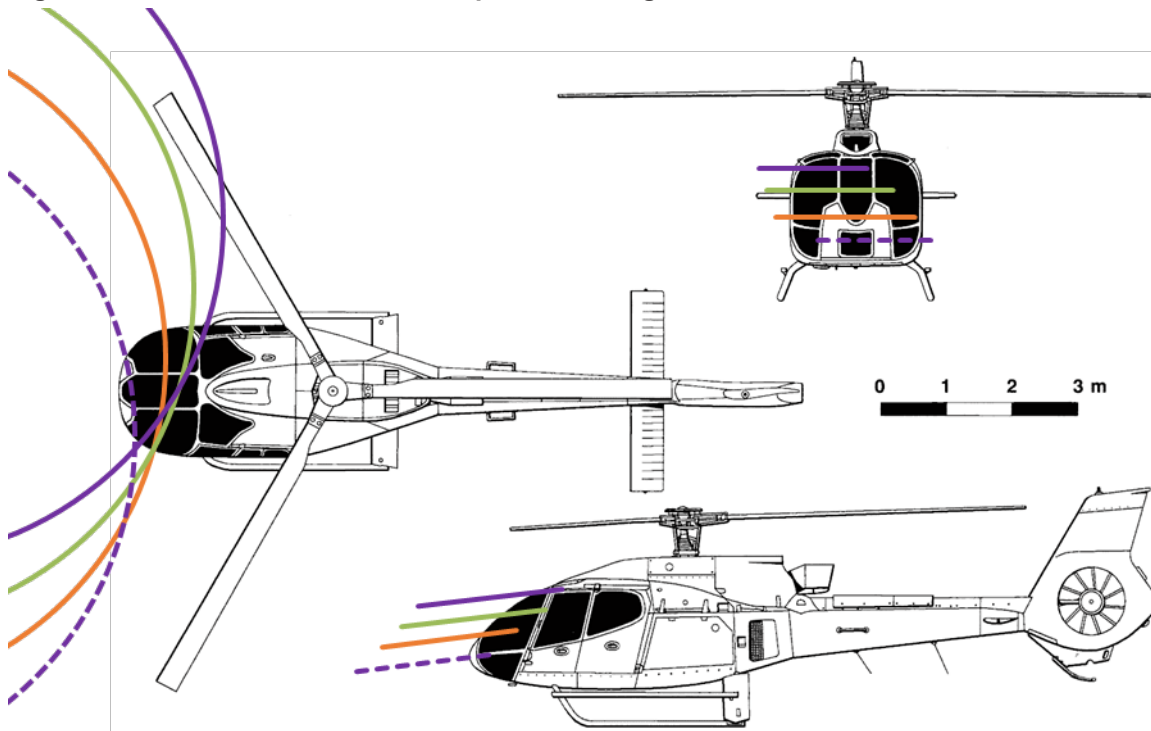
*The orange, green and purple circles represent the blade tip path, which is not circular but rather moving in an elliptical and eccentric motion. The blade tip path is represented in the above image as blade discs at one third rotation intervals.
Source: Drawingdatabase.com, modified by the ATSB*

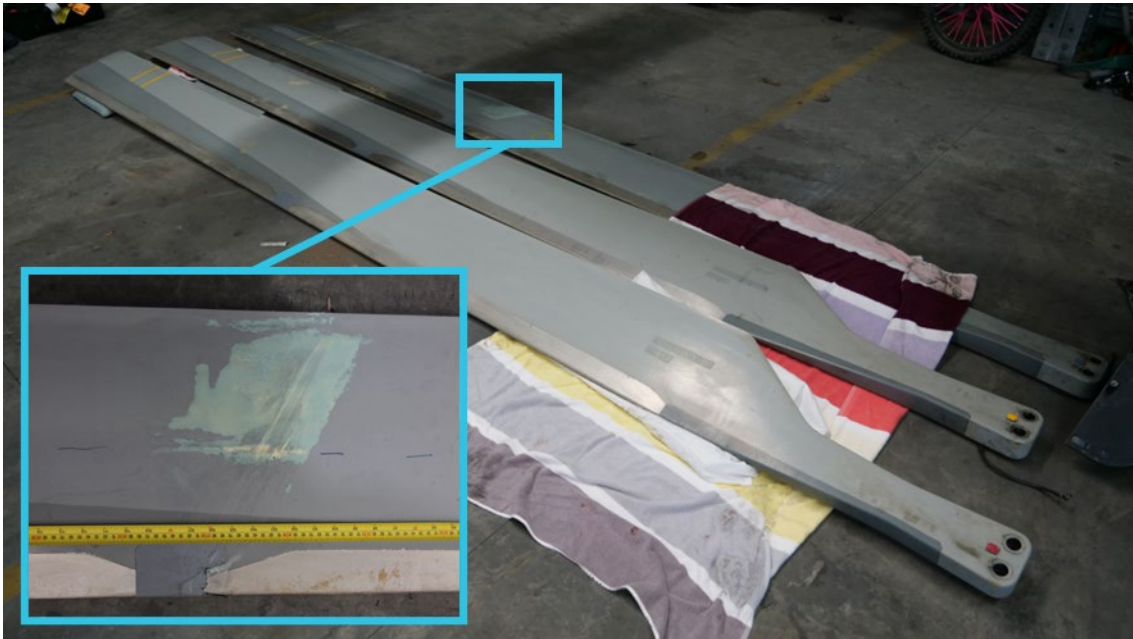
Figure B4: Paint removal mark in VH-XH9 blue blade (dashed blue pen mark denotes delamination edge)

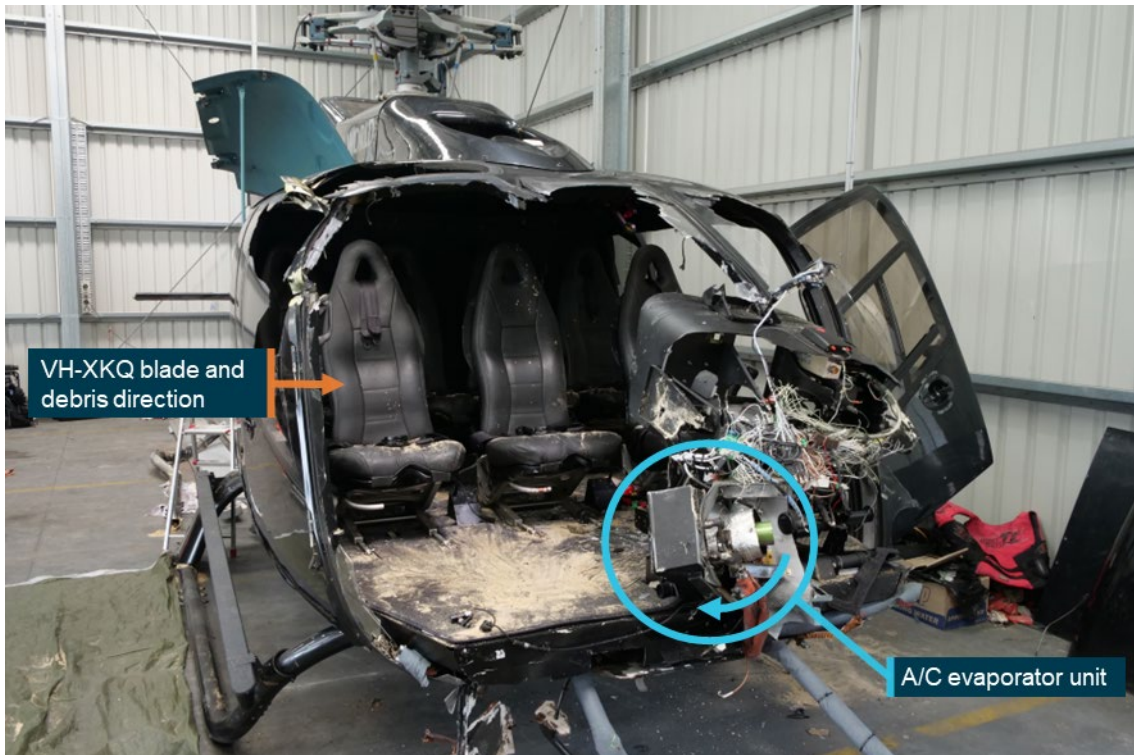
Figure B5: VH-XH9 air-conditioning cockpit evaporator unit distorted in the direction of VH-XKQ's travel

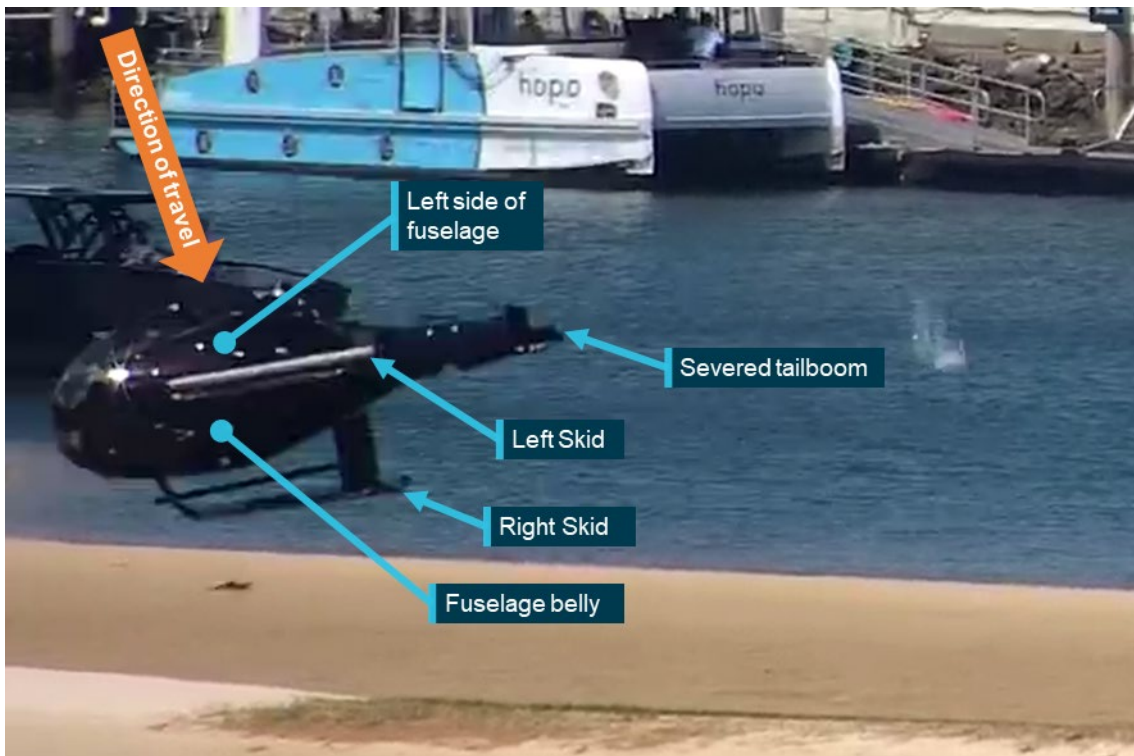
Source: Gold Coast Safety Camera Network, annotated by the ATSB
