Australian Government

Australian Transport Safety Bureau

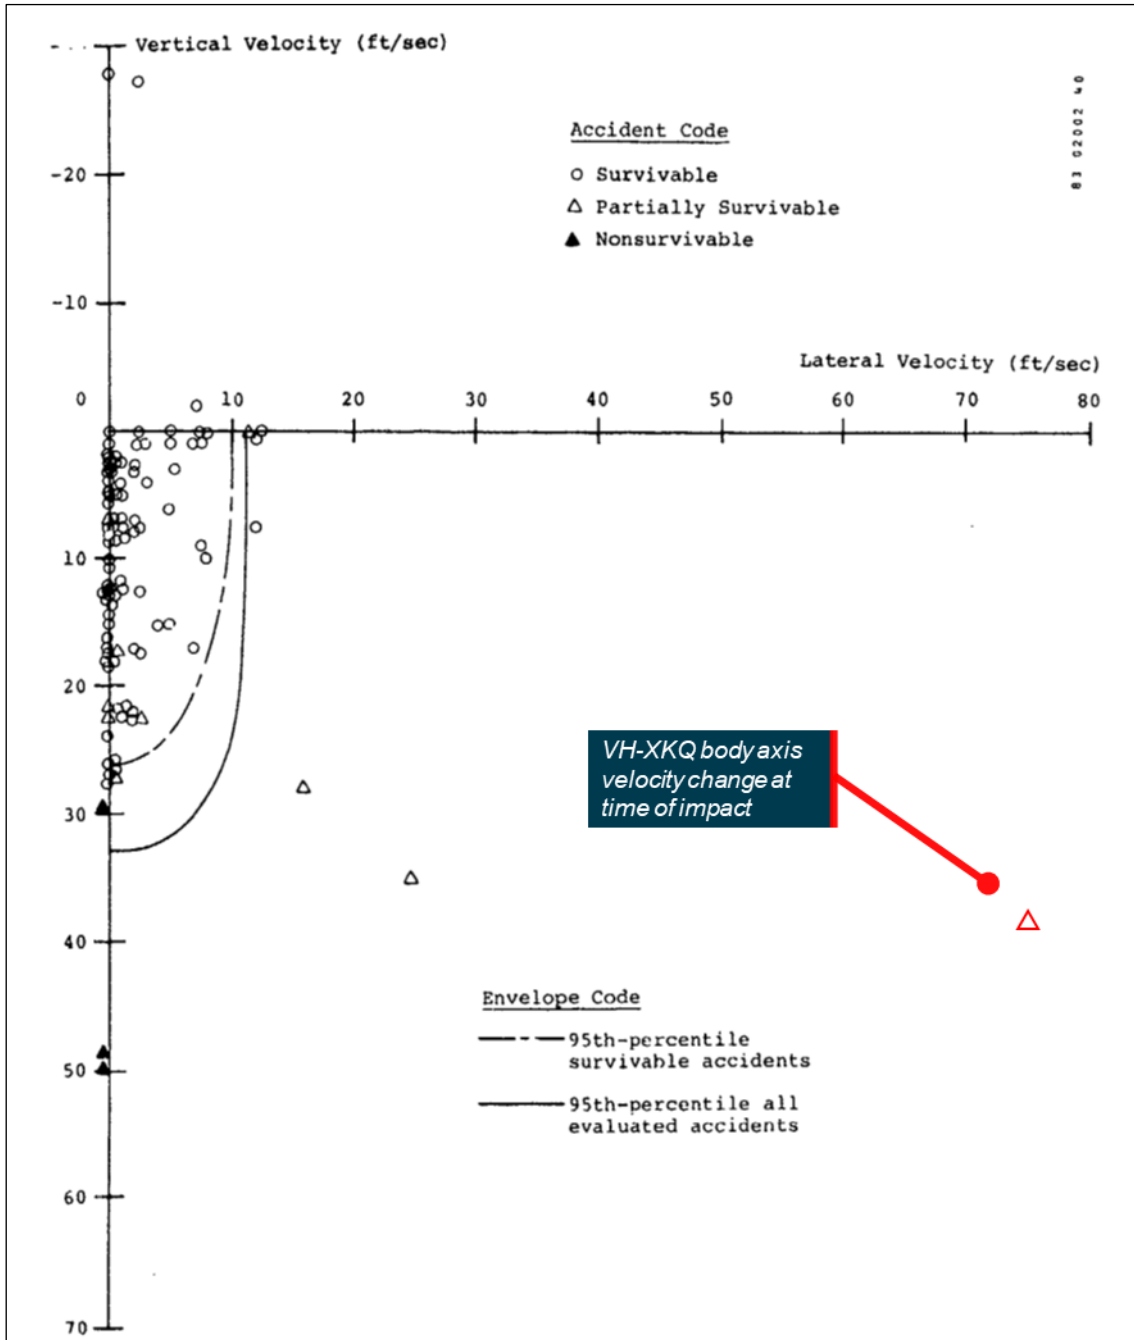
When VH-XKQ impacted the ground, the lateral vertical velocity was at least 7 times more severe than the 95th percentile of historical survivable accidents. The accident was at least 3 times more extreme than the next most severe partially survivable accident documented.
 Source: Analysis of Rotorcraft Crash Dynamics for Development of Improved Crashworthiness Design Criteria, 1985, annotated by the ATSB

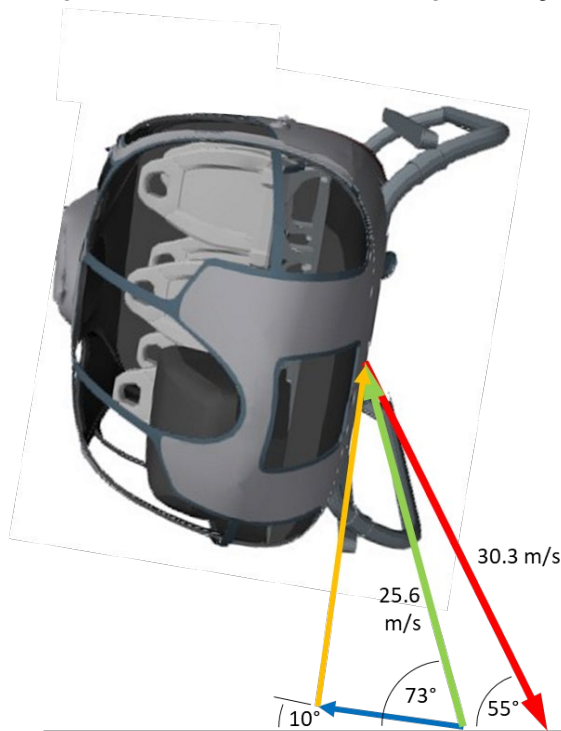
Source: 3dcadbrowser.com, annotated by ATSB

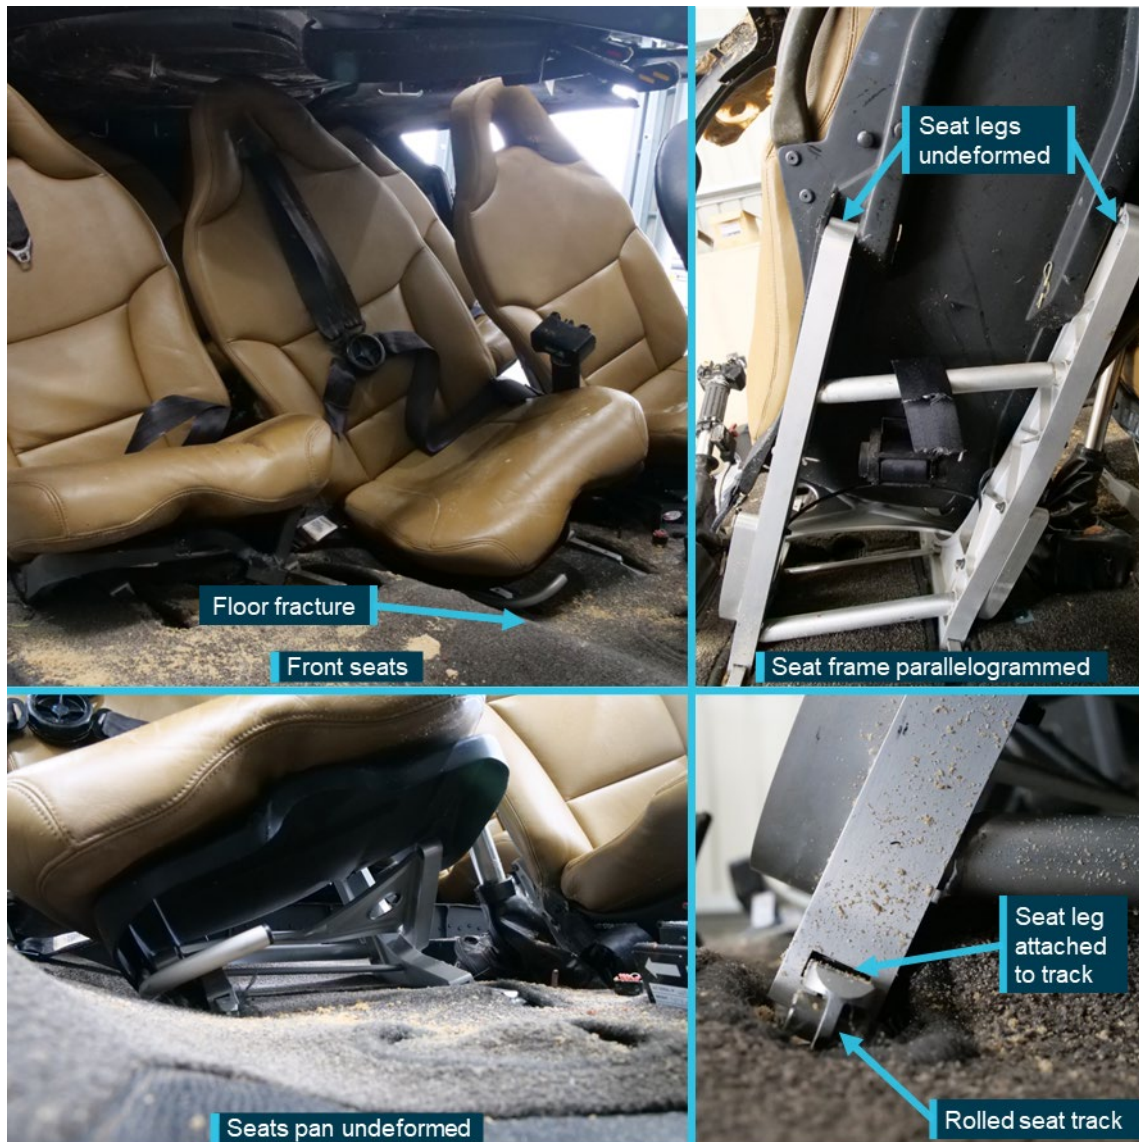
Figure B12: Composite picture of typical seat damage

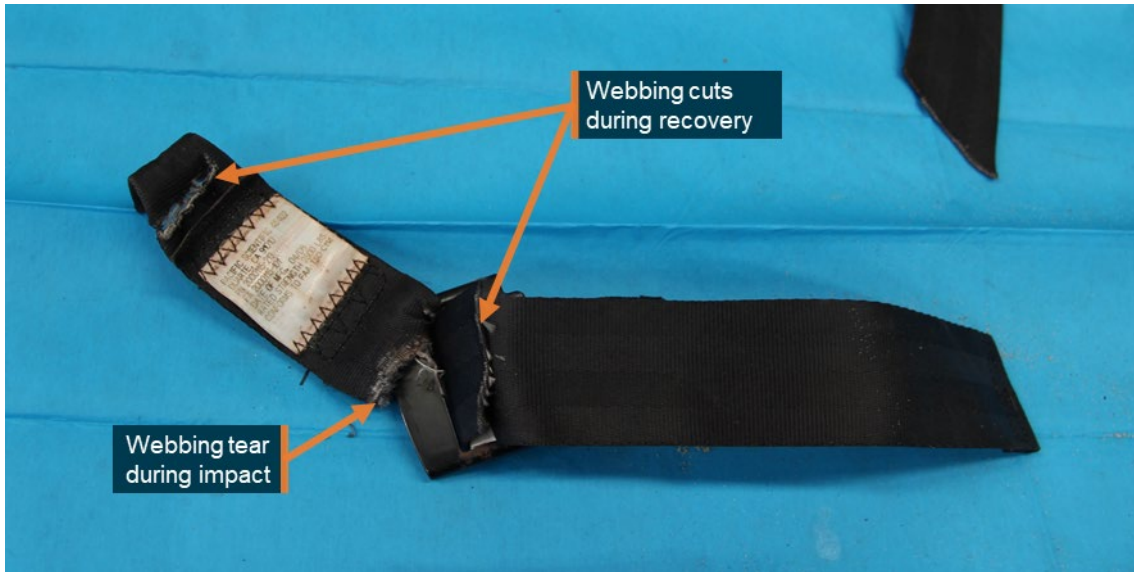
Figure B13: Rear right inboard seat right lap belt

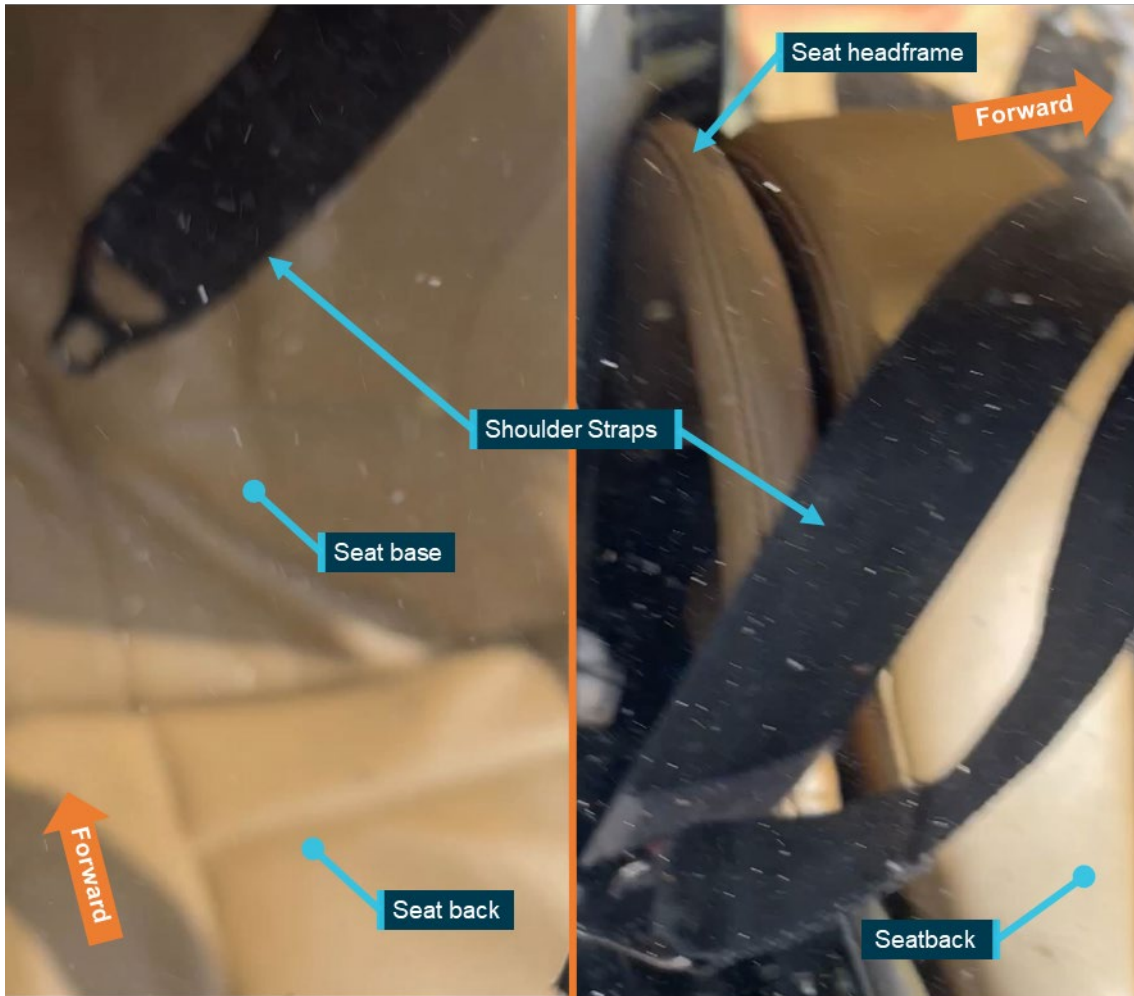
Source: Passenger video on board VH-XKQ, annotated by the ATSB

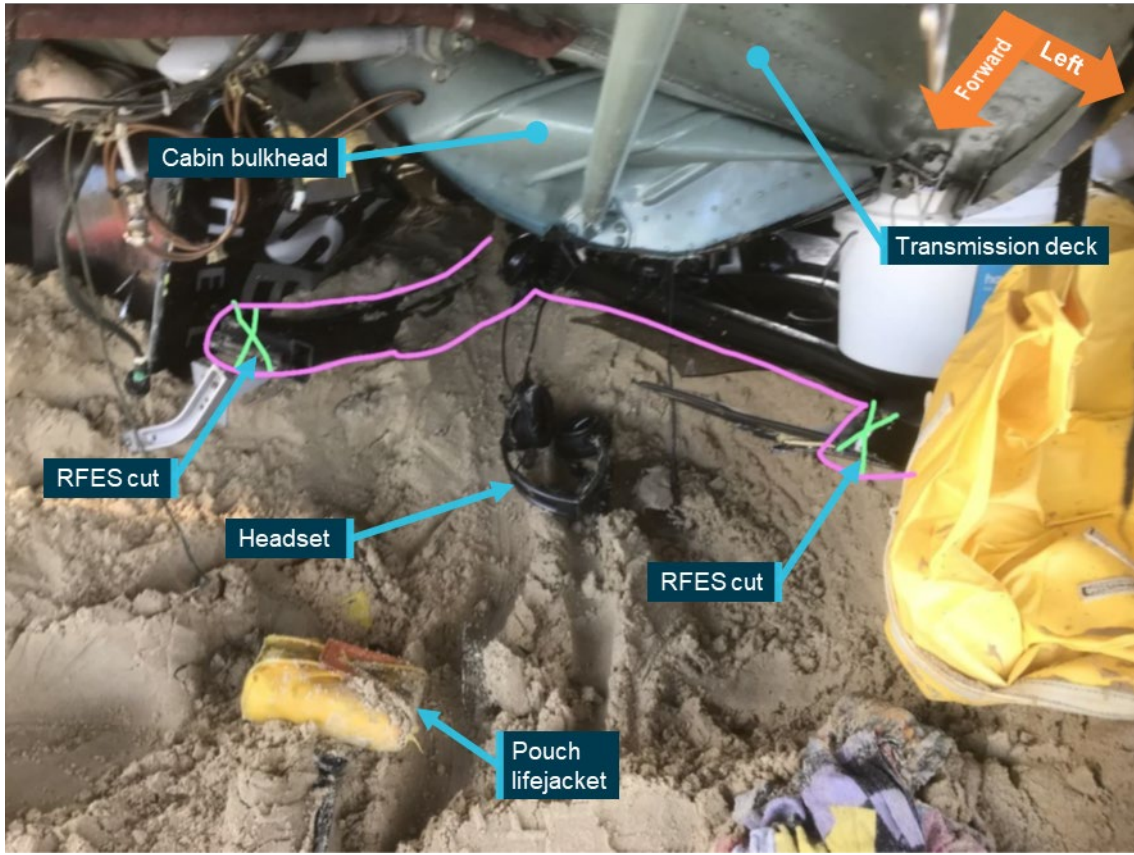
Source: QFES, annotated by QFES and ATSB
