Pilot incapacitation, loss of control and collision with terrain involving Gulfstream 695A, VH-HPY

55 km south-east of Cloncurry Airport, Queensland on 4 November 2023

AO-2023-053

Final – 19 June 2025

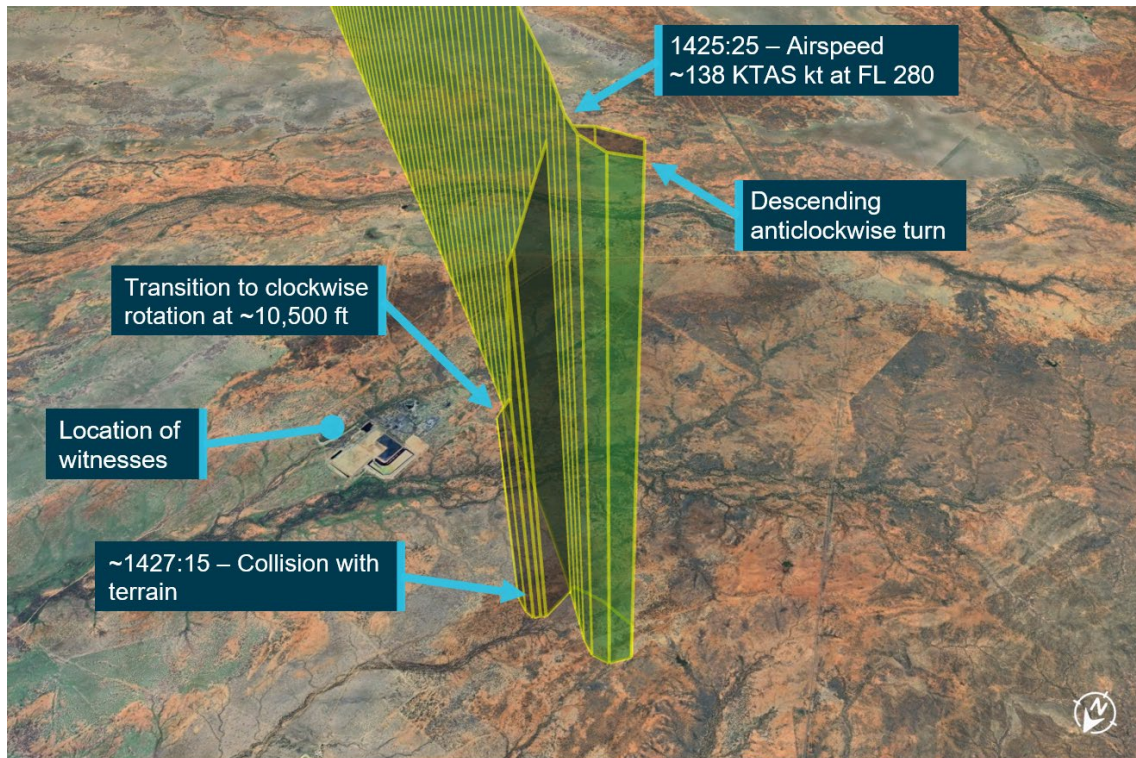
Figure 4: Flight path of VH-HPY during the descent from FL280

Recorded data indicated that, at 1423:20, the aircraft’s airspeed began to reduce from a cruise airspeed of about 236 KTAS.⁶ At 1425:25, the airspeed had decreased to about 138 KTAS and the aircraft departed controlled flight (see *Flight performance analysis*). The aircraft initially entered a descending anticlockwise⁷ turn with an increasing rate of descent. At an altitude of about 10,500 ft, the aircraft transitioned into a tight clockwise helical descent, likely an aerodynamic spin,⁸ with a subsequent average rate of descent of about 13,500 ft/min (Figure 4).

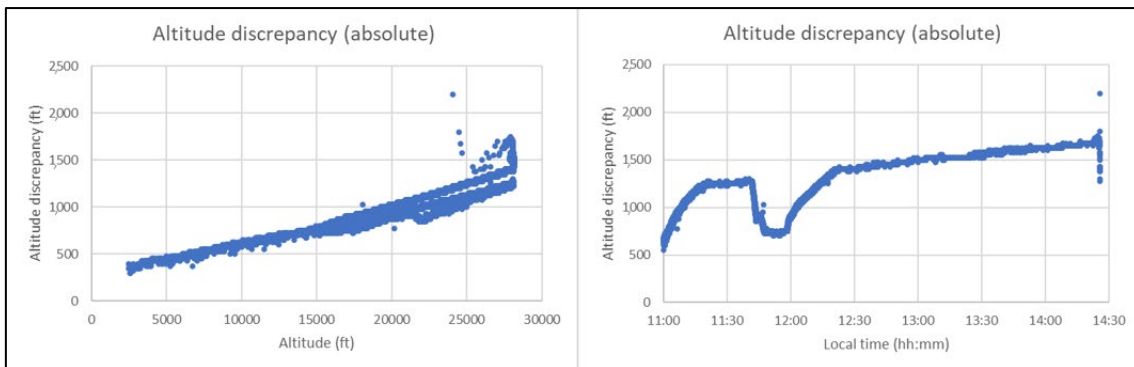
Figure 9: Scatter plot of pressure and GPS altitude discrepancy with altitude (left) and over time (right)

The ADS-B data that was broadcast from the aircraft during the accident flight contained a discrepancy between the pressure altitude and the GPS altitude (Figure 8).²² At the start of the second cruise phase, the broadcast pressure altitude was 28,000 ft while the GPS altitude was 29,400 ft. At the end of the second cruise phase (approximately 2 hours later), the broadcast pressure altitude was 28,050 ft while the GPS altitude was 29,750 ft. The difference in pressure and GPS altitudes over the entire flight varied with altitude and flight time and is shown on a scatter plot below (Figure 9).

When the above data was corrected for local barometric pressure and GPS ellipsoid modelling, the difference in altitudes at the end of the second cruise phase of flight was about 1,400 ft. The GPS altitudes from ADS-B, OzRunways and TrackPlus, which had independent GPS sources and data processing, were broadly aligned over the entire flight, and it is therefore likely that the pressure altitude was reading low and the aircraft was likely flying at FL294 (i.e. the actual position of the aircraft was likely higher than indicated). The reason for the discrepancy could not be determined, although a static source leak inside the cabin could not be discounted.

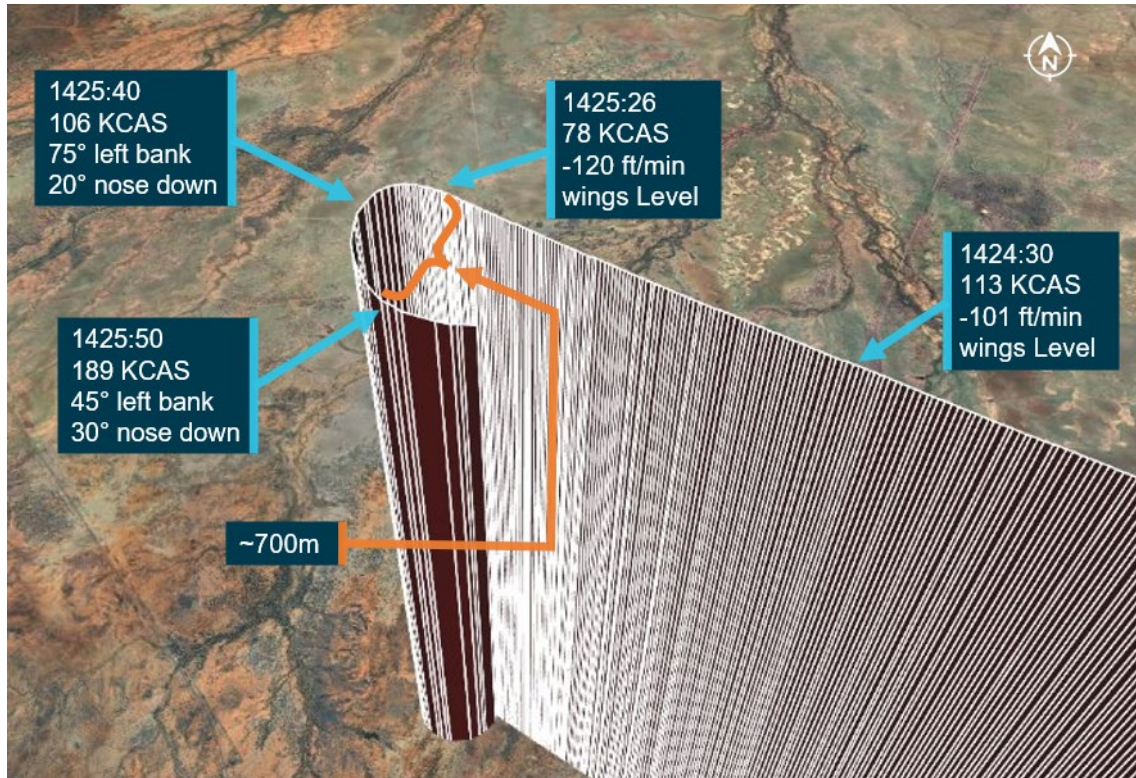
Figure 11: Deceleration and loss of control

At 1425:40, the aircraft's heading had turned through 85° and it had accelerated to about 106 KCAS. From this point, over the following 10 seconds, the angle of bank was estimated to reduce to around 45° and the nose-down pitch change slowed until it stabilised about 30° nose down all while the calculated AoA remained constant at around 8°. During this period, the aircraft's heading turned through a further 100° and the speed increased to about 189 KCAS. The diameter of the turn was approximately 700 m (Figure 11).

Because of the extreme attitude of the aircraft from this time on, the ADS-B data and TrackPlus data became unreliable, likely due to the angle of the onboard antenna and reflected signals. The last reliable ADS-B position information occurred at 1425:50 and at 25,500 ft standard barometric altitude and 189 KCAS. Only horizontal ADS-B position information remained valid for another 5 seconds, by which point the aircraft had turned through a ~270° track angle and crossed back through its original track.

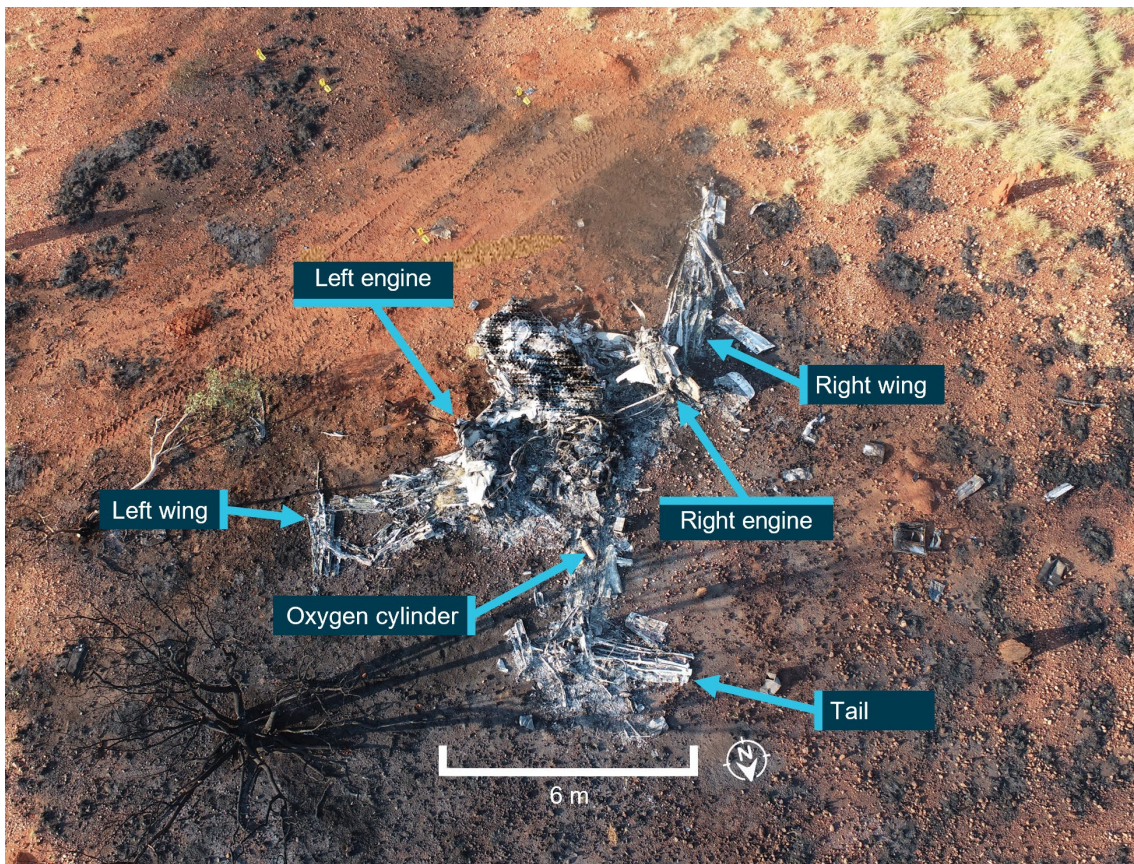
Figure 12: Overview of the accident site

The aircraft was destroyed by the impact with terrain and a subsequent fuel-fed post-impact fire (Figure 12). The ATSB conducted an onsite examination of the aircraft wreckage. The ground impact marks and wreckage position indicated that the aircraft impacted terrain upright with a shallow, nose-down attitude with little forward momentum. Immediately surrounding the wreckage, numerous landscape features (a tree and termite mounds) remained upright and had not been disturbed by the aircraft impact or its liberated debris (Figure 13). The compression and displacement of the aft fuselage relative to the engines, the displacement of the inboard wing section and the aircraft nose, showed that the aircraft was rotating clockwise on impact with the terrain, which was highly indicative of a spin.

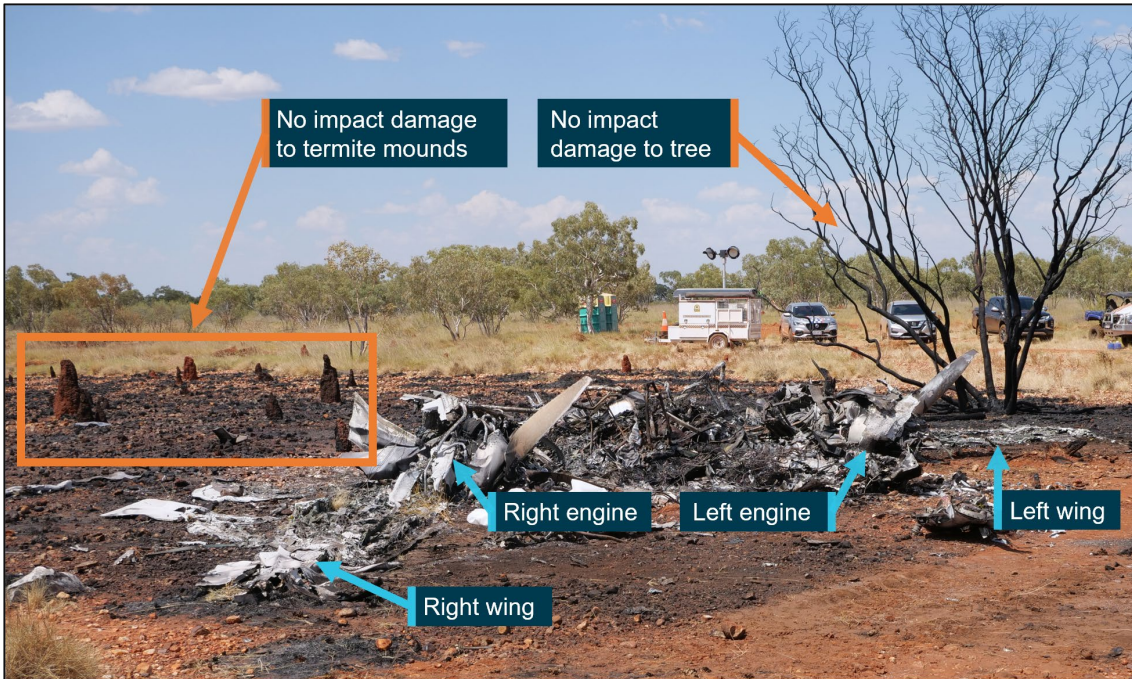
Figure 13: Heavily disrupted and burnt remnants of the wreckage at the accident site

The surrounding landscape features (termite mounds and a tree) remained upright and were not disturbed from the impact.
Source: ATSB

All major aircraft components were accounted for at the accident site. The disruption to the airframe from the impact and the subsequent fire damage limited the extent to which the aircraft could be examined. The oxygen cylinder fitted to the aircraft was located in the wreckage and its associated components had been significantly fire damaged, precluding any assessment of the oxygen system’s serviceability prior to the accident. Additionally, the components comprising the pressurisation system were unable to be assessed due to the extent of damage sustained.

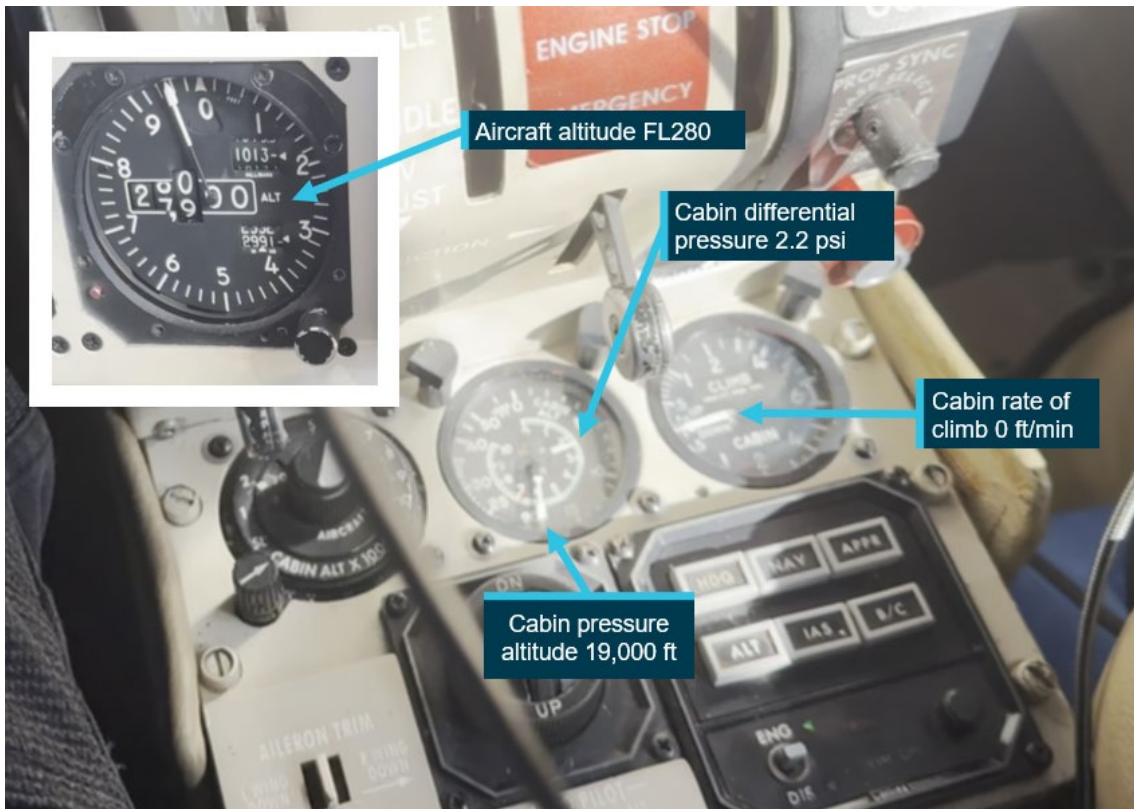
Figure 15: Inflight cockpit indications captured on video footage 27 October 2023

The most recent example occurred on 27 October 2023, 8 days prior to the accident, during a line scanning flight from Toowoomba with the COO, as pilot in command, and camera operator 2 on board. The COO used their phone to video the cockpit indications of the defect. The video captured the aircraft in cruise at FL280, with a cabin differential of 2.2 psi and a cabin altitude of about 19,000 ft (Figure 15). There was no audible cabin alarm on the video's audio.

The COO stated that, on that occasion, the pressurisation system defect had manifested during climb, but they elected to continue to their cruise altitude of FL280 as they hoped the system would rectify itself after a short time. They stated that they maintained FL280, while using the aircraft's emergency oxygen system as a supplemental oxygen supply, for a period of about 20 minutes before the pressurisation system 'probably' started working again. They also stated that they silenced the cabin altitude alerting system using the inhibit button located near the power levers. The defect was not entered in the aircraft's maintenance release, but the occurrence was communicated directly to the maintenance provider via text message with the accompanying video (see also *Recent maintenance*).
