Safety Advisory Notice

Number: AO-2024-001-SAN-001
Released: 22 August 2025

Uncommanded engine acceleration events on single-engine PT6A powered aircraft

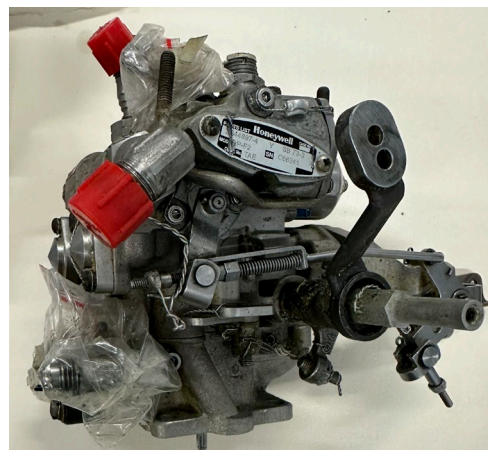
Fuel control unit (Source: ATSB)

The ATSB's examination determined that the uncommanded engine acceleration was very likely associated with an engine fuel control unit (FCU) malfunction. It was identified that there was no documented procedure or troubleshooting information available in the aircraft flight manual and there was limited industry awareness of this type of event and how it should be managed in-flight.

AO-2024-001-SAN-001: In the absence of a flight manual procedure and with limited industry awareness, the ATSB encourages operators of single-engine PT6A powered aircraft to consider potential responses to an uncommanded engine acceleration event for different phases of flight, and to document and train pilots on appropriate actions to ensure operations are performed correctly and consistently.
