Loss of control and collision with terrain involving Beechcraft E55, VH-OMD

Cowra Airport, New South Wales on 11 April 2024

ATSB Transport Safety Report

AO-2024-011

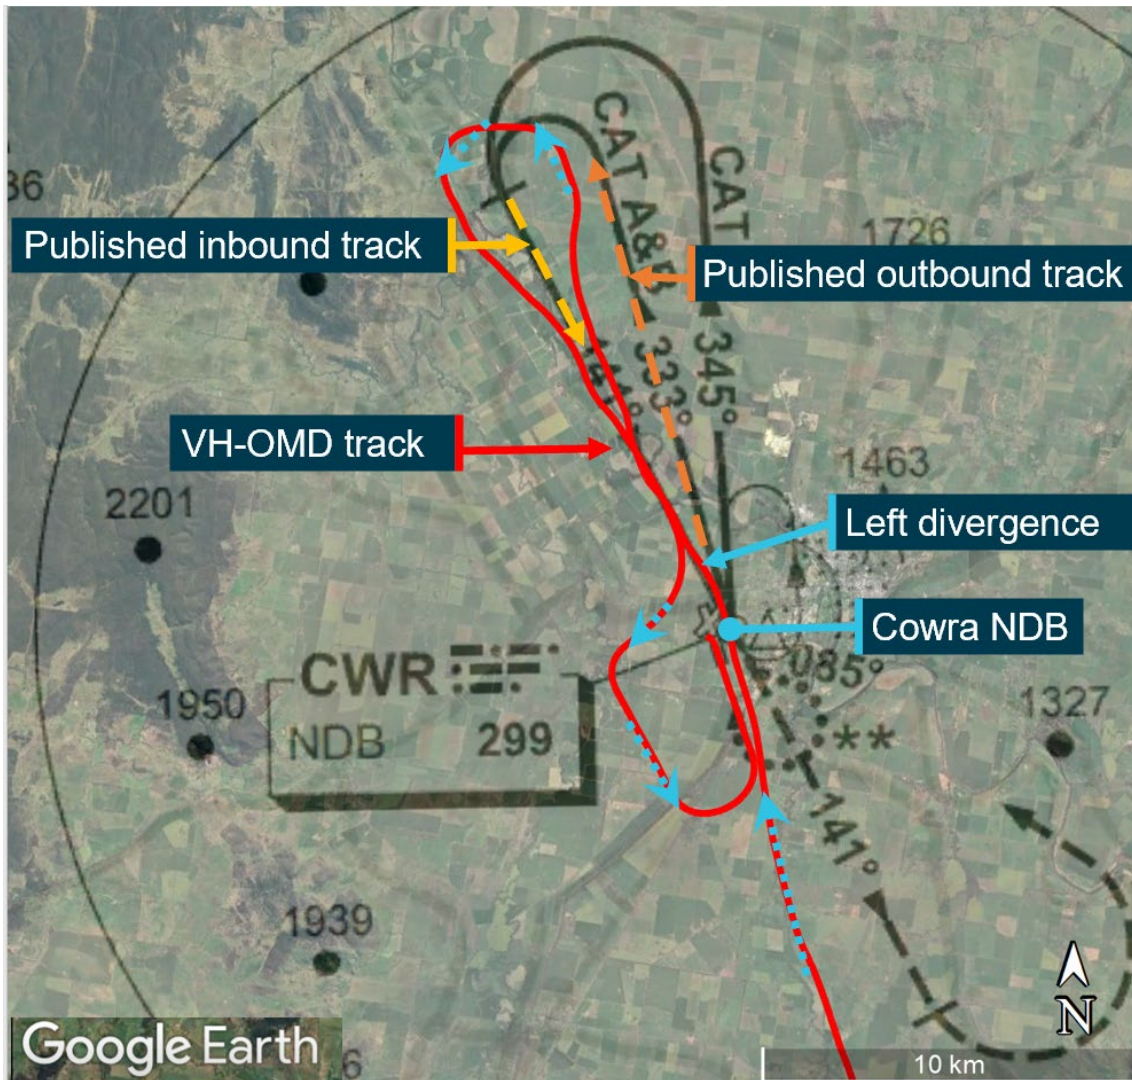
Figure 2: VH-OMD track overlaid on published Cowra NDB approach

In response, the student conducted initial engine failure checks and identified that the left engine was inoperative. At that time, the flight crew did not complete the operator’s one engine inoperative procedure to either feather the left propeller or set zero thrust to simulate a feathered propeller (see the section titled *Simulated one engine inoperative – Fly Oz procedures*). The flight path data showed that, consistent with the simulated left engine failure, the aircraft deviated left of

the published outbound track, and tracked outbound on the published inbound track for about 2 minutes, before starting to correct to the right (Figure 2).

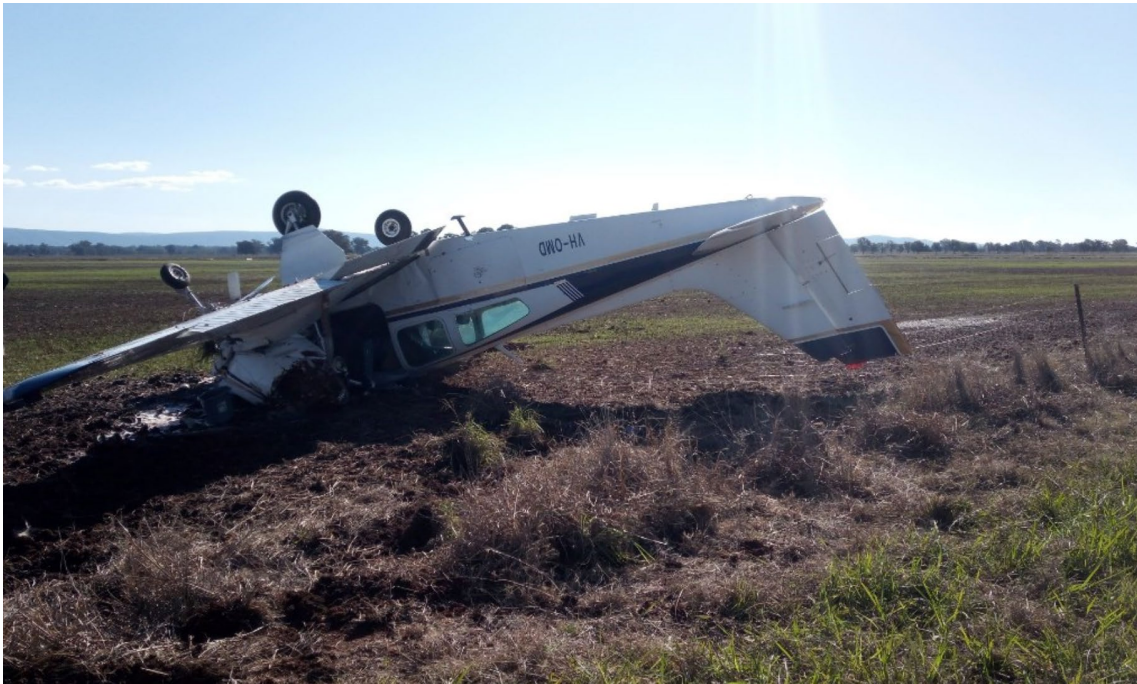
Figure 4: VH-OMD accident site

The aircraft collided with the ground in a nearly vertical nose-down attitude and came to rest inverted (Figure 4). The student and instructor sustained minor injuries and it is possible that their recollection of events may have been affected by trauma associated with the collision. The aircraft was substantially damaged.

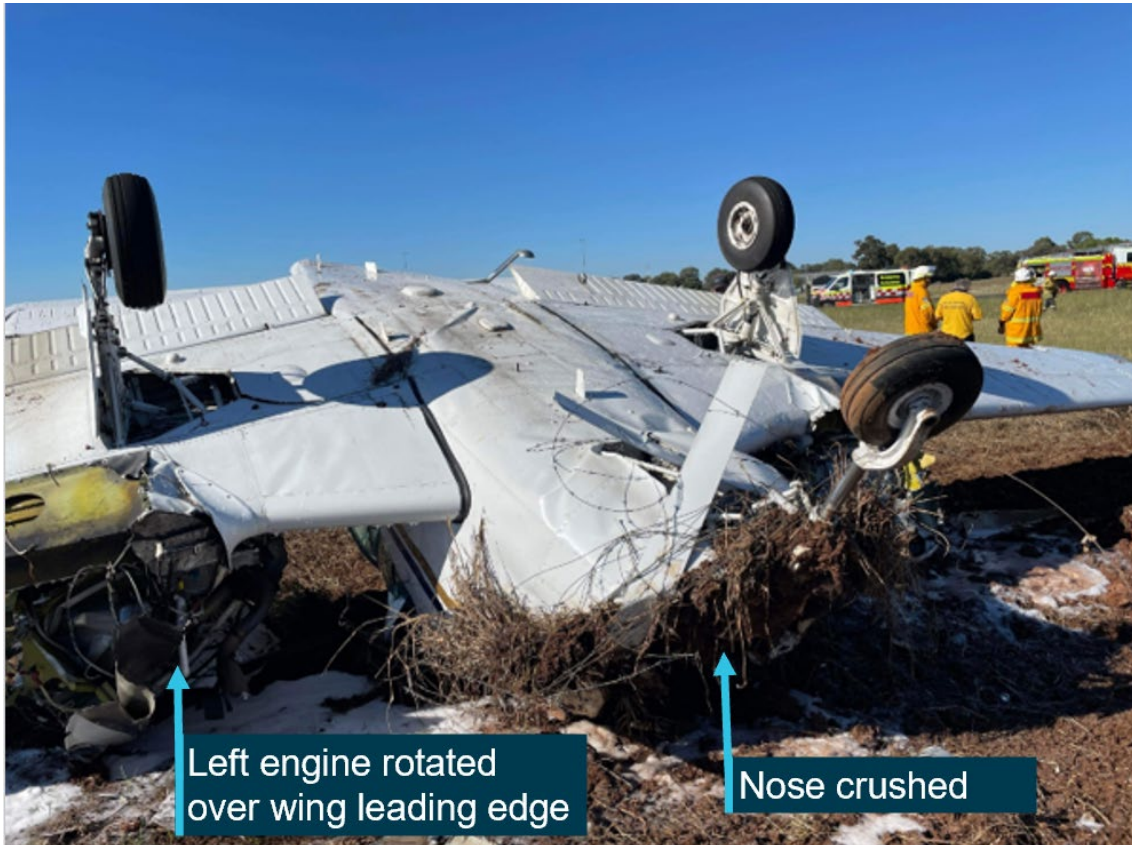
Figure 7: Impact damage to VH-OMD

Both engines had folded backwards around the wing leading edge, which pulled the engine control cables such that the engine control levers were no longer representative of the pre-impact positions. Damage to the wing leading edge resulted in fuel leaking, but there was no post-impact fire. The aircraft departed with full fuel, and had approximately 400 L of fuel remaining on board at impact. Both fuel selectors were set to ON. Flight control continuity was established.

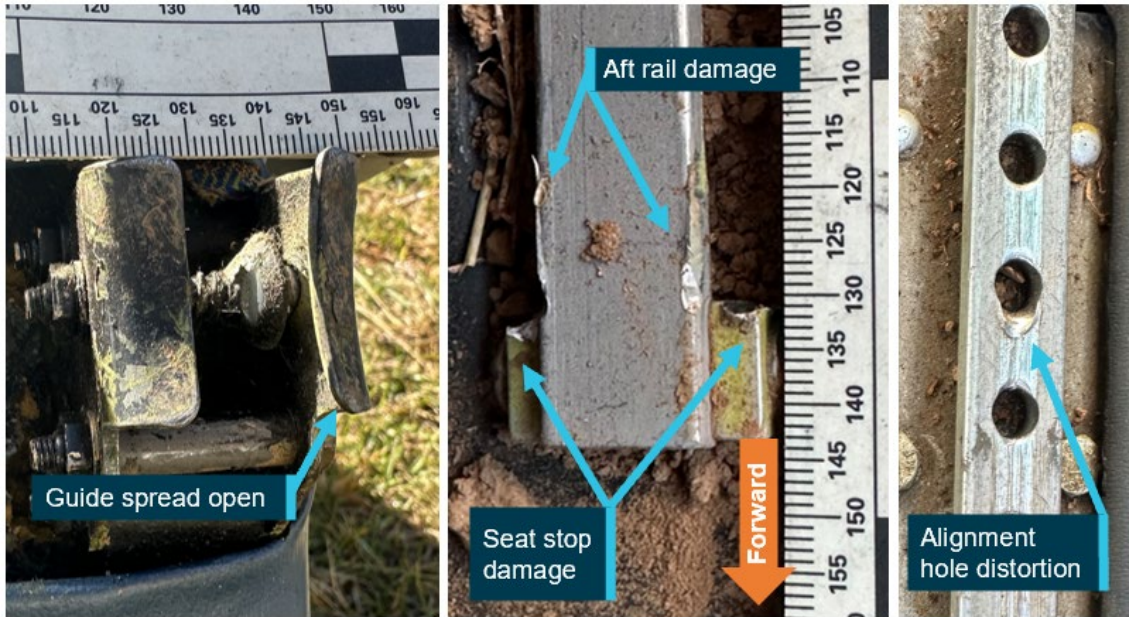
Figure 8: Spreading of one seat guide (left) and associated damage to the rails (right)

Damage and distortion to the seat rails and seat guides was consistent with forward and right forces sustained during the impact sequence. Both seats' centre rails exhibited distortion and smearing on the forward edge from the locking pins being forced from their rail holes. The left seat

locking pin was bent rearward, and the right seat alignment pin had sheared. Figure 8 shows spreading of one of the seat guides and the associated damage to the seat rails.

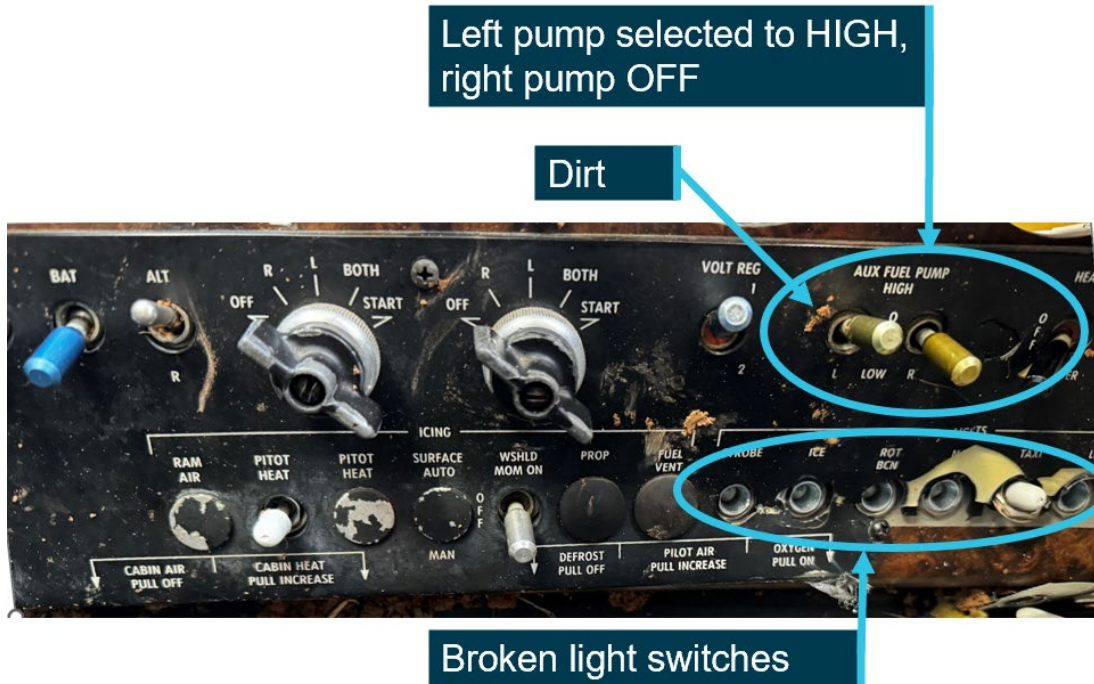
Figure 9: Panel showing post-impact switch positions and disruption

A post-impact photograph showed the left engine auxiliary pump in the high position (Figure 9). However, as the entire panel had come adrift, there was dirt adjacent to the switch, and most of the switches in the row beneath it had broken off, its post-impact position was not considered reliable evidence of its position at the time of the accident. The switch panel location was also consistent with injury to the student's knee. Additionally, the student reported that the pump had been used only for priming prior to engine start then confirmed to be off and not used again during the flight. The metal fuel pump switches were also by design unlikely to be confused with the smaller plastic light switches in the row below and inadvertently selected. It was therefore unlikely to have been on prior to the accident.

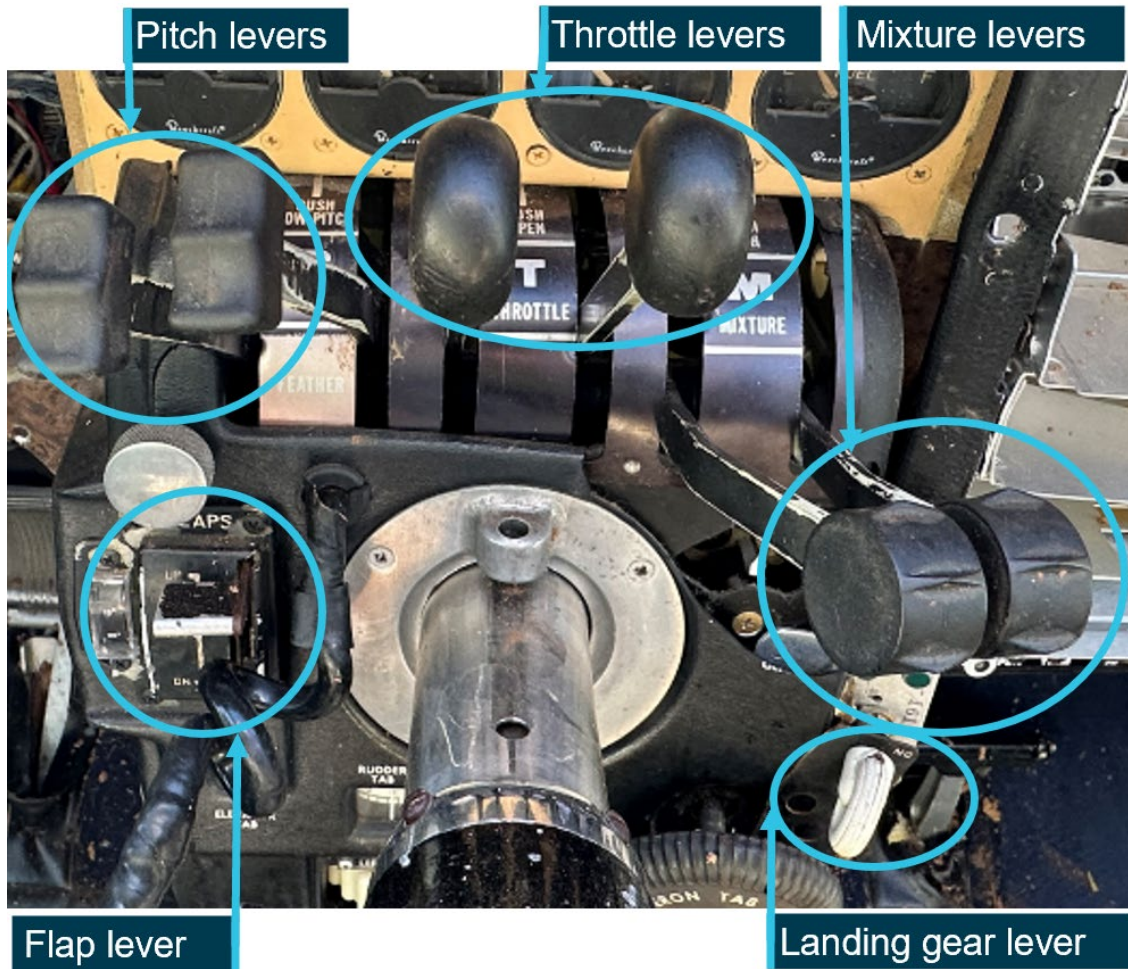
Figure 11: VH-OMD engine control levers

Figure 11 is a post-accident photo of VH-OMD's engine control levers, which are all black, the throttle pair is in the middle and each pair has different shaped knobs. Additionally, the landing gear selector was to the right of the centre console and the flaps to the left. As VH-OMD was certified prior to the standardisation requirements, it was not required to comply with subsequent FARs.

In this case, as the instructor primarily flew VH-OMD, and it was the only twin engine aeroplane the student had flown (other than a simulator), habit interference was unlikely. However, the lack of colour differentiation in the levers, and particularly not having red mixture control levers, may have reduced the opportunity for rapid visual identification of the mixture lever position.
