Runway excursion involving GippsAero GA8, VH-IDM

Whitsunday Airport (Shute Harbour), Queensland on 2 November 2024

ATSB Transport Safety Report

AO-2024-056

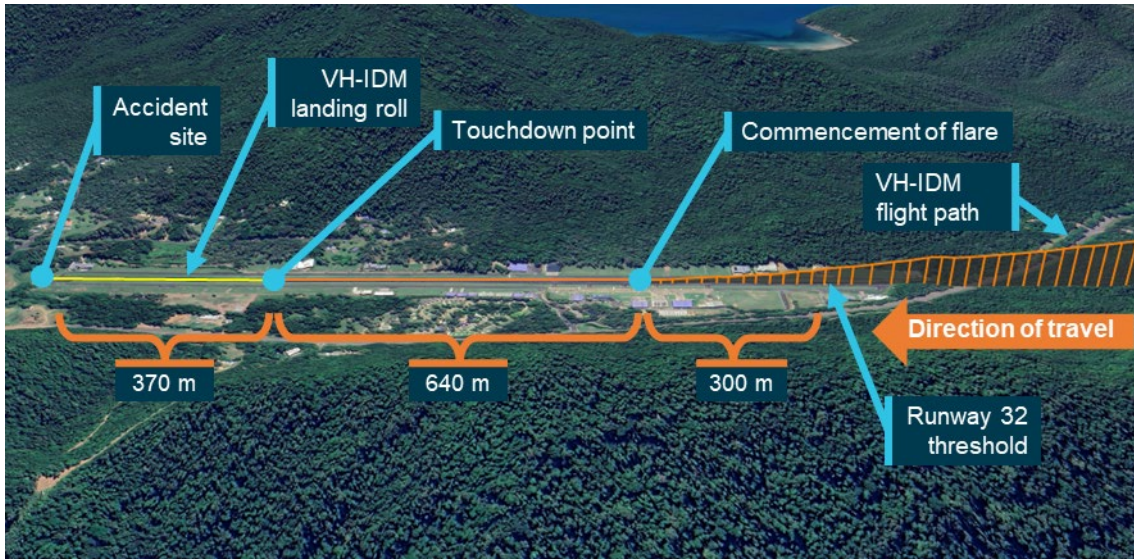
Figure 2: VH-IDM flight path and landing roll

The aircraft continued the approach (Figure 2), remaining above the desired approach path while the airspeed varied between 85–95 kt. The aircraft passed over the displaced threshold of the runway at approximately 100 ft AGL. The pilot commenced the flare about 300 m beyond the displaced threshold, at an airspeed of approximately 90 kt. The aircraft then floated for about 640 m before touching down at a groundspeed of 65 kt with 370 m of runway remaining. The pilot recalled that throughout the approach and landing they did not consider conducting a go-around³ and were focused on landing the aircraft.

After the commencement of the flare, the aircraft floated for approximately 640 m. During the float, the aircraft decelerated and with about 560 m of runway remaining was at the landing approach speed of 71 kt (see the section titled Landing Performance). Subsequently, the main wheels contacted the ground with approximately 370 m of runway remaining at a groundspeed of 65 kt. The aircraft took 18 seconds to reach the end of the runway, during which the groundspeed slowed from 65 kt to 24 kt.

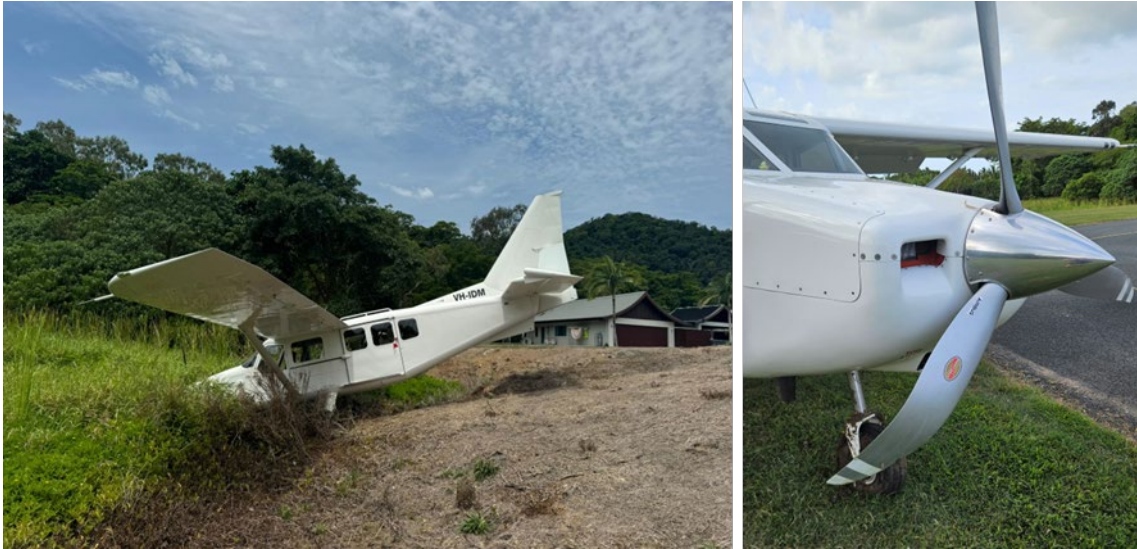
Figure 3: VH-IDM damage

After touching down, the pilot retracted the flaps and recalled attempting to apply full braking pressure. They further recalled that the brakes did not perform as expected and they were unable to bring the aircraft to a stop. Subsequently, veering slightly right, the aircraft departed the end of the runway at a groundspeed of 24 kt. The aircraft travelled briefly across grass before entering marshy ground and coming to rest in a ditch, as the propellor struck the ground. Neither the pilot nor any of the passengers were injured and the aircraft received damage to the propellor and firewall (Figure 3)

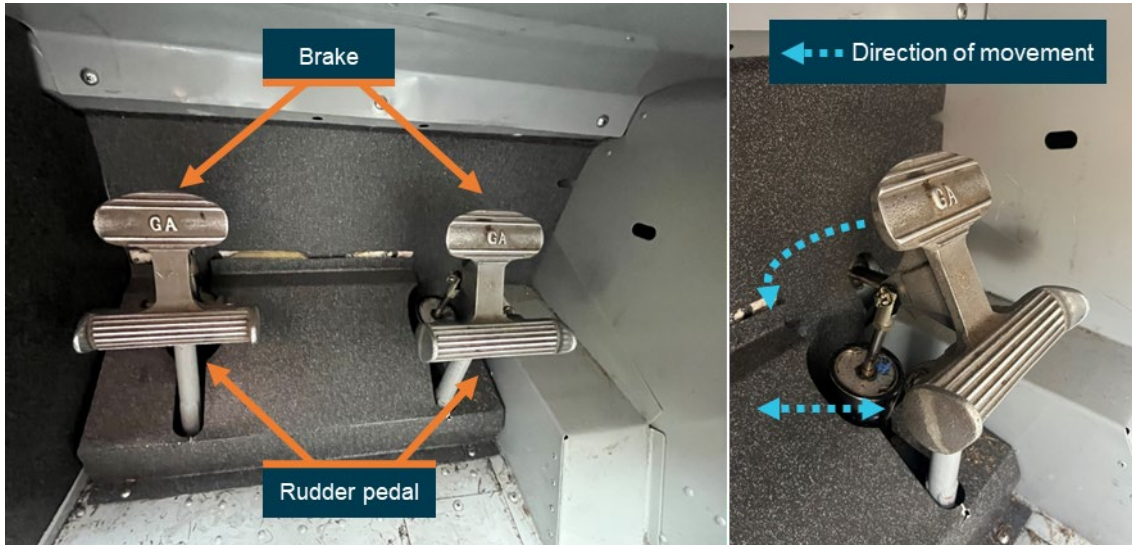
Figure 4: GA8-TC rudder pedals and brakes

The aircraft's brake system included toe brakes incorporated into the rudder pedals. Each rudder pedal was connected hydraulically to a brake unit on the corresponding main landing gear wheel and was engaged by applying pressure to the top of the pedal (Figure 4). During flight, a pilot's feet rested on the floor in contact with the lower part of the rudder pedals to control the rudder. On the ground, a pilot would move their feet up on the pedal so that the top of the foot could be used to apply brake pressure. The heel was then used to maintain rudder control and nosewheel ground steering.

The pilot did not report any issues with the braking performance of the aircraft prior to take-off, and the ATSB was advised that no fault was found with the brakes during the post-accident inspection. Additionally, there were no marks observed on the runway to indicate that the wheels had locked up and the aircraft had skidded. The pilot also advised that their seat position had been adjusted appropriately and that all controls, including the rudder pedals, could be used effectively.

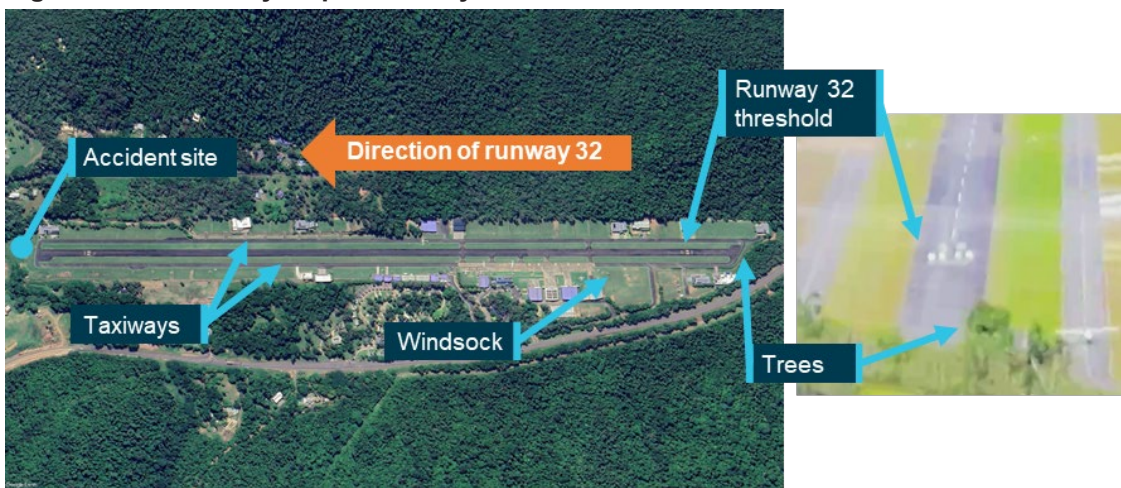
Figure 5: Whitsunday Airport runway environment

Whitsunday Airport (Shute Harbour) was a privately-owned, uncertified airport (aircraft landing area) located in hilly terrain onshore from the Whitsunday Islands. The airport had a single sealed runway 14/32, which was 1,410 m long and 15 m wide (Figure 5). Runway 32 had a displaced threshold due to trees in the undershoot, which reduced the runway available for landing to 1,310 m. The displaced threshold and departure end of the runway were at elevations of approximately 80 ft and 20 ft respectively, giving it a downslope of approximately 1.4%.

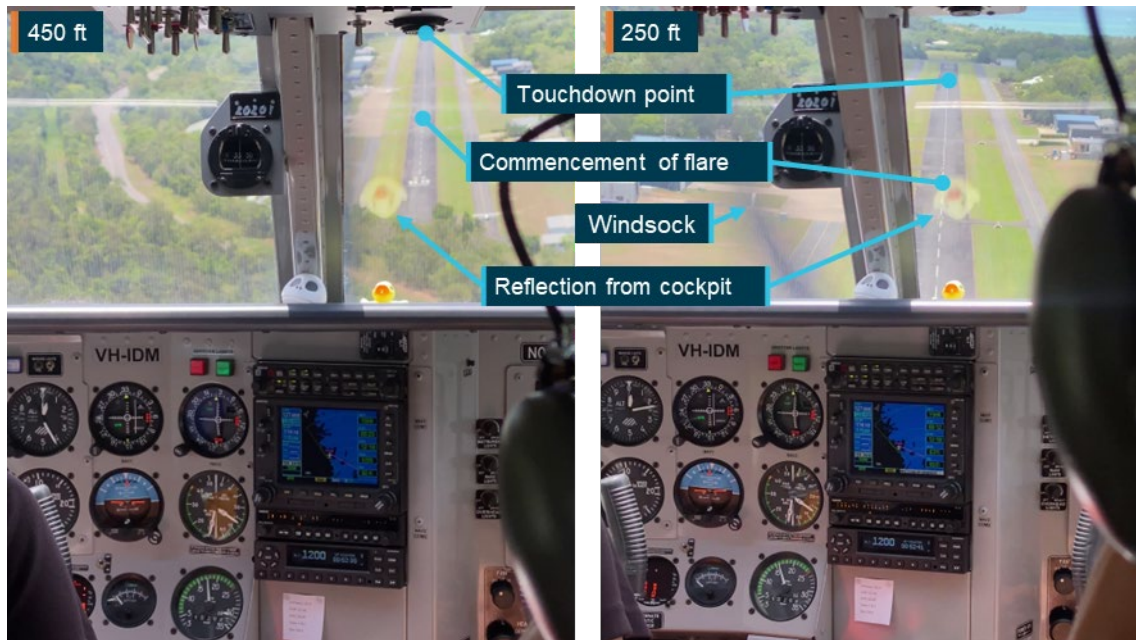
Figure 6: Passenger video footage

From the passengers' videos, the ATSB was able to determine the flight path and speed of the aircraft throughout the approach and landing. While the pilot advised their intended aim point was just past the displaced threshold, the aircraft maintained an average descent path of approximately 7° towards a landing spot 300 m beyond the displaced threshold. Overhead the displaced threshold, the aircraft was approximately 100 ft above ground level. Throughout the approach, the navigation unit displayed the groundspeed as between 90–95 kt. The airspeed indicator was also periodically visible and showed readings up to 95 kt.

The pilot was observed to reduce the throttle at several points during the final approach with the last reduction observed just prior to the flare. This indicated the approach was conducted with some power. The pilot was also observed to interact with the radio unit during the final approach, which was likely when responding to the trailing aircraft. The video confirmed that the flaps were set to 38° for landing and were retracted immediately upon touchdown. Also on touchdown, the pilot's feet moved upwards on the rudder pedals and pressure was applied against the pedals during the landing roll. However, it could not be ascertained whether the pressure was maintained throughout the landing roll, or whether the pressure was being applied to the top of the pedals to apply brakes or to the bottom of the pedals for rudder and steering.
